NDI No. PA 01073
PENN DER No. 10-63

LAKE SAXONY DAM

PACW 51-81C-0027
PHASE I INSPECTION REPORT

NATIONAL DAM INSPECTION PROGRAM

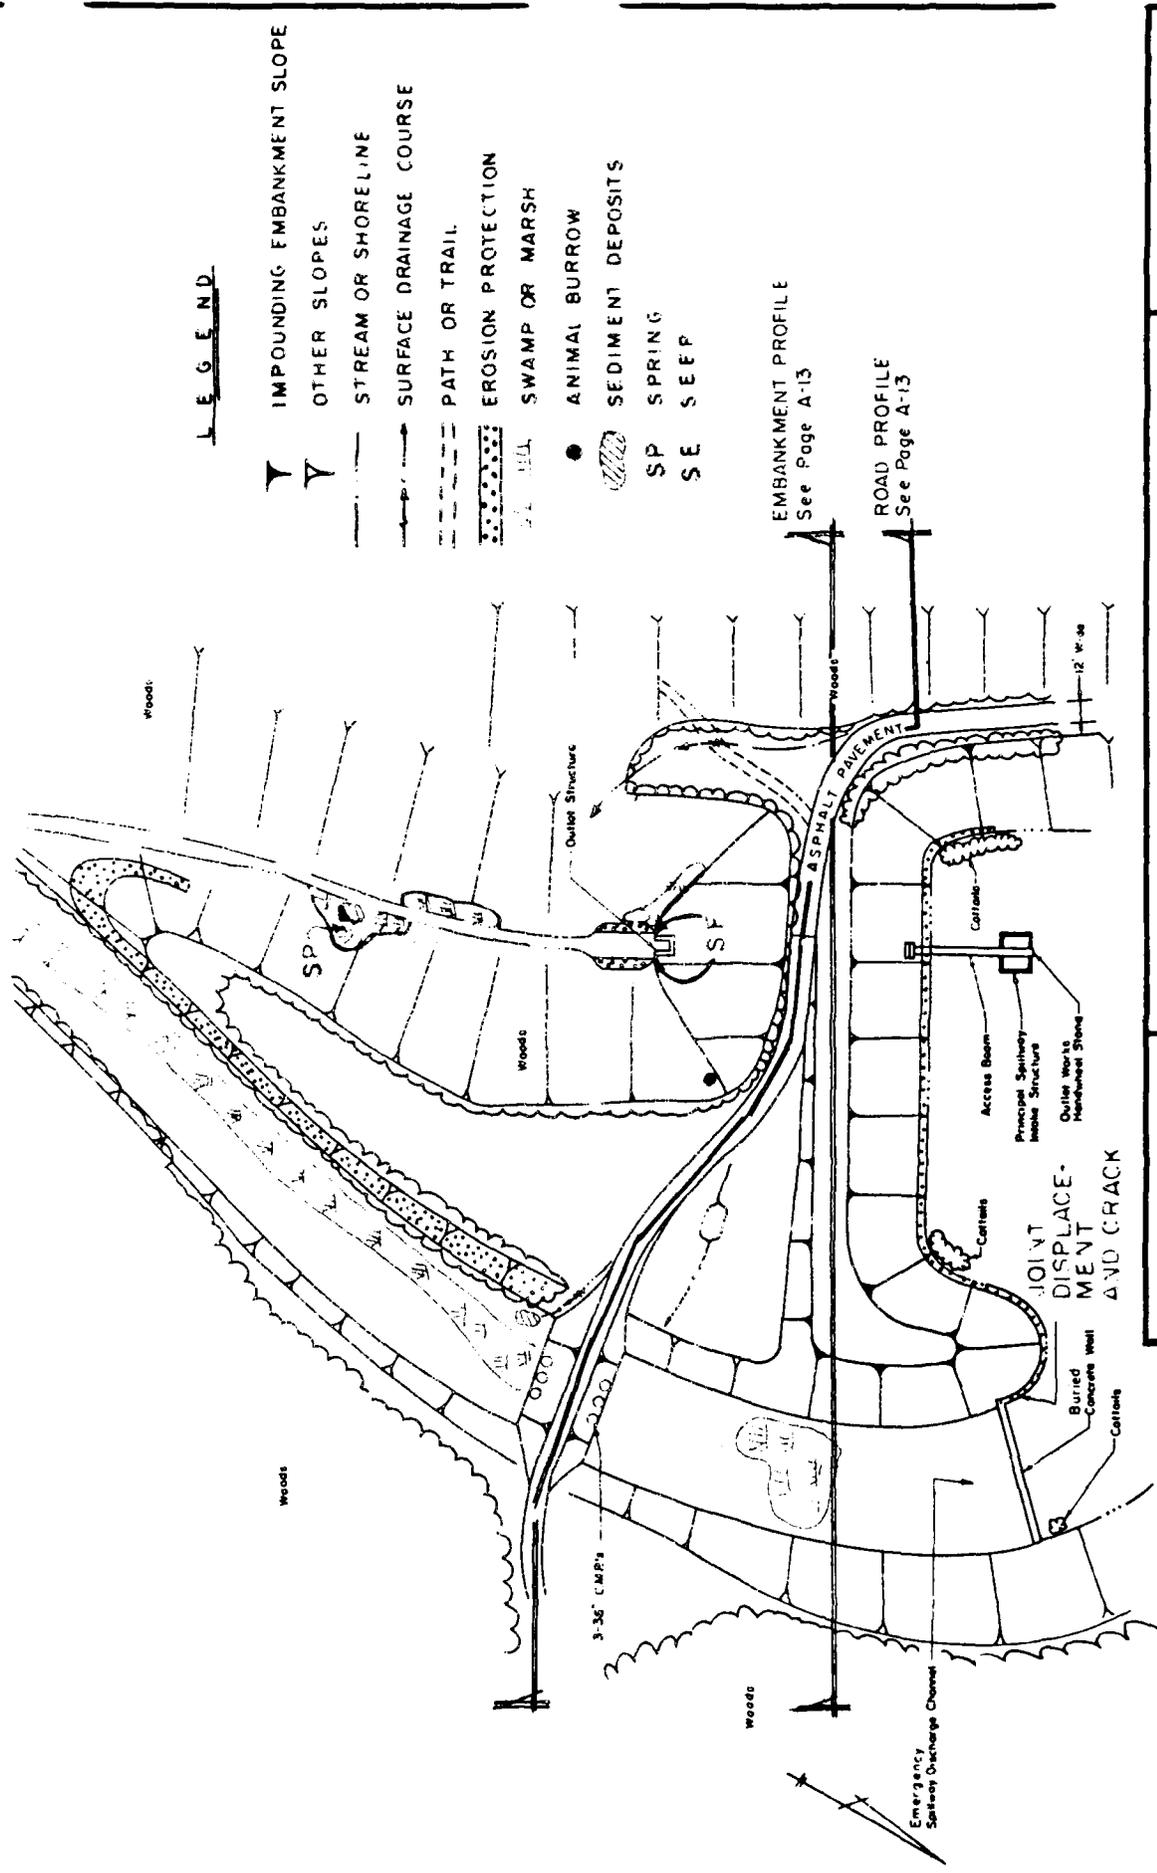
DATE: MAY 1981		LAKE SAXONY	
SCALE: NONE		NATIONAL DAM INSPECTION PROGRAM	
DR: JF	CK: JEB	ACKENHEIL & ASSOCIATES	
DWG. NO. 801380-1		CONSULTING GEO SYSTEMS, INC. ENGINEERS 1000 BANKSVILLE RD. PITTSBURGH, PA. 15216	
		FIELD SKETCH

A swampy zone was observed in the junction between the embankment and the right abutment. The swampy zone extended from approximately mid-height of the embankment down to the stilling pool below the principal spillway outlet structure. Two seeps were flowing from the embankment along the wingwalls of the outlet structure. The seep on the right appeared to have a greater discharge than the seep on the left but flow quantities were too small to estimate. Both seeps were located in a region of significant iron staining.

An animal burrow was observed near the junction of the embankment and the abutment on the left side of the dam just below the road.

(2) Downstream Spring: A spring, discharging an estimated 20 to 25 gallons per minute, was observed on the Sarver Run creek bank, approximately 250 feet below the crest of the embankment. A considerable amount of fine soil sediment was observed below the spring and the area was heavily iron stained. A sediment deposit was observed at the point where the spring flow entered the creek channel. The owner's representative advised that the spring predated the dam.
