DELAWARE RIVER BASIN  
COHANSEY RIVER, CUMBERLAND COUNTY  
NEW JERSEY

# SUNSET LAKE RACEWAY DAM NJ 00764

## PHASE 1 INSPECTION REPORT NATIONAL DAM SAFETY PROGRAM

REPT. NO: DAEN | NAP - 53842 / NJ 00764 - 81 / 07

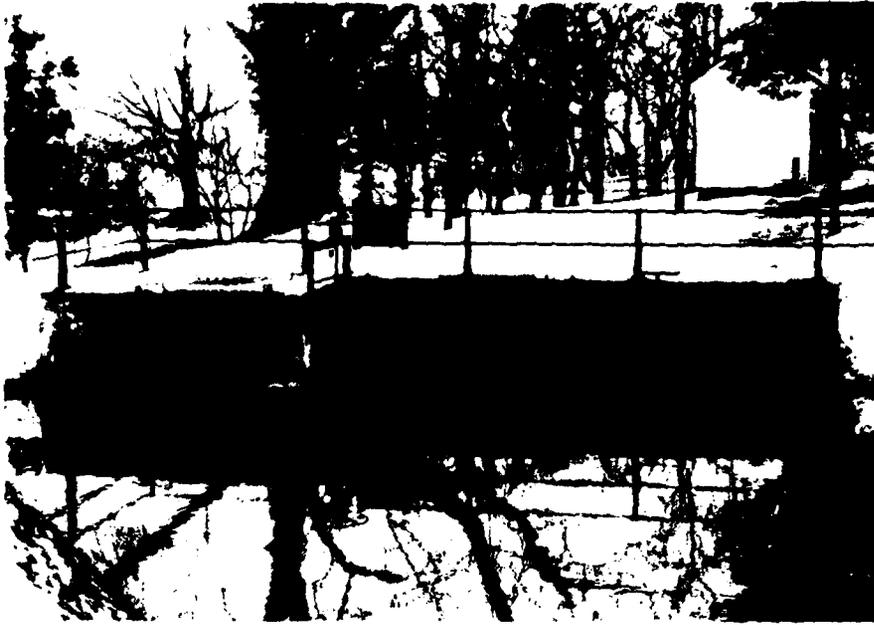
PHOTO 1  
SPILLWAY AT DOWNSTREAM END OF RACEWAY (STA 0+0)

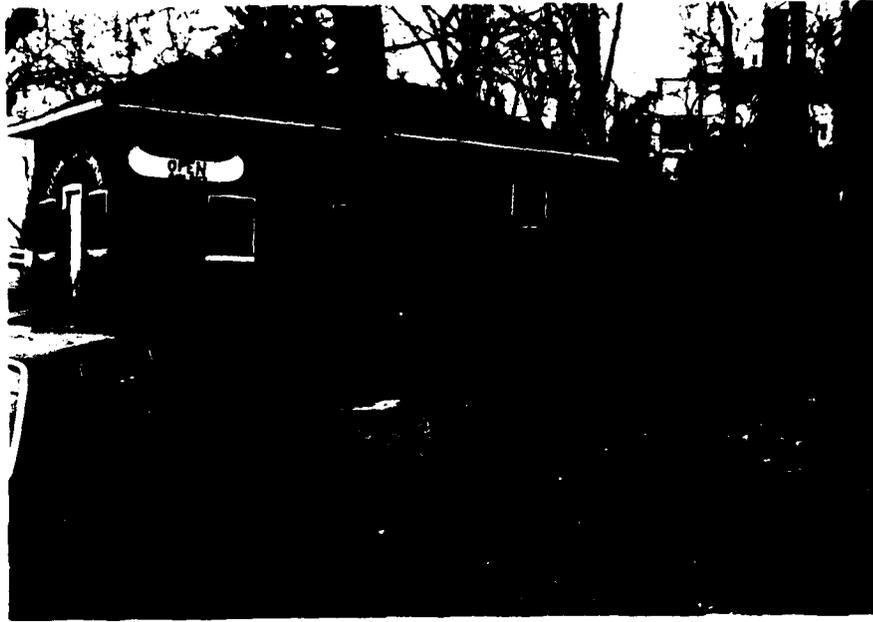
PHOTO 5  
DOWNSTREAM FACE OF EMBANKMENT AT PARK BUILDING  
(APPROX. STA 1+0)

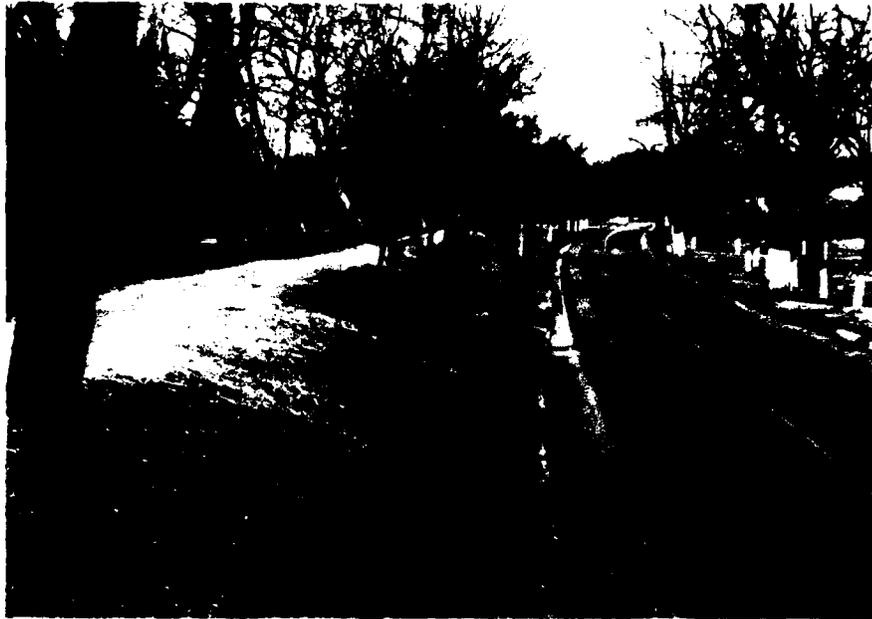
- Sta 10+20 to 19+70 - The downstream face of the dam was observed to be generally grass covered with a few bare patches evident.
- Sta 19+70 to 22+65 - Gabion riprap slope protection was observed on the upstream embankment immediately downstream of the footbridge located at Sta 19+70. Upstream from the pedestrian footbridge the downstream face of embankment was observed to be generally covered with grass, briars,

PHOTO 7  
DOWNSTREAM FACE OF EMBANKMENT (APPROX. STA 11+0)

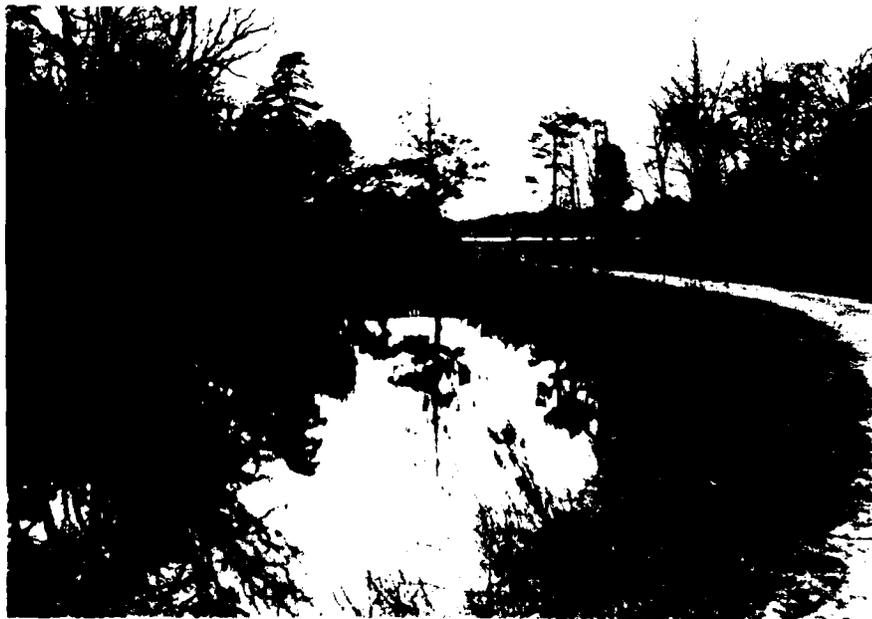
PHOTO 8  
UPSTREAM FACE OF EMBANKMENT IN VICINITY OF ENTRANCE  
FROM SUNSET LAKE
