DELAWARE RIVER BASIN  
WELDON BROOK, MORRIS COUNTY  
NEW JERSEY

**N.J. NO NAME  
NO. 30 DAM  
NJ 00339**

**PHASE 1 INSPECTION REPORT  
NATIONAL DAM SAFETY PROGRAM**

JULY 1981

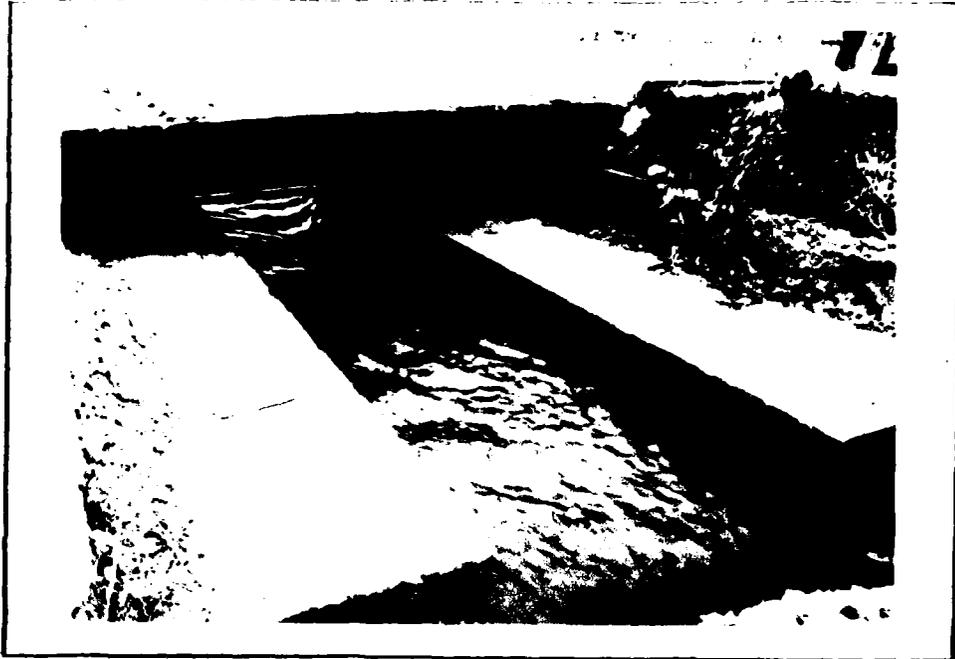
The weir is 10.5 feet wide.  
Concrete is severely spalled and  
rebars are exposed.

3. VIEW OF THE SPILLWAY CREST AND ERODED CONCRETE ON THE  
DOWNSTREAM SIDE. (4/24/81)

Concrete should be  
repaired.

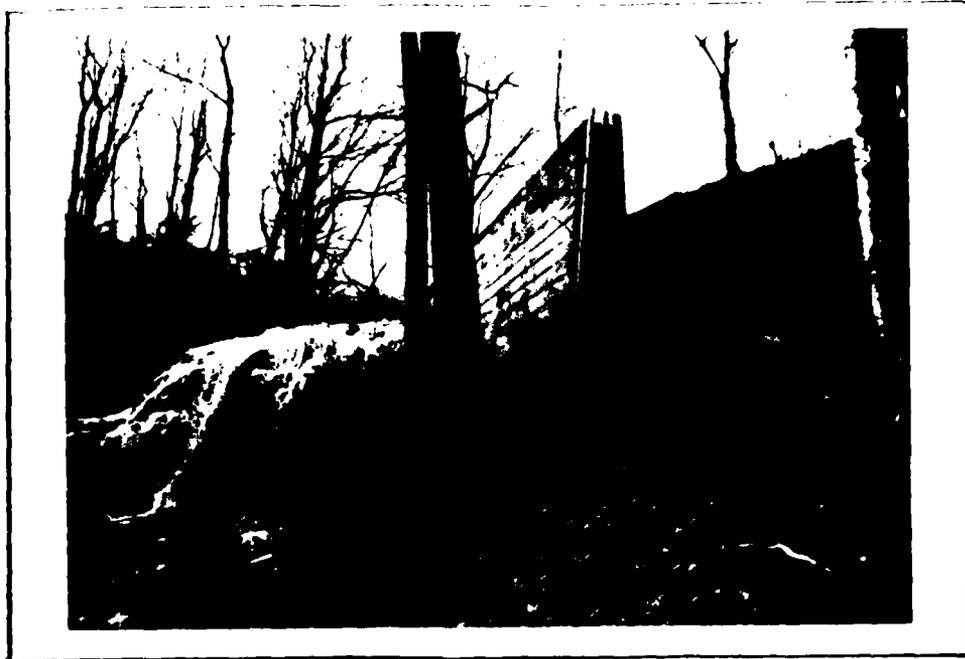
c. Appurtenant Structures. The concrete abutments of the spillway are severely spalled. Large chunks of concrete can be easily removed by hand. Exposed reinforcing bars are visible on the left side of the spillway. The damage was observed to be most severe on the upstream side. The spillway discharges onto a large rock outcrop and the water falls vertically from the rock to the discharge channel at the toe of the dam.

5. VIEW OF THE LEFT END OF THE CONCRETE WALL SHOWING PROTRUDING REINFORCING BARS AND WOOD FORMWORK IN PLACE. (4/24/81)

8. The deteriorated concrete on the spillway should be repaired.

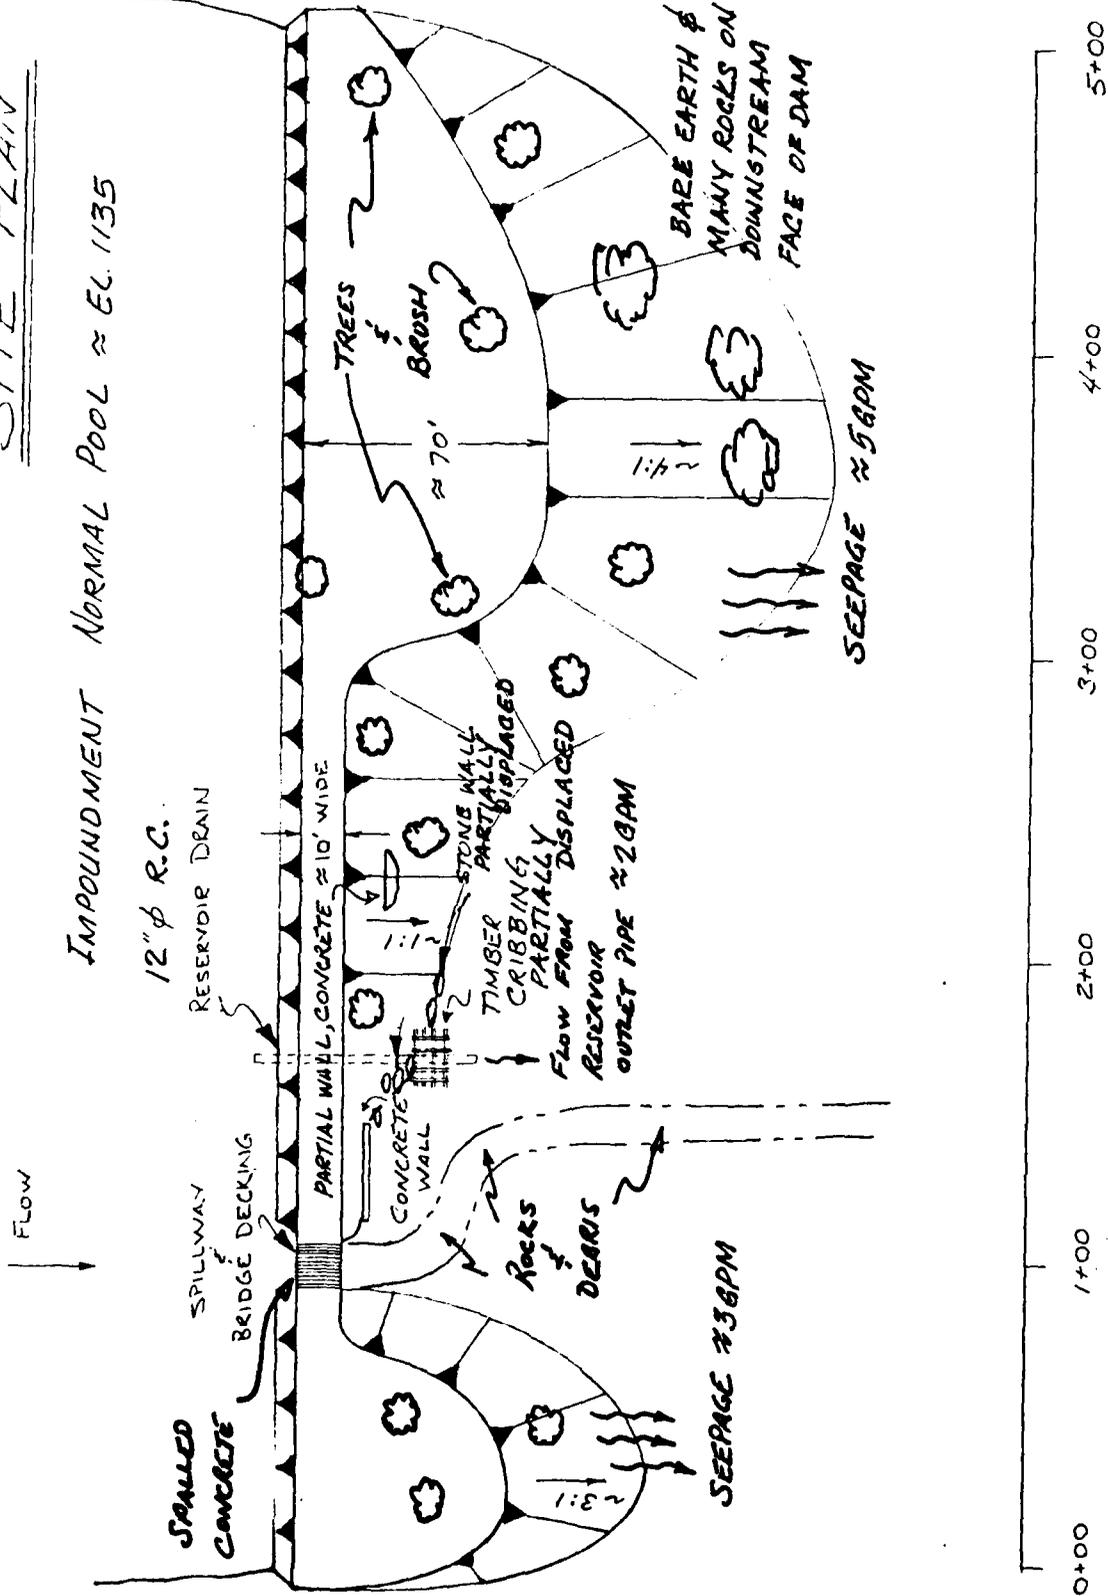
SITE PLAN

SEEPAGE ≈ 5 BPM
