SUNSHINE LAKE DAM NJ 00766

PHASE 1 INSPECTION REPORT NATIONAL DAM SAFETY PROGRAM

Philadelphia District
Corps of Engineers
Philadelphia, Pennsylvania

JULY 1981

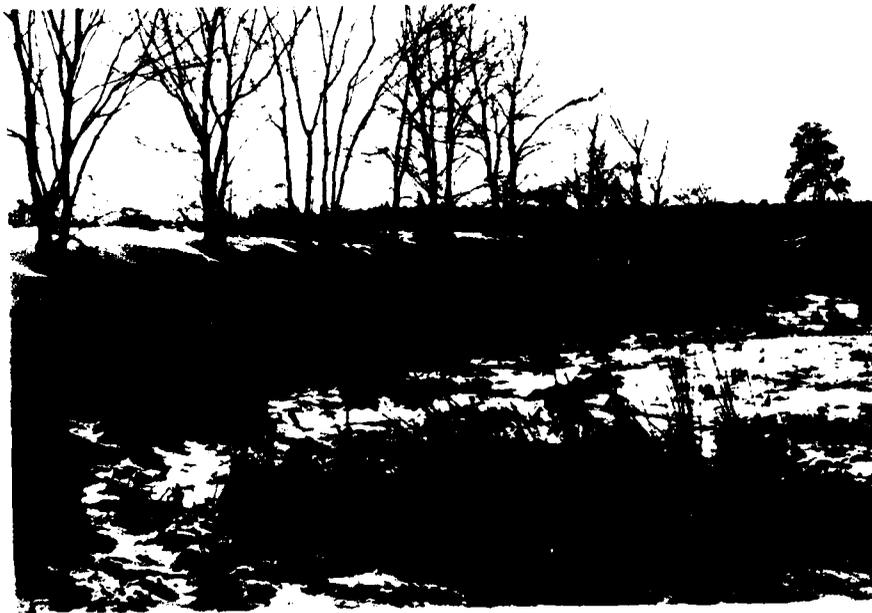
PHOTO 6
DOWNSTREAM FACE OF DAM
