**FIELD TEST OF EXPEDIENT  
PAVEMENT REPAIRS  
(TEST ITEMS 16-35)**

**MICHAEL T. McNERNEY  
ENGINEERING RESEARCH DIVISION**

**NOVEMBER 1980**

**ENGINEERING & SERVICES LABORATORY  
AIR FORCE ENGINEERING & SERVICES CENTER  
TYNDALL AIR FORCE BASE, FLORIDA 32403**

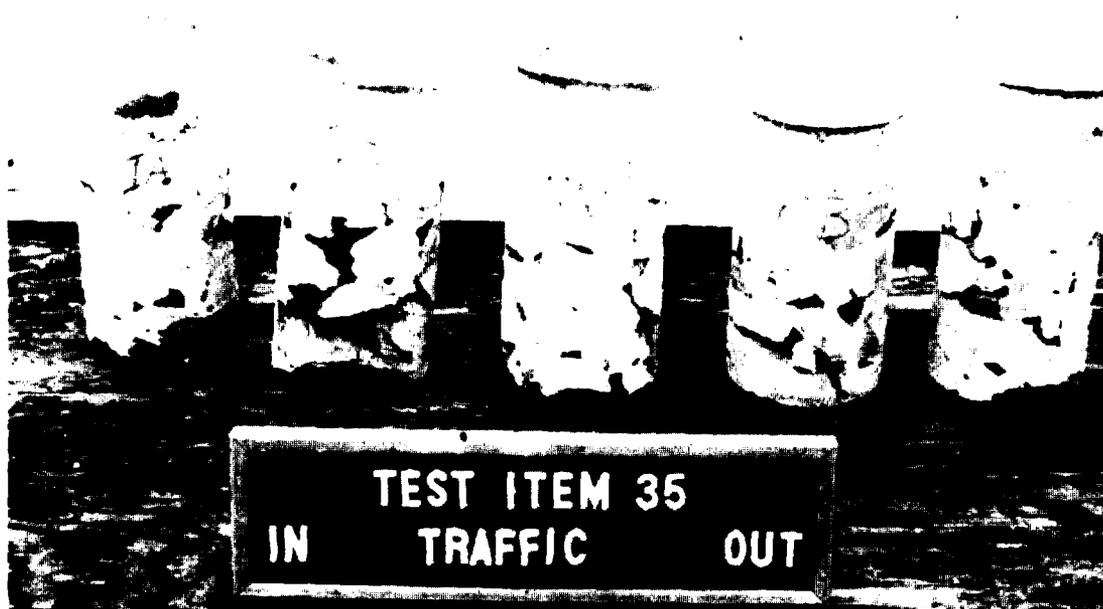
Figure 22. Core Samples

Flexing was severe enough to rule out C-141 traffic over the test pit. Core samples were taken and found to have monomer at the top and bottom with aggregate in between (Figure 22).

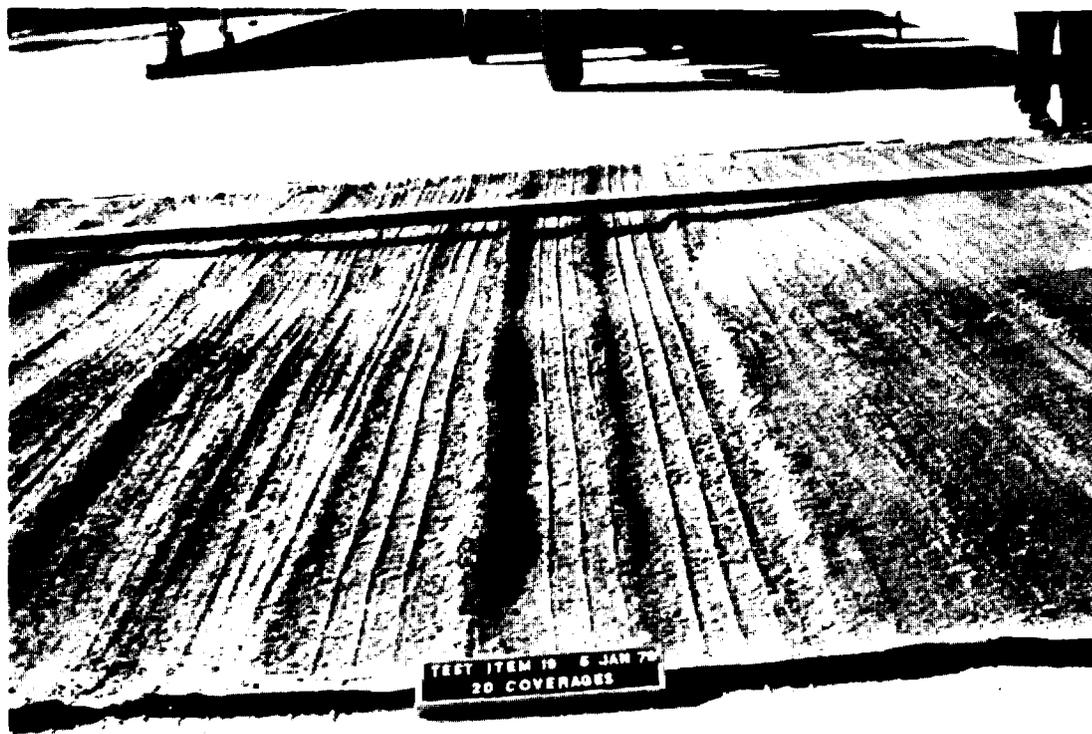
Figure 24. Surface Condition After 20 Coverages of the F-4 Load Cart

(3) Results. During the first coverage of the F-4 load cart, surface flooding was observed and a pumping effect occurred as the load cart passed over the surface. The surface showed ruts of approximately 0.75 inch, and crushed limestone tended to be pushed out of the test pit. After 20 coverages, consolidation of 2.4 inches was measured in the traffic lane (Figure 24). Traffic was halted, and density readings were obtained.

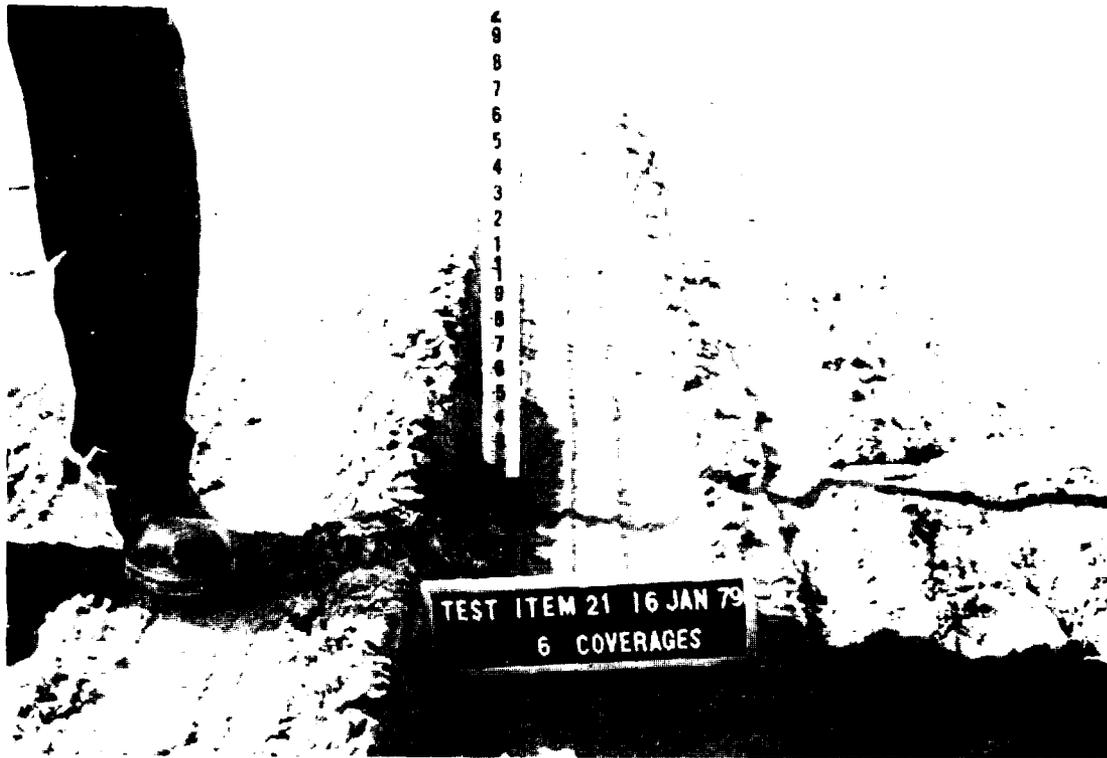
Figure 29. Second Failure After Repairing Test Item 21

Though considered a failure according to Corps of Engineers criteria, the test was continued by adding more crushed stone and compacting with 12 additional coverages. Six coverages of the 1-4 load cart resulted in a second failure of the test item (Figure 29).

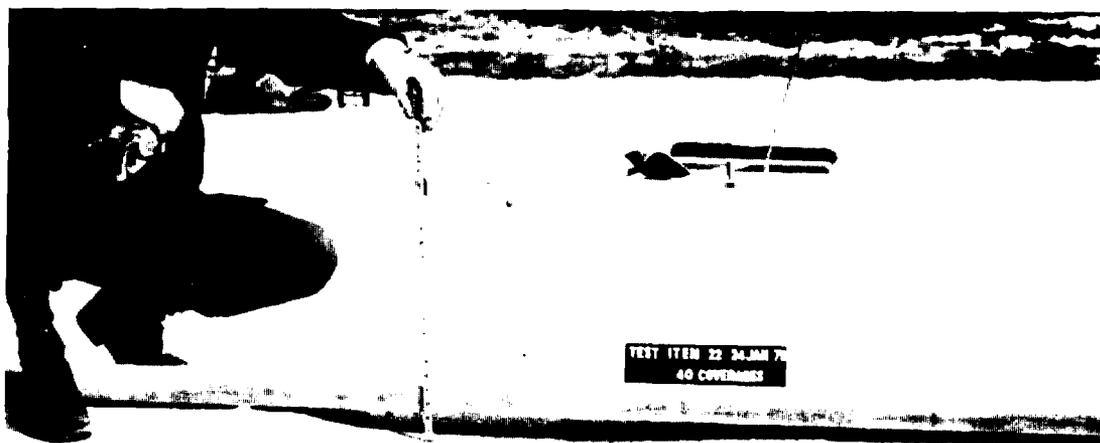
Figure 31. Consolidation of Surface After 40 Coverages, Test Item 22

(3) Results. After 40 coverages with the F-4 load cart, repairs became necessary when the load cart encountered difficulty entering and exiting the pit due to consolidation of 2.25 inches in the traffic lane (Figure 31).

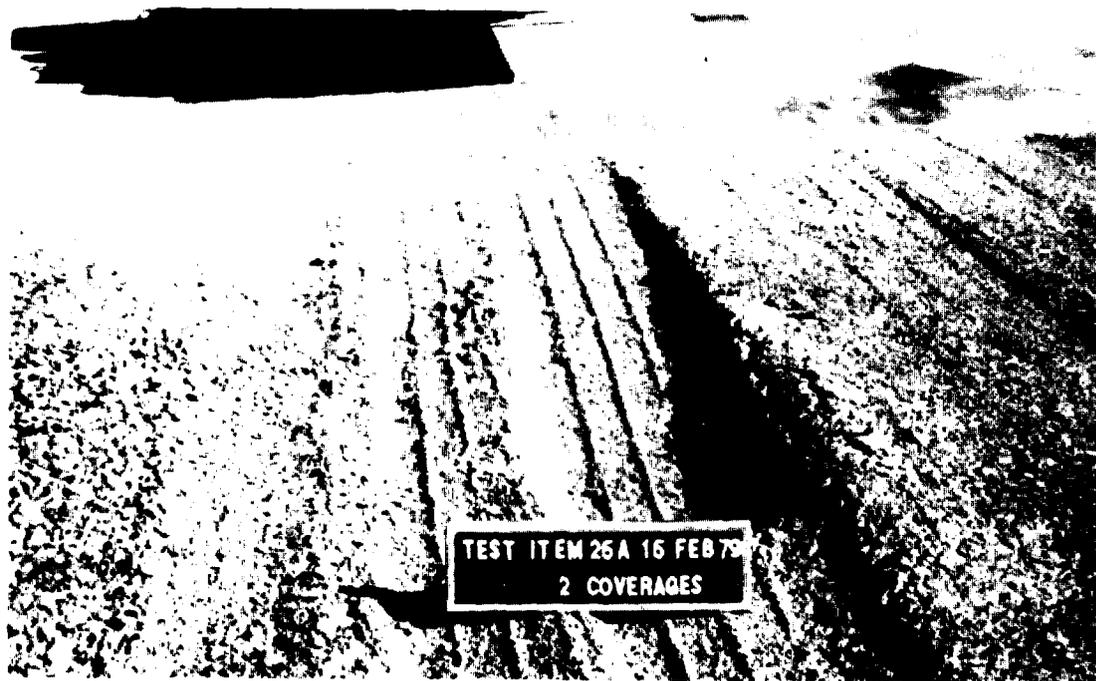
Figure 37. Rutting of Base Course After Two Coverages, Test Item 25

(3) Results. After compaction, prior to initiation of F-4 load cart traffic, water was seen standing in the low spots of the base course. After two F-4 load cart coverages, rutting started and a soft spot was detected near the center of the test pit (Figure 37).

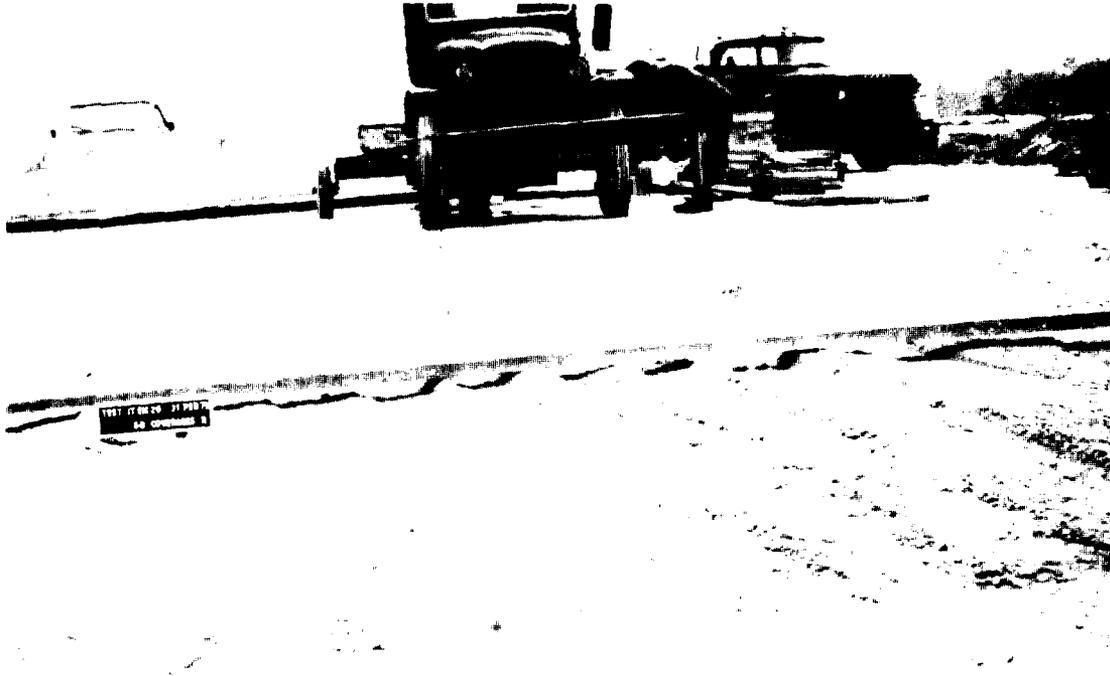
Figure 41. Surface deformations After 60 Coverages, Test Item 26

(2) Results. After compaction, the limestone showed a moisture content of 2.8 percent and a dry density of 141.7 pcf. Twenty coverages of the F-4 load cart produced deformations of approximately 2 inches; deformations had increased to 3 inches after 40 coverages when it became necessary to add limestone and repair the surface. Figure 40 provides profile data prior to repairs. After 60 coverages, the surface deformation was as shown below (Figure 41).

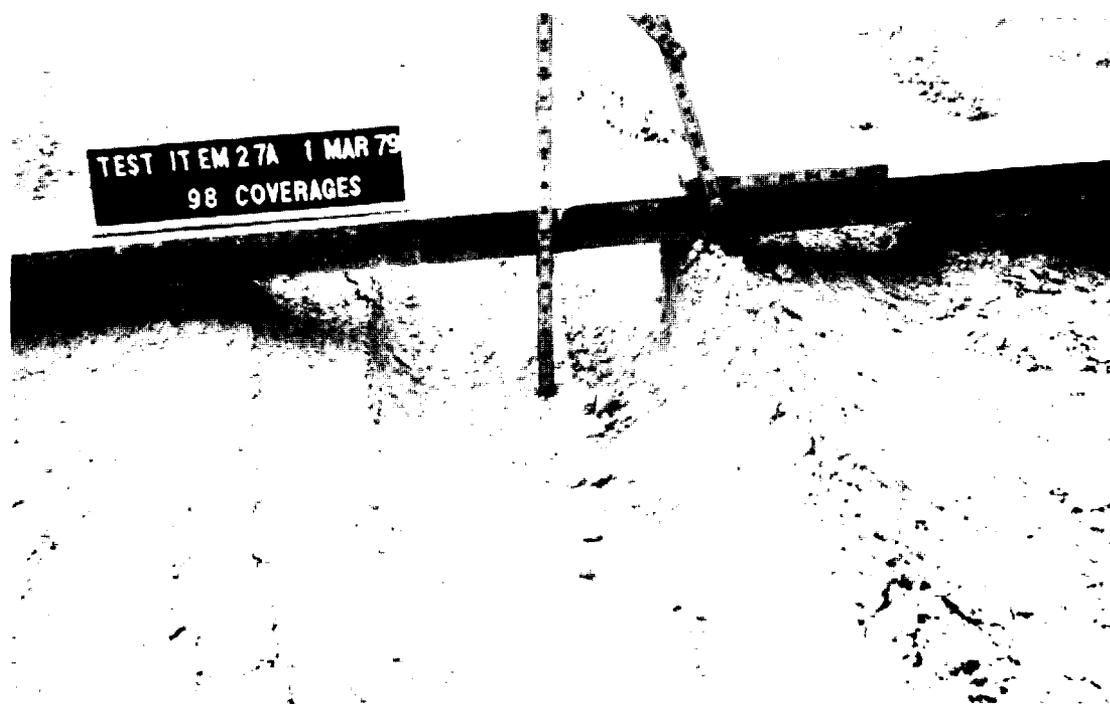
Figure 44. Failure of Test Item 27 (RayGo 510A)  
After 98 Load Cart Coverages

continue the evaluation in order to obtain additional data. Limestone was then added to item 28 and compacted with eight coverages of the RayGo 510A. Although no standing water was visible after compaction, item 28 was characterized as spongy and unstable. Two passes of the F-4 load cart confirmed the suspicion that the repaired test item possesses very little strength. Additional trafficking resulted in progressive deterioration of the surface until further testing of item 28 was abandoned after 24 coverages. After four coverages, test item 27 had encountered much less of a problem, showing deflections of less than 1 inch. Test item 27 sustained 48 coverages before a hump developed in the center of the pit, causing a near-failure. Repairs were made at this point and trafficking continued. Two more repairs were necessary before the failure criteria was exceeded during the 98th coverage (Figure 44).

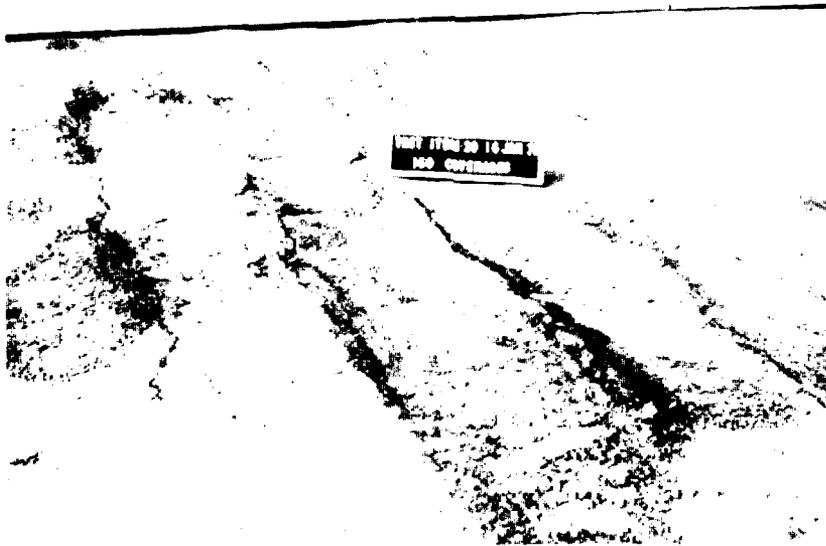
Figure 51. Surface Condition of Amalgapave®, Item 20

was being pushed onto the concrete pad and had to be shoveled back into the pit, creating a FOD problem. Rutting and small amounts of loose gravel being pushed out of the pit became more severe after 40 coverages and grew progressively worse as the coverages increased. After 150 coverages the asphalt had broken into individual pieces 12 to 18 inches long, causing more loose gravel and chunks of asphalt to leave the pit, thus creating a more dangerous hazard to aircraft (Figure 51).

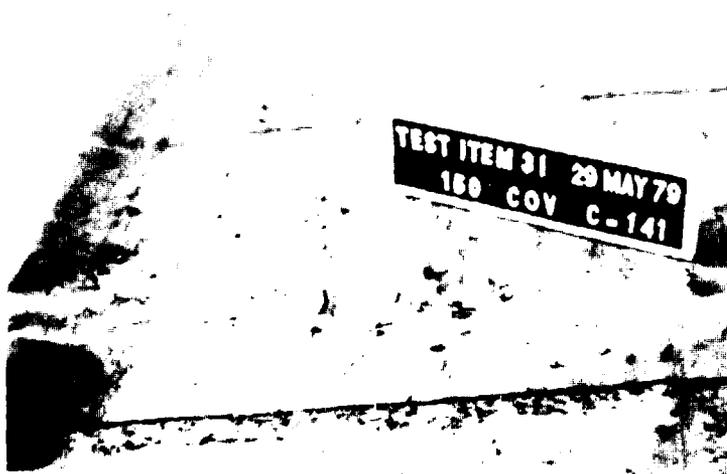
Figure 57. Flaking of Membrane, Item 31
