MISCELLANEOUS PAPER SL-81-16

# STRUCTURAL STABILITY EVALUATION GULL LAKE DAM

June 1981

Final Report

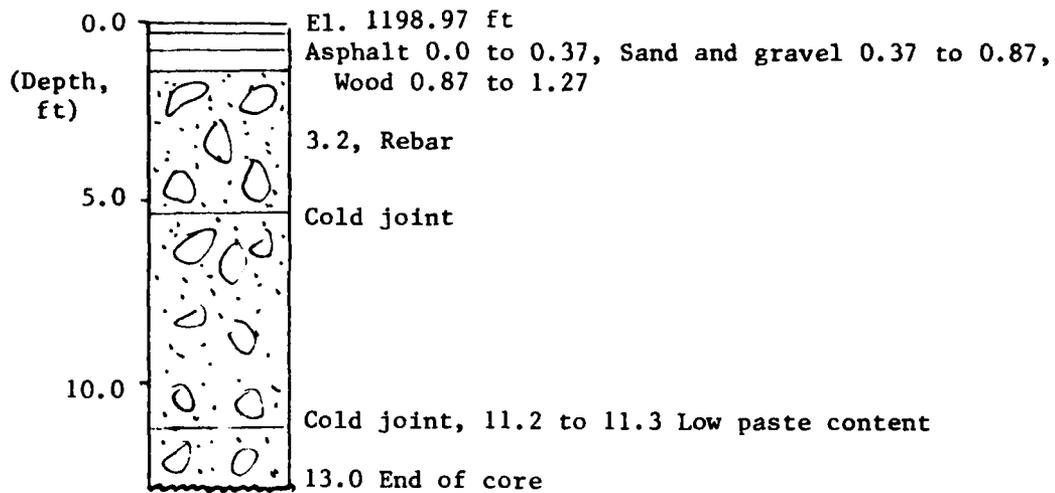
Figure 7. Core log, hole G-P2, Gull Lake Dam

24. The concrete from both cores was intact except for horizontal cold joints formed in both cores at depths of 5.3 and 11.3 ft. Although the concrete was not air-entrained and did show evidence that some alkali-silica reaction had occurred, there was no significant cracking or deterioration of the concrete. Therefore, it was concluded that the concrete from this structure, as judged by these cores, was in good physical condition.

2-in. maximum size crushed aggregate composed of granite, granite gneiss, and dark, fine-grained igneous rock particles. Some alkali-silica reaction gel was found coating aggregate surfaces. Ettringite needles found in voids and coating aggregate surfaces. Non air-entrained concrete. Fine aggregate was natural sand.

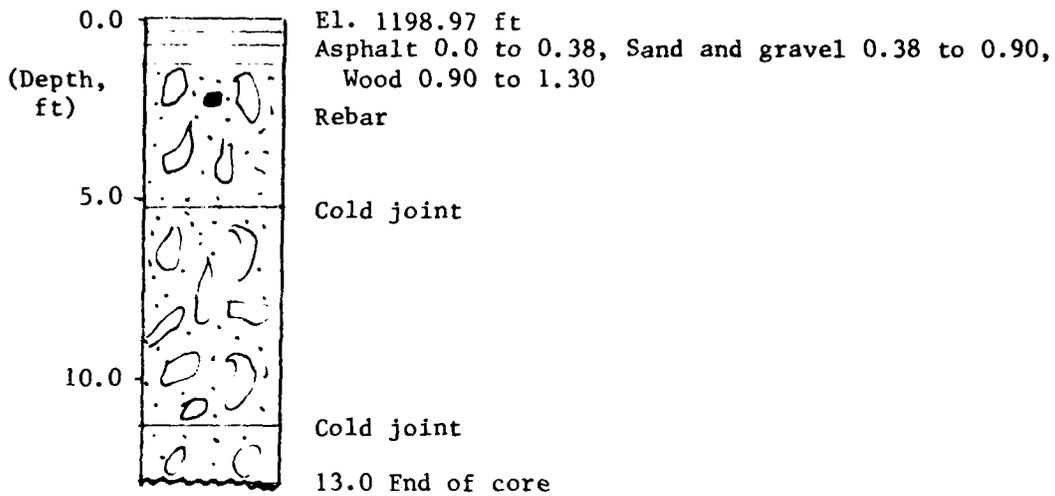
Figure 8. Core log, hole G-P4, Gull Lake Dam

2-in. maximum size crushed aggregate composed of granite, granite gneiss, and dark, fine-grained igneous rock particles. Some alkali-silica reaction gel was found coating aggregate surfaces. Ettringite needles found in voids and coating aggregate surfaces. Fine aggregate was natural sand. Non air-entrained concrete.

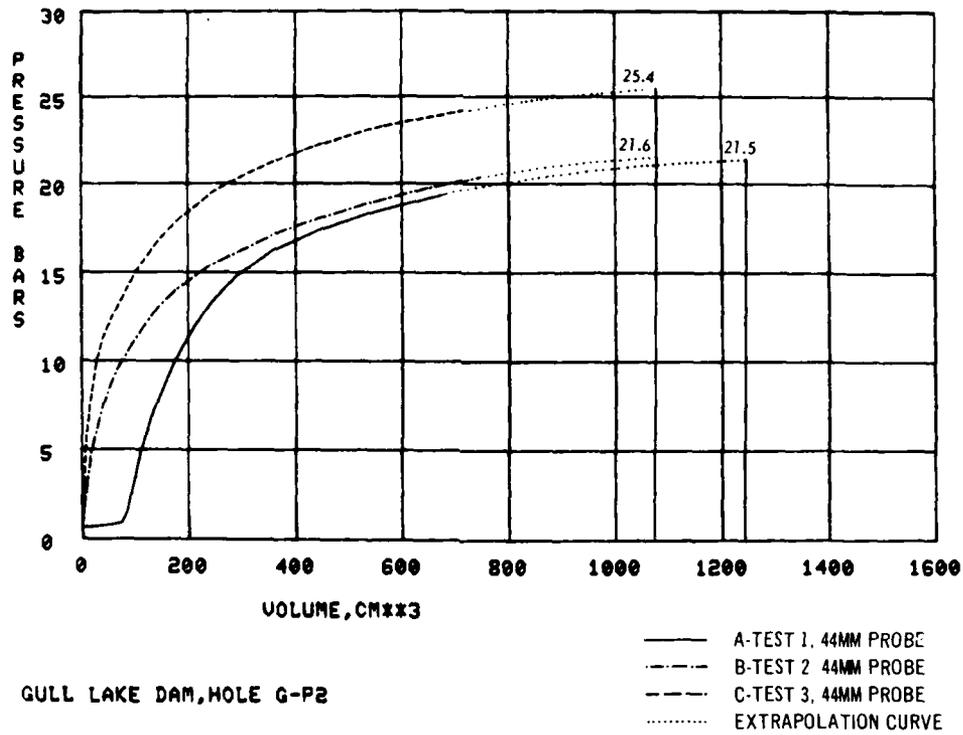
Figure 15. Pressure versus volume, curves extrapolated to obtain limit pressures, Gull Lake Dam, hole G-P2

33. Several methods were used in obtaining the limit pressure of the foundation material, but it was found that extrapolating the curves out to two times the initial volume of the cavity gave excellent results. The limit pressures were obtained and are presented in Figures 15 and 22 for hole G-P2 and G-P4, respectively.

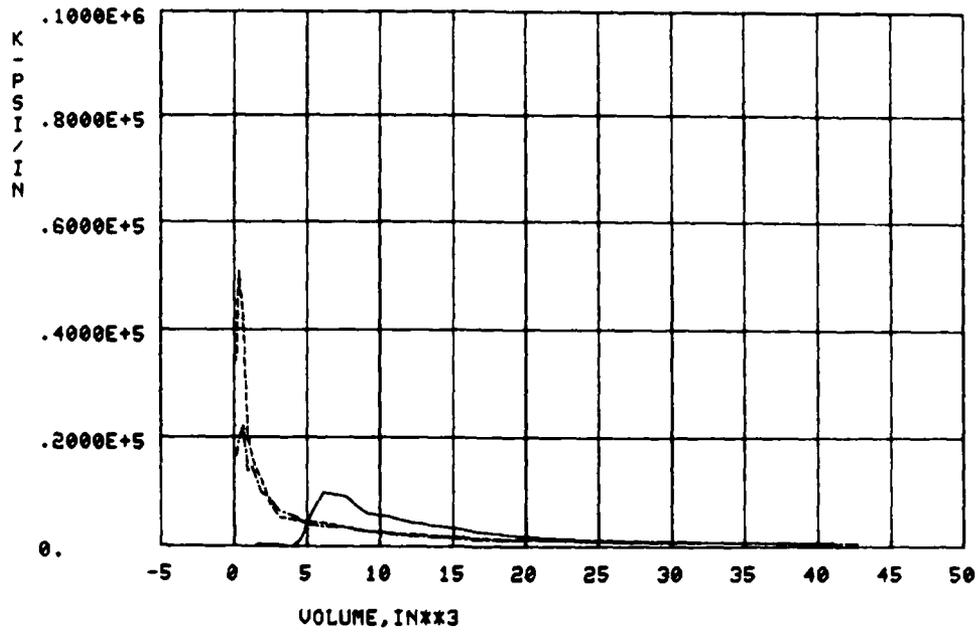
Figure 19. Modulus of subgrade reaction, Gull Lake Dam, hole G-P2

45. At Gull Lake Dam a conservative constant subgrade modulus would be used. The variation in subgrade modulus with depth into the foundation (Figures 19 and 26) does not show a distinct pattern that justifies using a variable subgrade modulus. Hole G-P2 indicates an increase in subgrade modulus with depth (Figure 19), but the data from hole G-P4 do not indicate this variation. It would take much more data to accurately define and use a variable subgrade modulus for the foundation at Gull Lake Dam. However, the test data were adequate for an average value analysis of the piling foundation. A subgrade of 6000  $\frac{\text{psi}}{\text{in.}}$  was used. If the piling layout was deemed adequate by this analysis, the whole dam could be considered adequate in stability.

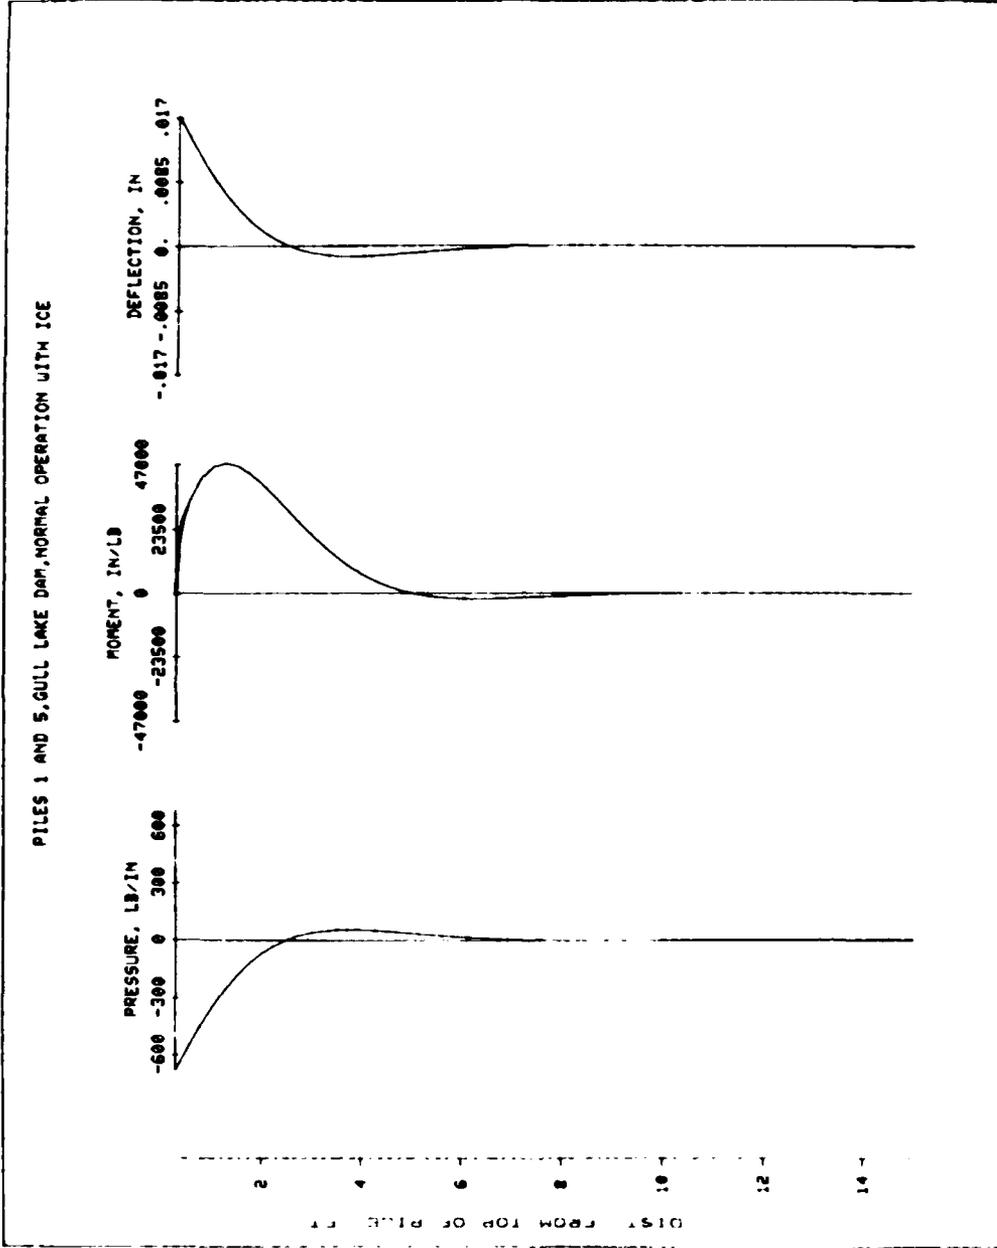
Figure 32. Pressures, moments, and deflections along length of pile for most case loading (normal operations plus ice).

It was determined that the horizontal and vertical forces on the piling were not excessive in relation to the material properties of the pile. The pile deflections were also adequate under all load conditions.

55. The pile head-stiffness matrix was then used as input in another computer program that uses the direct stiffness analysis to obtain the forces and deflections of the piles. A beam on an elastic foundation analysis was performed and the pressures, moments, and deflections along the length of the most critically loaded pile were determined.
