Name Of Dam: UNIVERSITY COMMONS DAM
Location: RICHMOND, VIRGINIA
Inventory Number: VA. NO. 76008

PHASE I INSPECTION REPORT NATIONAL DAM SAFETY PROGRAM

**SCHNABEL ENGINEERING ASSOCIATES, P.C./
J. K. TIMMONS AND ASSOCIATES, INC.
February, 1981**

NAME OF DAM: UNIVERSITY COMMONS DAM
LOCATION: RICHMOND, VIRGINIA
INVENTORY NUMBER: VA. NO. 76008

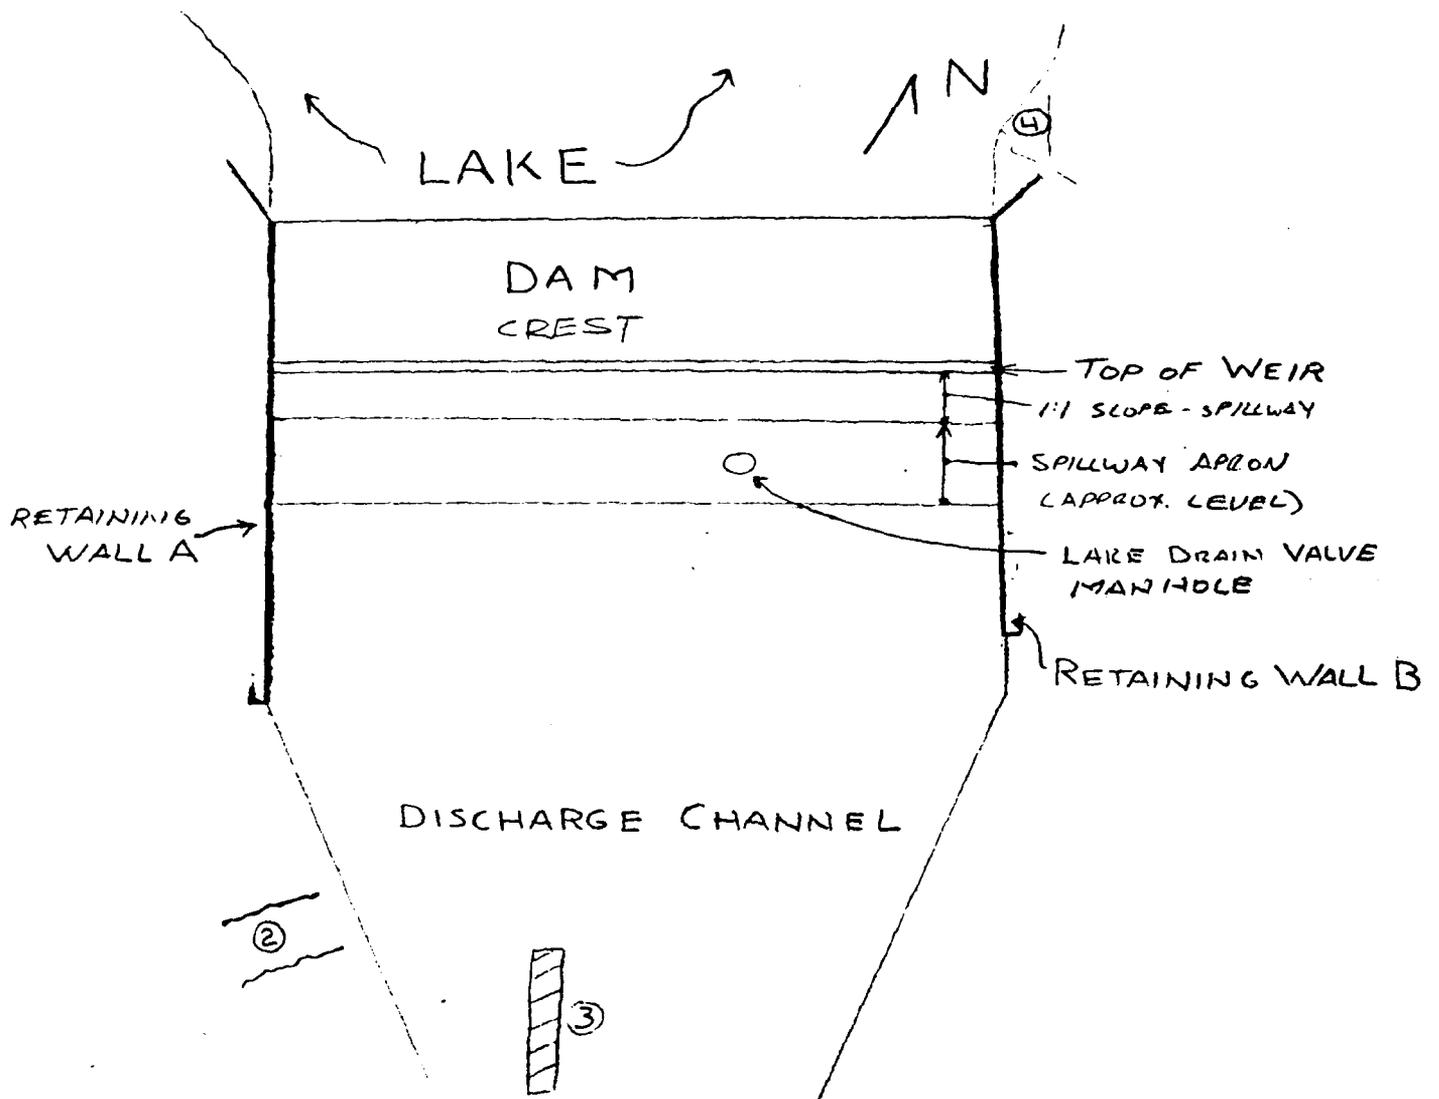
FIELD SKETCH

Some discoloration and seepage (less than 1 gpm) was noted in the vicinity of the construction joints in the discharge channel concrete membrane approximately 80 ft downstream of the spillway (see Field Sketch, Appendix III, Sheet 1).

Some seepage was observed coming from several construction joints in the concrete discharge channel area approximately 80 ft below the spillway. The concrete was slightly stained indicating possible seepage through the embankment.

Possible seepage was noted from several of the joints in the downstream concrete apron. See Sheet 1. This seepage was marked by discoloration of the concrete at the joints, indicated possible seepage through the embankment. Seepage was estimated at less than 1 gpm.

3. SEEPAGE FROM CONSTRUCTION JOINTS IN CONCRETE MEMBRANE APPROXIMATELY 80 FT DOWNSTREAM FROM SPILLWAY.

4. SMALL EROSION GULLIES 1 FT x 2 FT LEFT UPSTREAM ABUTMENT.

7.3.2 The seepage from the discharge channel concrete membrane should be monitored. If any increase in seepage flow rates are observed, a professional Geotechnical Engineer should be contacted to evaluate the problem and make recommendations for required corrective measures.

These seepage areas should be monitored for any increase in water condition such as the presence of fines in the water.
