Name of Dam: Unimin Tailings Dam

Location: Frederick County, Commonwealth of Virginia

Inventory Number: VA 06918

PHASE I INSPECTION REPORT  
NATIONAL DAM SAFETY PROGRAM

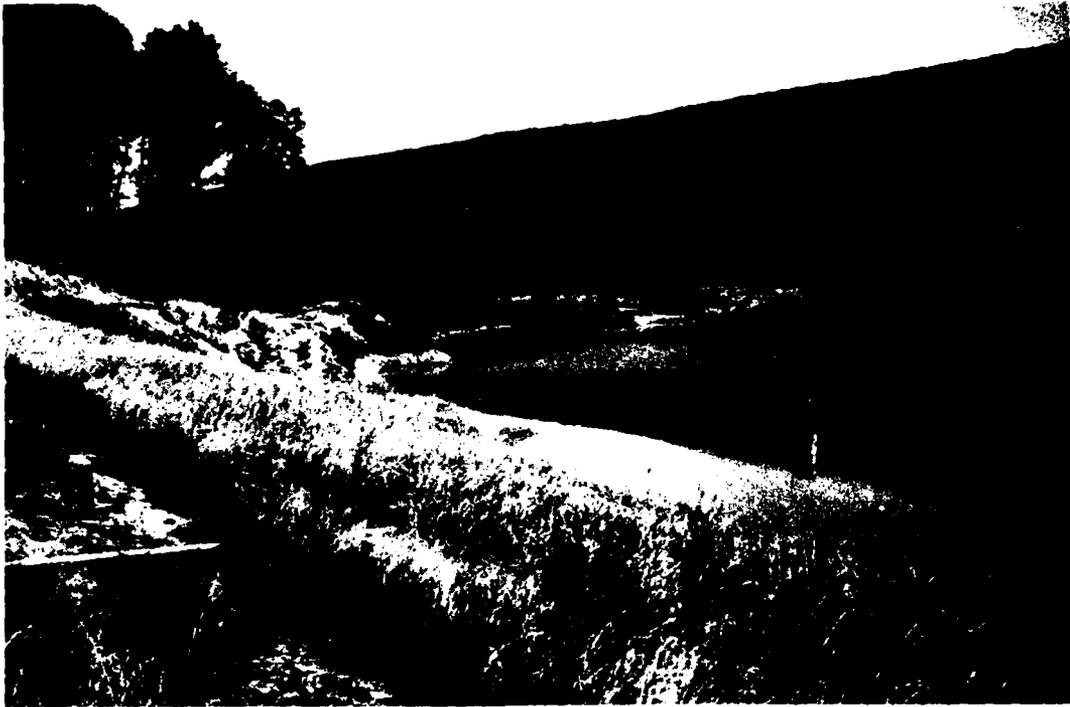
**PHOTO 1. Emergency Spillway (Natural Saddle) and Decant Inlet**

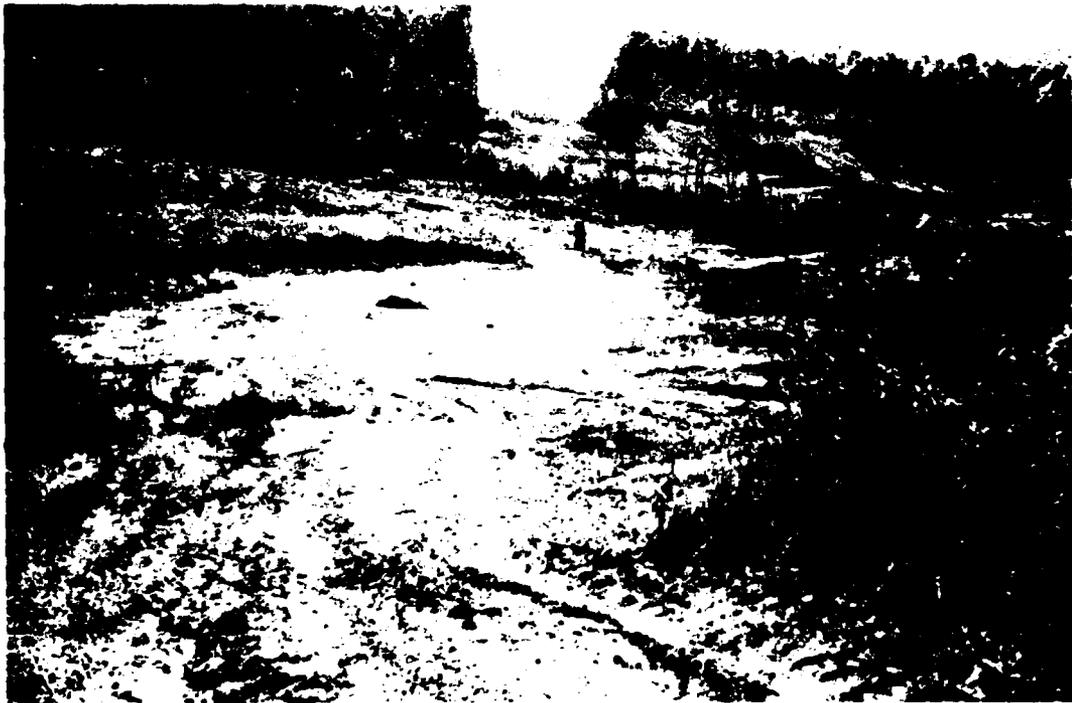
**PHOTO 2. View Across Emergency Spillway Control Section  
Note: Men Standing on Small Berm in Eroded Discharge Channel**

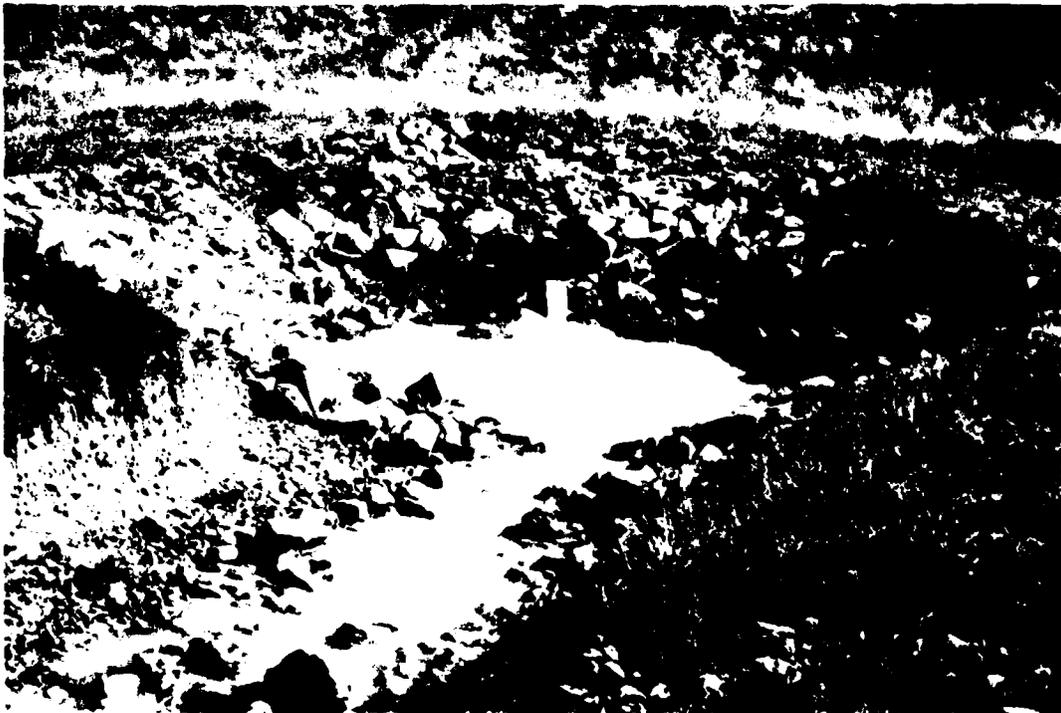
**PHOTO 4. Decant Outlet and Stilling Basin**

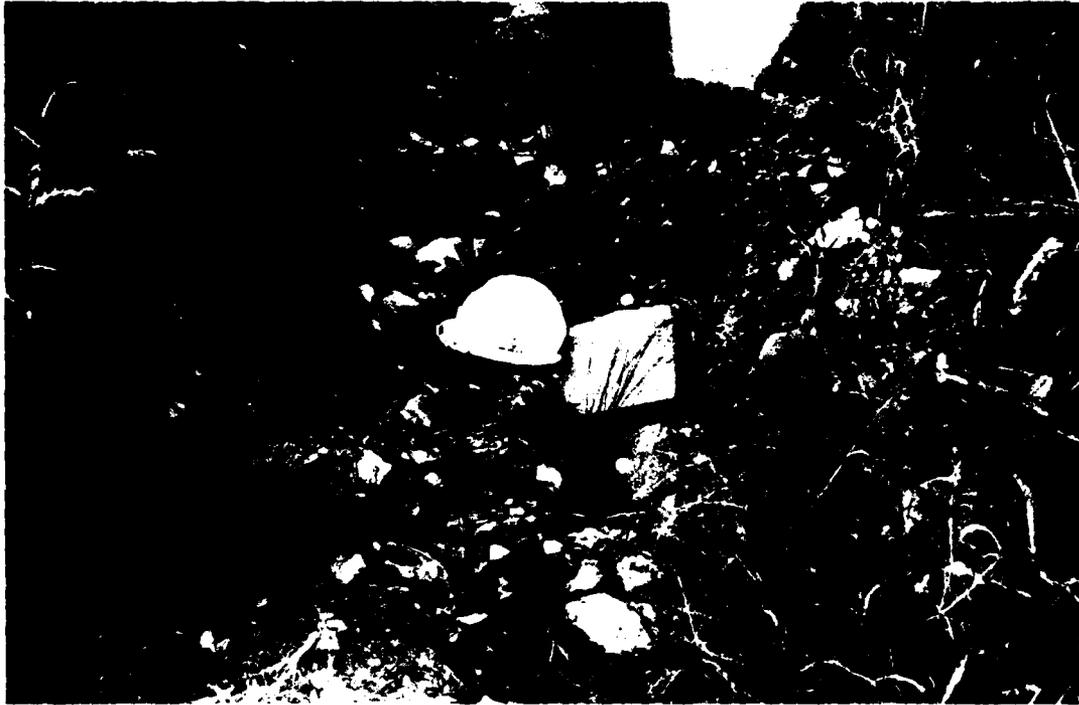
**PHOTO 7. Erosion at Junction of Downstream Embankment with  
Left Abutment**

- 3.2 Evaluation: The embankment was found to be in generally fair to good condition, with no surface cracks or sloughs. All areas of erosion on the embankment should be repaired, particularly the erosion rills below the bench on the downstream embankment. A grass cover should be established on all the sparsely vegetated areas of the embankment. The eroded junctions of the left and right abutments with the downstream embankment should be repaired and riprap placed to minimize erosion. The drains for seepage control that are reportedly located to the left and right of the principal spillway outlet should be uncovered.
