Name of Dam: Unimin Fresh Water Pond Dam  
Location: Frederick County, Commonwealth of Virginia  
Inventory Number: VA 06917

# PHASE I INSPECTION REPORT NATIONAL DAM SAFETY PROGRAM

January 1981

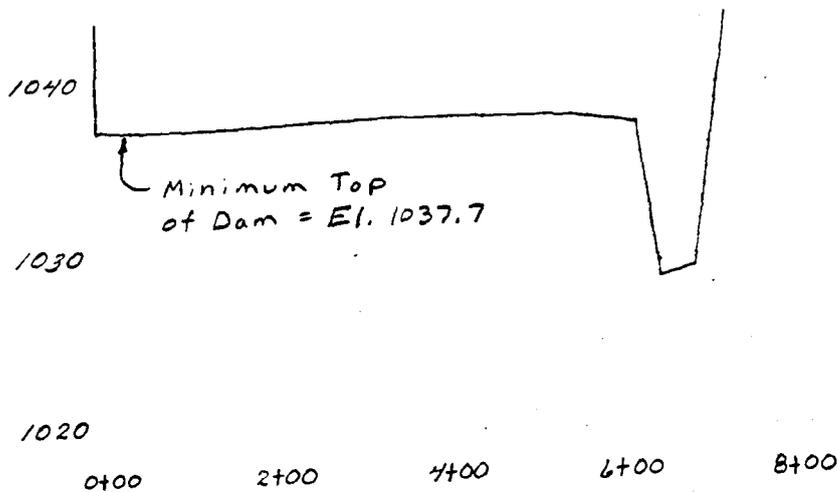
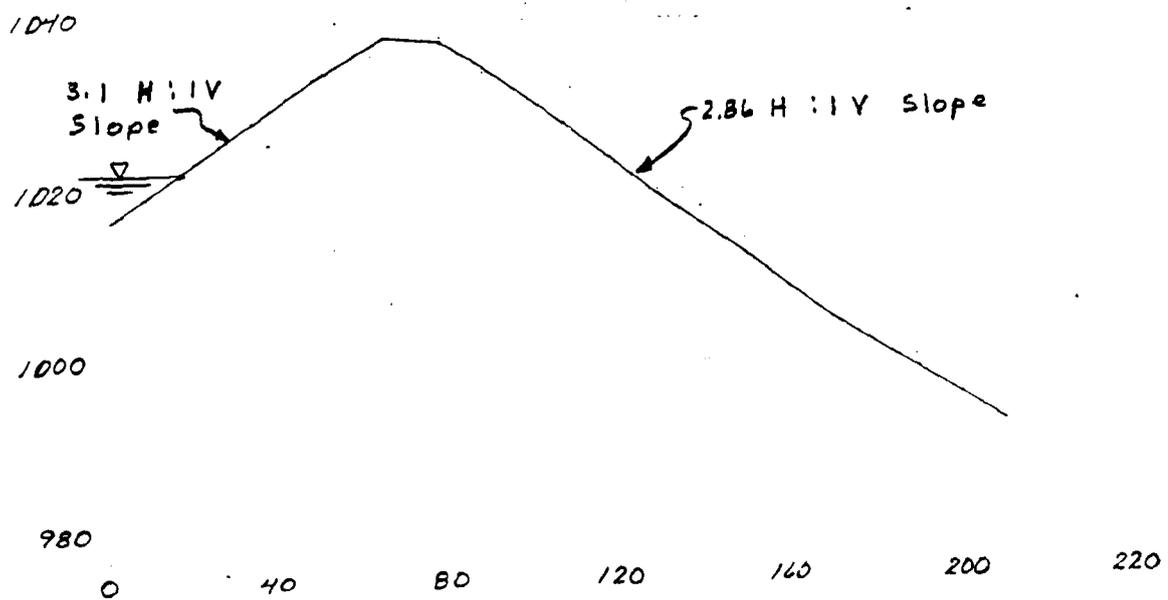
PLATE 2

According to guidelines outlined in Design of Small Dams by the U.S. Department of Interior, Bureau of Reclamation, the upstream slope of a small homogeneous dam constructed of slightly plastic fine grained soils (ML, CL), with a stable foundation, should be 3.5H:1V if subject to rapid drawdown. The recommended downstream slope is 2.5H:1V. A crest width of 19.2 feet is recommended, considering the height of the dam. Based on these guidelines, the upstream slope and crest width are inadequate while the downstream slope is adequate.

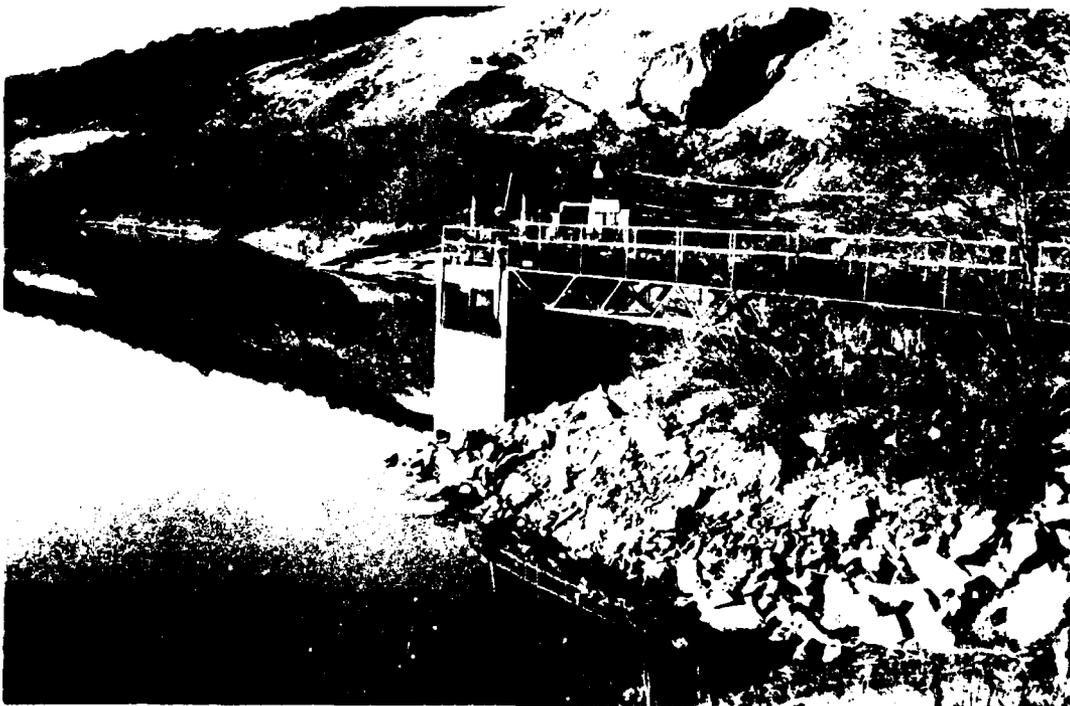
3.1.3 Appurtenant Structures: The principal spillway for the dam is a square shaped concrete tower with a spillway intake consisting of two rectangular openings with crests at elevation 1028.0 feet T.B.M. (see Photo 4).

Three "Rodney Hunt" liftgates are located on the concrete intake tower (see Photo 4). Two liftgates are intakes for the water supply sump, and the third is a drawdown gate for dewatering the reservoir. Controls for the lifts are located on top of the concrete intake tower and are reached by means of a steel catwalk extending out from the upstream top of the dam to the intake tower. The liftgates are in good condition.

**PHOTO 4. Riser for Principal Spillway and Pump Platform**

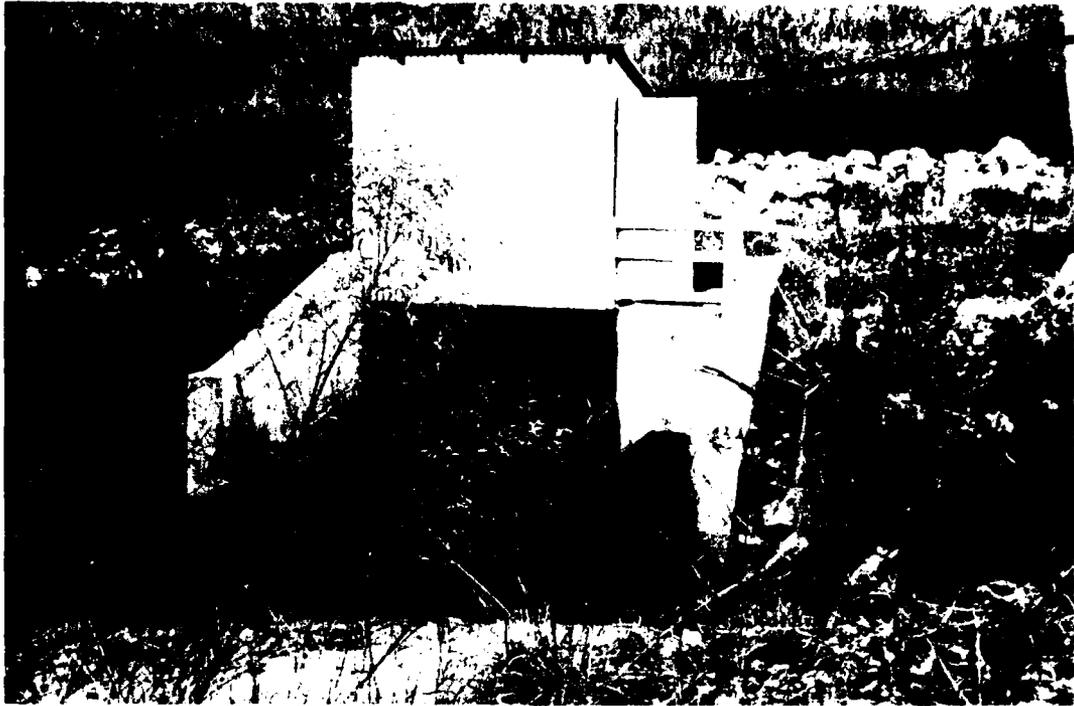
**PHOTO 5. Principal Spillway Outlet**
