Name Of Dam: ELON WATER WORKS  
Location: AMHERST COUNTY, VIRGINIA.  
Inventory Number: VA 00908

## PHASE I INSPECTION REPORT NATIONAL DAM SAFETY PROGRAM.

PREPARED BY  
NORFOLK DISTRICT CORPS OF ENGINEERS  
803 FRONT STREET  
NORFOLK, VIRGINIA 23510

JANUARY 1981 81 9 03.050

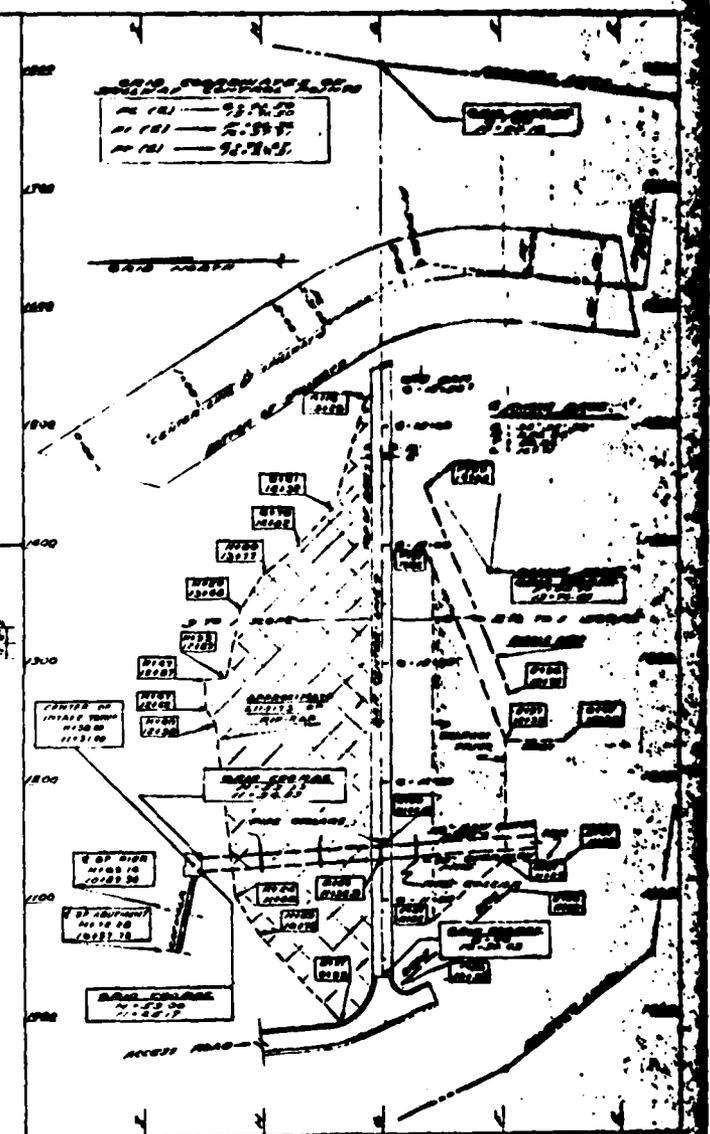
PLATE 4

3.1.2 Embankment: The embankment is in good condition. A cross section and plan view are provided on Plate 4 and 5, Appendix I, respectively. An overall view of the dam is provided at the beginning of the report.
