Name Of Dam: MOORE  
Location: PITTSYLVANIA COUNTY  
Inventory Number: VA 14323 ✓

## PHASE I INSPECTION REPORT NATIONAL DAM SAFETY PROGRAM

Name of Dam: Moore Dam  
State: Virginia  
Location: Pittsylvania County  
USGS Quad Sheet: Brosville, Virginia - N.C.  
Stream: McGuff Creek  
Date of Inspection: 26 February 1981

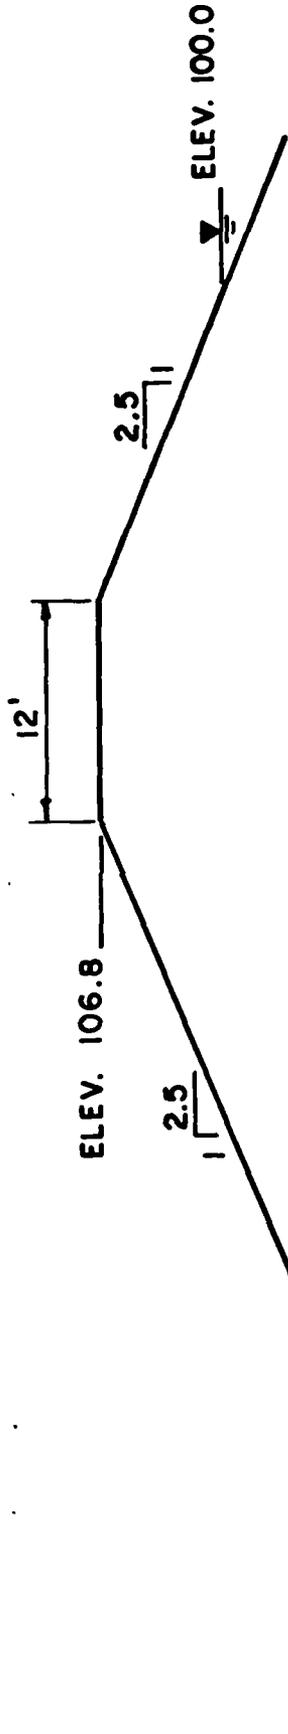
TYPICAL CROSS SECTION

3.1.2 Embankment: A sketch of the embankment showing a cross section and crest profile is provided on Plate II, Appendix I. A plan view is given on Plate III, Appendix I.
