BEATTIES MILL DAM

(NJ 00821)

PHASE I INSPECTION REPORT.
NATIONAL DAM SAFETY PROGRAM

REPT. NO.: DAEN/NAP-53842/NJ00821-81/08
AUGUST 1981

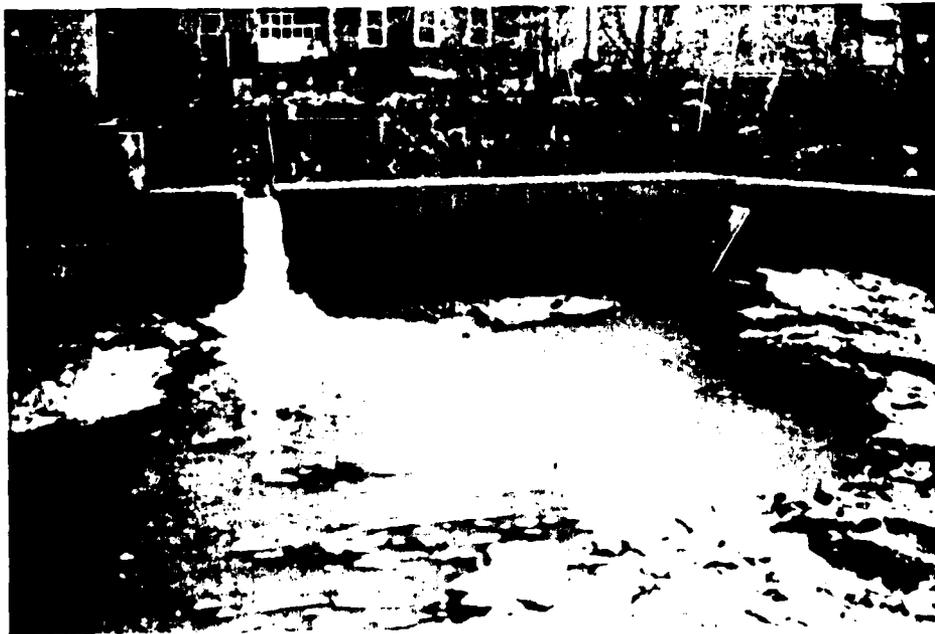
View of right wingwall and abutment. Note low level flow notch.

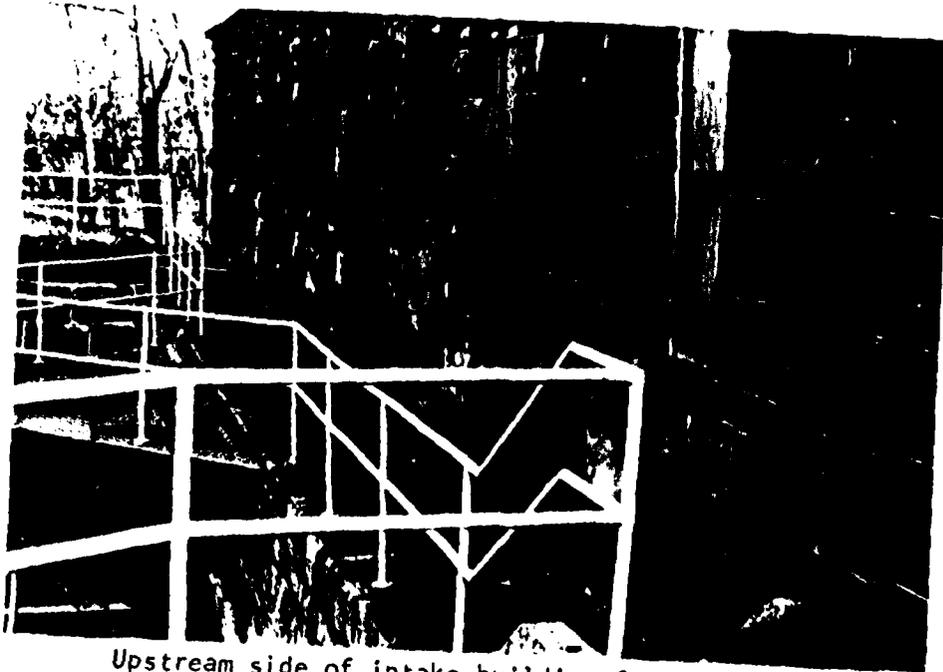
Upstream side of intake building for canal to water treatment plant. Note high water mark from 1903 flood to the right of and below the right window.
