LAKE ZISKE DAM  
DENT COUNTY, MISSOURI

MISSOURI INVENTORY NO. 30071

PHASE I INSPECTION REPORT  
NATIONAL DAM SAFETY PROGRAM

SEPTEMBER 1978

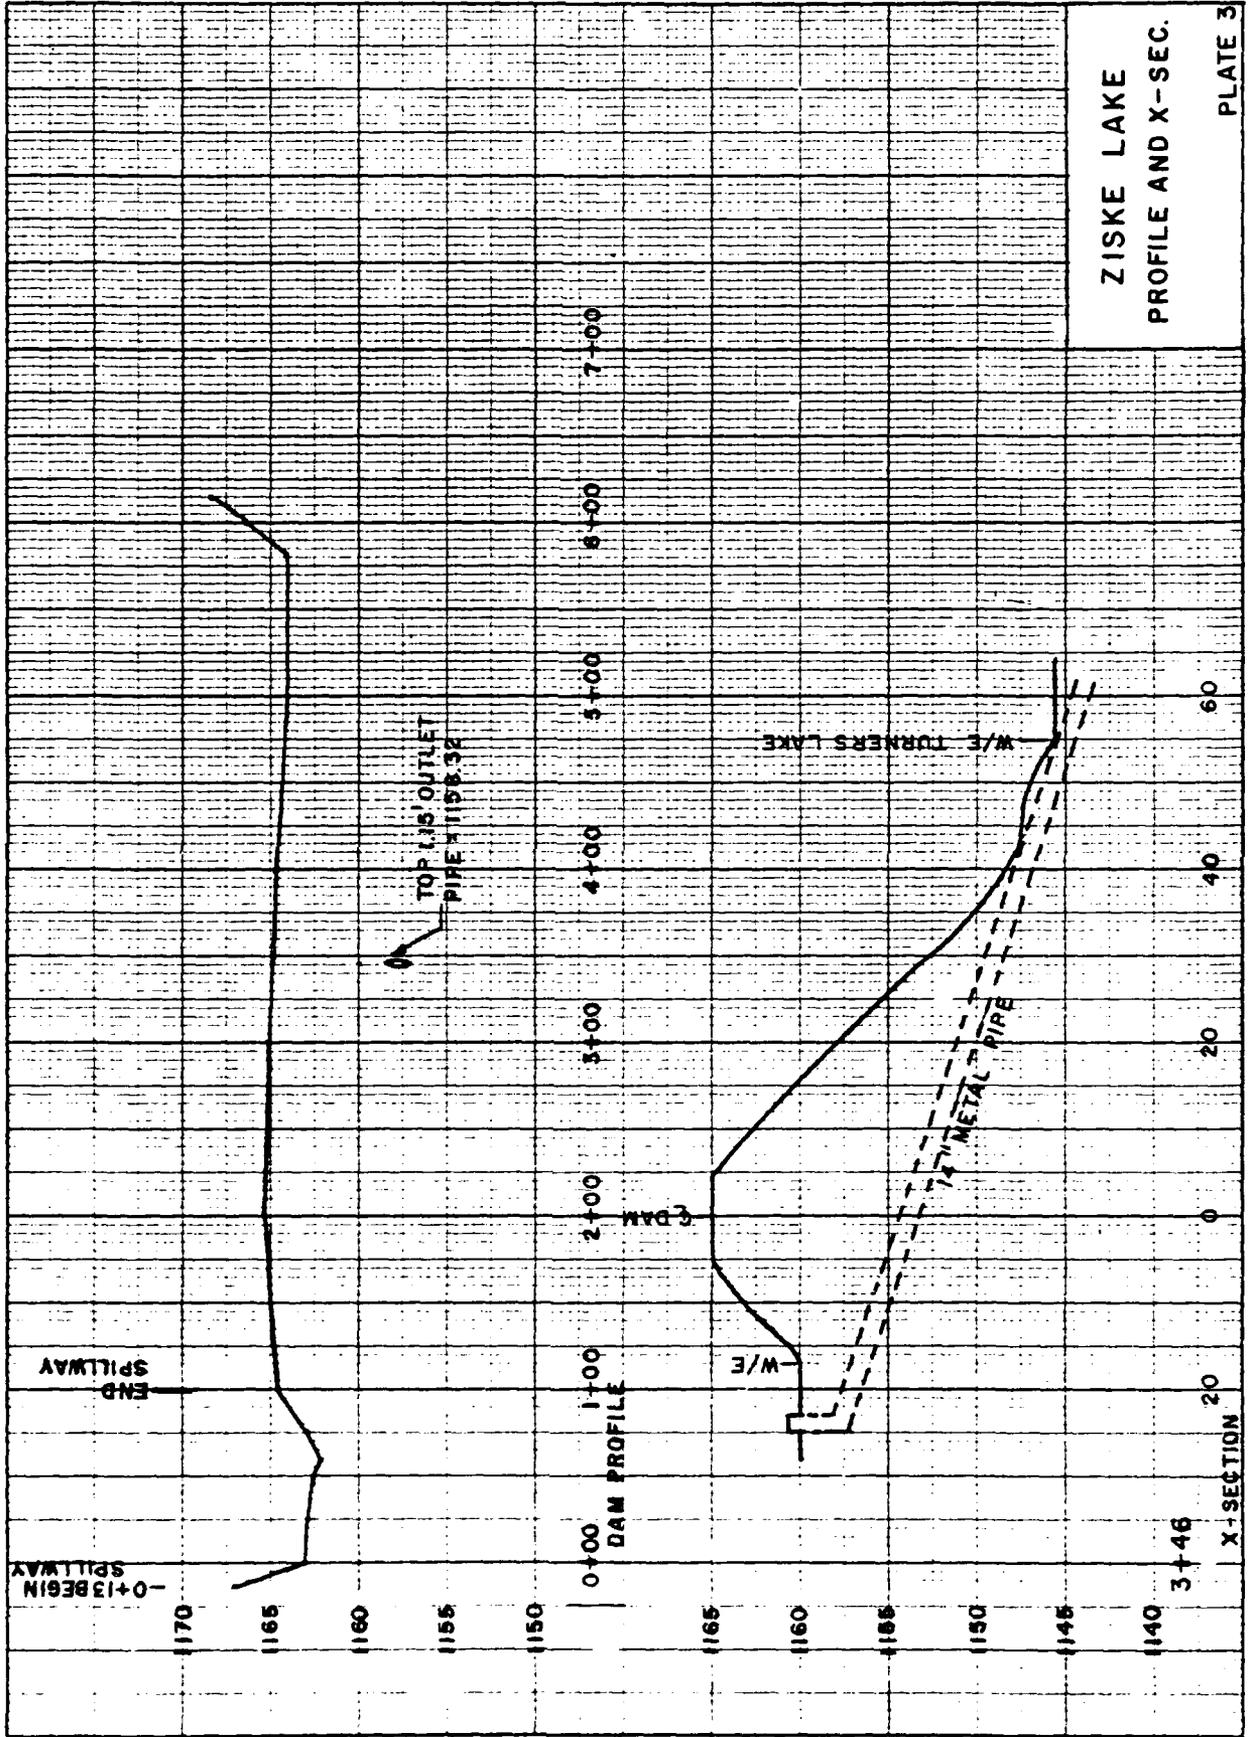
An embankment cross-section near the maximum height for the dam is shown on PLATE 3. In a few areas, the embankment slopes are considerably steeper than the section shown. It is difficult to determine the reason for the irregular slopes, especially since there was heavy vegetation on the slope but it appears that the slope was constructed irregularly. No burrows were noted, but some could be present and masked by vegetation.

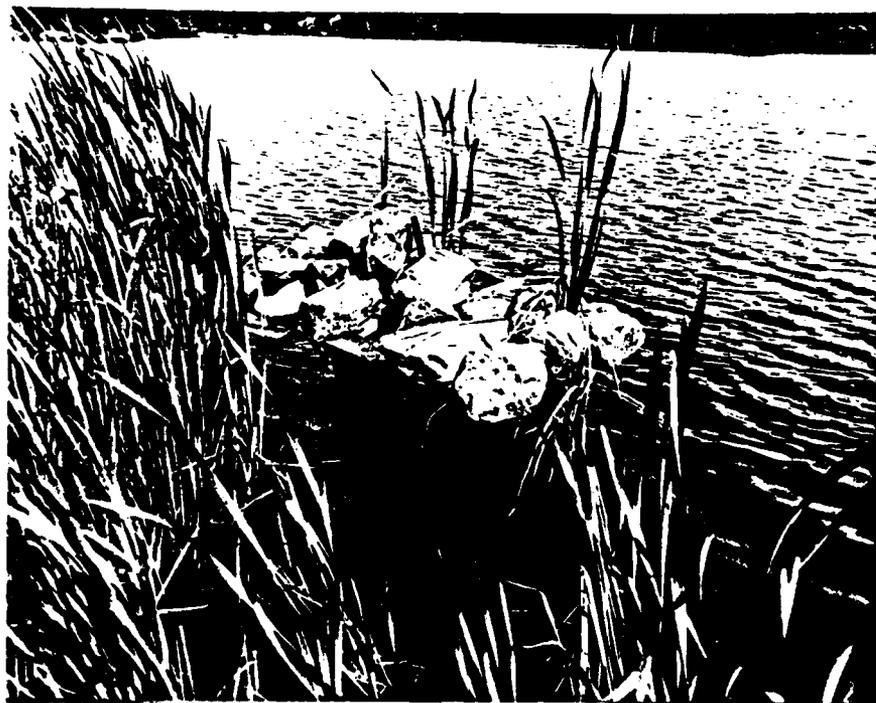
Photo 10: Overflow Intake Center  
Upstream of Dam

There is an overflow intake pipe structure at approximately the center of the dam and 2 to 3 feet out from upstream side of the dam. (See photograph 10). The inlet is approximately 1 foot below the spillway elevation and 3 feet below the top of the dam. The intake structure and discharge pipe consist of a 24-inch overflow pipe and a 14-inch metal discharge pipe approximately 86 feet long.

(1) The level of the lake is controlled by a conduit spillway which is located near the center of the dam approximately 24 feet upstream of the axis of the dam. The conduit spillway consists of a 24-inch diameter steel drop inlet with a grate on the top and a 14-inch steel pipe through the dam at the bottom of the drop inlet. The inverts of the drop inlet and the 14-inch pipe are at elevations 1161.0 feet and 1157.2 feet msl, respectively. (See photograph 10.)
