LAKE HARMONY DAM

MADISON COUNTY, MISSOURI

MO 30612

PHASE 1 INSPECTION REPORT
NATIONAL DAM SAFETY INSPECTION.

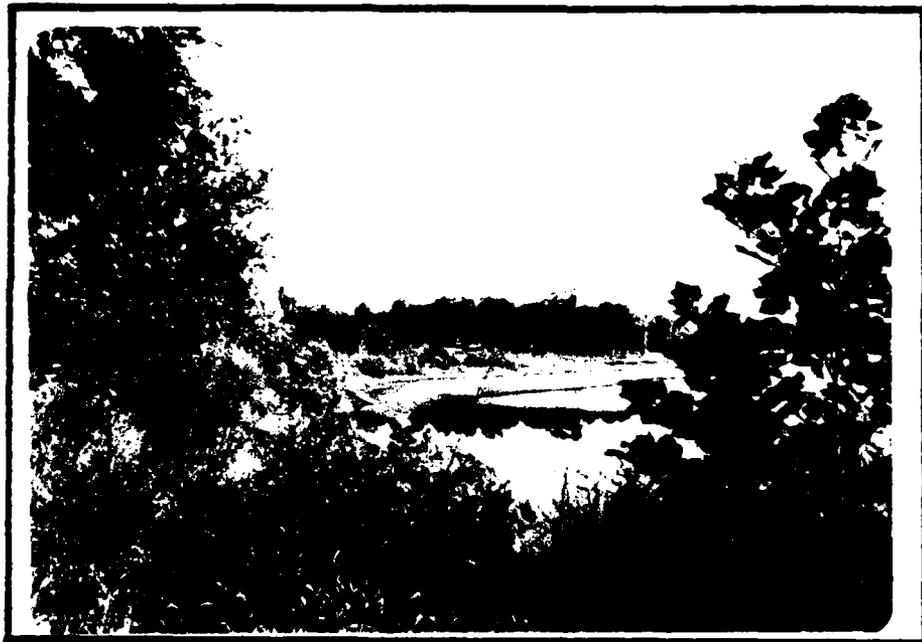
Photograph No. 1

Deficiencies visually observed for Lake Harmony Dam were no riprap on the upstream slope, seepage through the concrete portion of the dam and at the base of the concrete and vegetation (trees) growing on the upstream, downstream and crest of the dam. There is no warning system in effect or a safety inspection program. Stability and seepage analyses comparable to the requirements of the "Recommended Guidelines for Safety Inspection of Dams" are not available which is considered a deficiency. These deficiencies should be remedied at the direction of a professional engineer knowledgeable in the design and construction of concrete and earthfill dams.

Overview of crest and upstream slope.
