ASARCO LAKE DAM  
IRON COUNTY, MISSOURI

MISSOURI INVENTORY NO. 30216

PHASE I INSPECTION REPORT  
NATIONAL DAM SAFETY PROGRAM

NOVEMBER, 1978

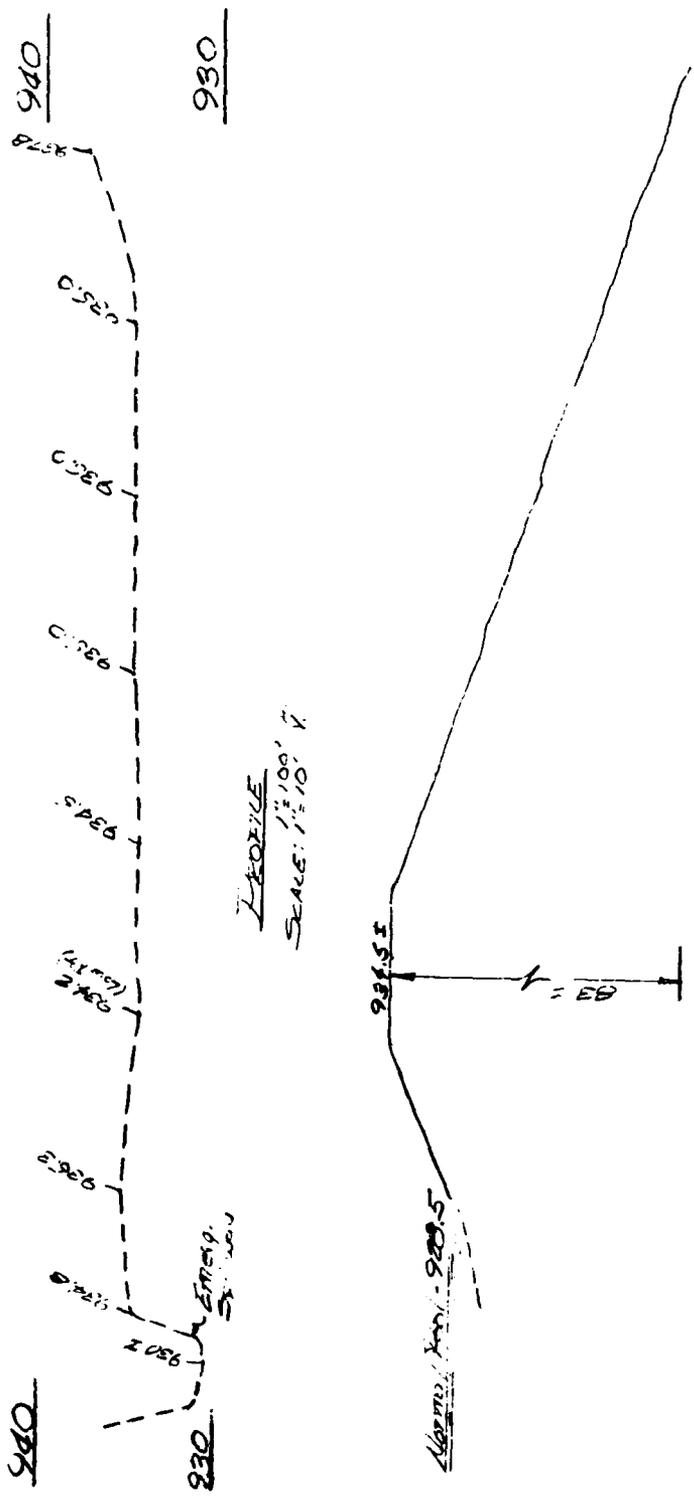
ASARCO LAKE  
 DAM PROFILE and  
 CROSS SECTION

- (5) Side Slopes - (Measured by slope meter/inclinometer in degrees and converted to ratios.)
    - (a) Downstream - 2.75 H to 1 V.
    - (b) Upstream - 2.25 H to 1 V to a 12' wide berm. Visibly flatter below waterline.
