Masters Lake Dam (MO 30065).
Upper Mississippi - Mississippi - Kaskaskia -
St. Louis Basin. Dent County, Missouri.
Phase I Inspection Report.

PHASE I REPORT
NATIONAL DAM SAFETY PROGRAM

Name of Dam	Masters Lake
State Located	Missouri
County Located	Dent County
Stream	Tributary To Loss Creek
Date of Inspection	September 26, 1978

PHASE I INSPECTION REPORT
NATIONAL DAM SAFETY PROGRAM
MASTERS DAM - ID NO. 30065

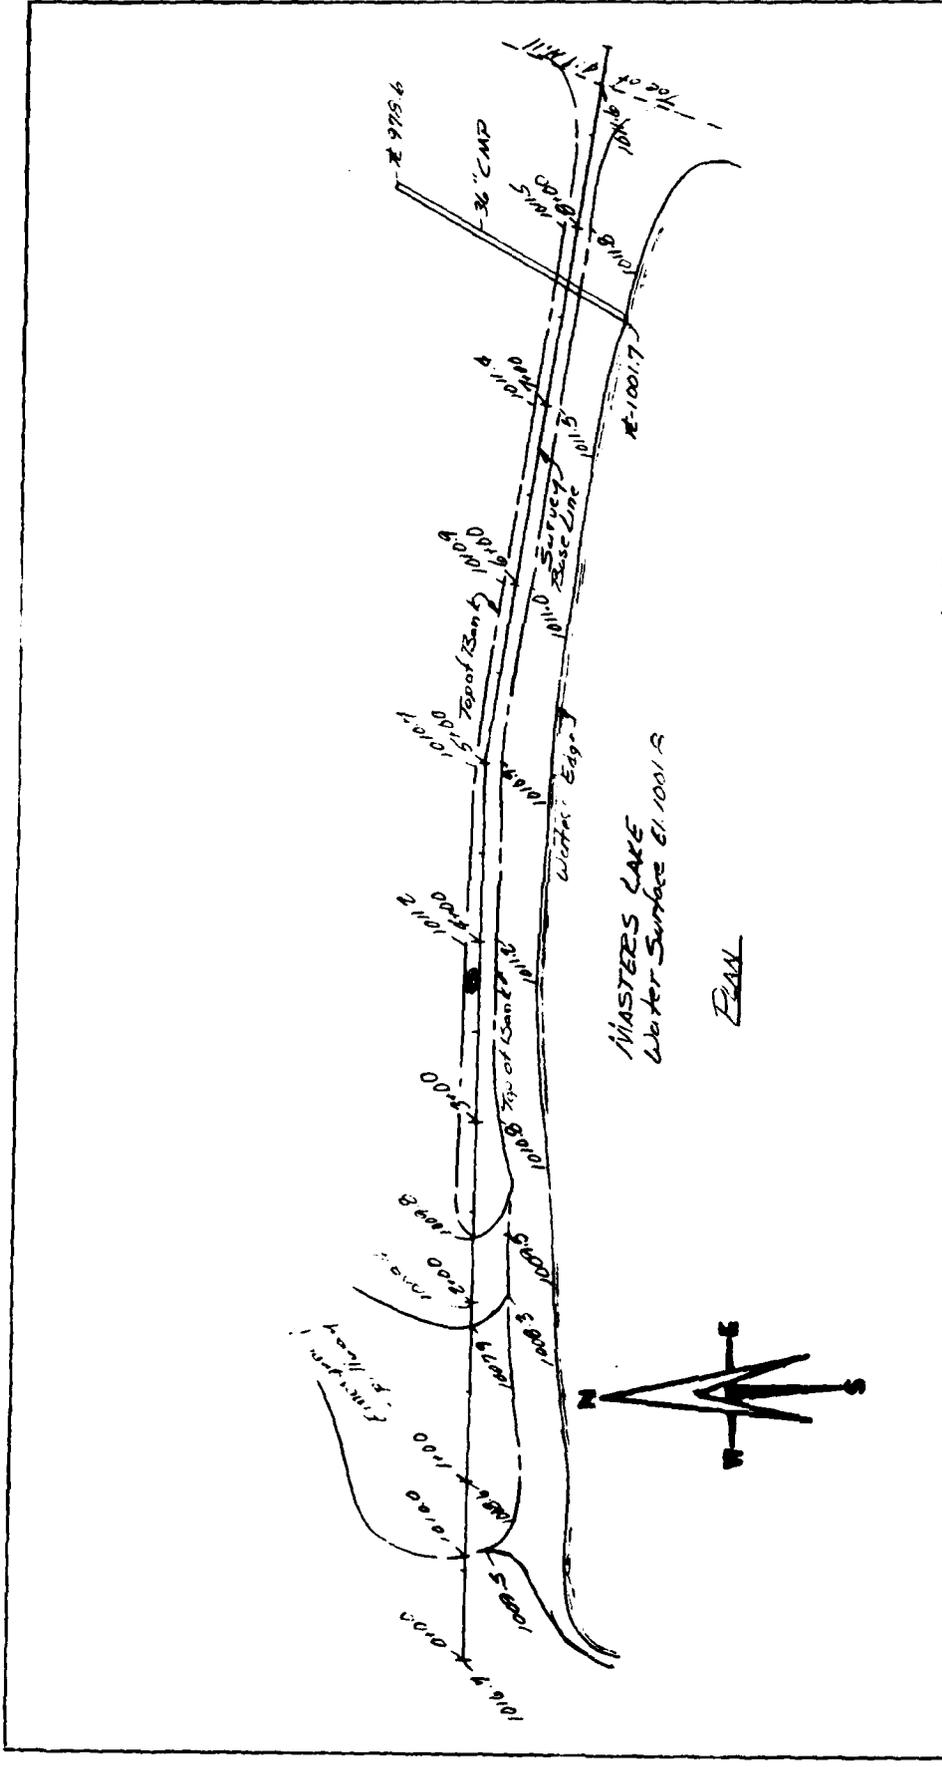
SCALE: 1"=100'± PLATE 3

**TOP OF DAM
ELEVATIONS**
