HILLTOP FISHING LAKE DAM
DUNKLIN COUNTY, MISSOURI
MO 40064

**PHASE 1 INSPECTION REPORT
NATIONAL DAM SAFETY PROGRAM**

MARCH 1981

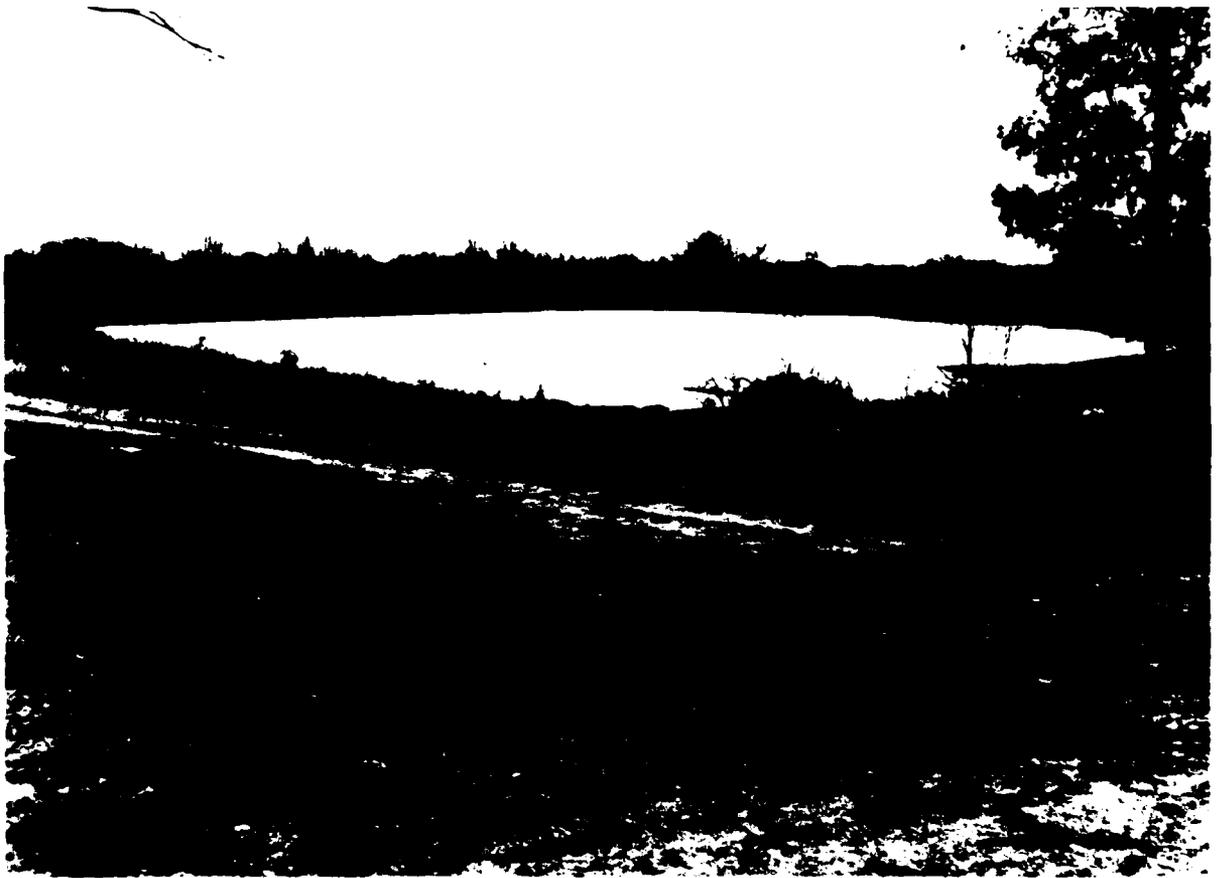
PHOTOGRAPH 1. OVERVIEW OF HILLTOP FISHING LAKE DAM.

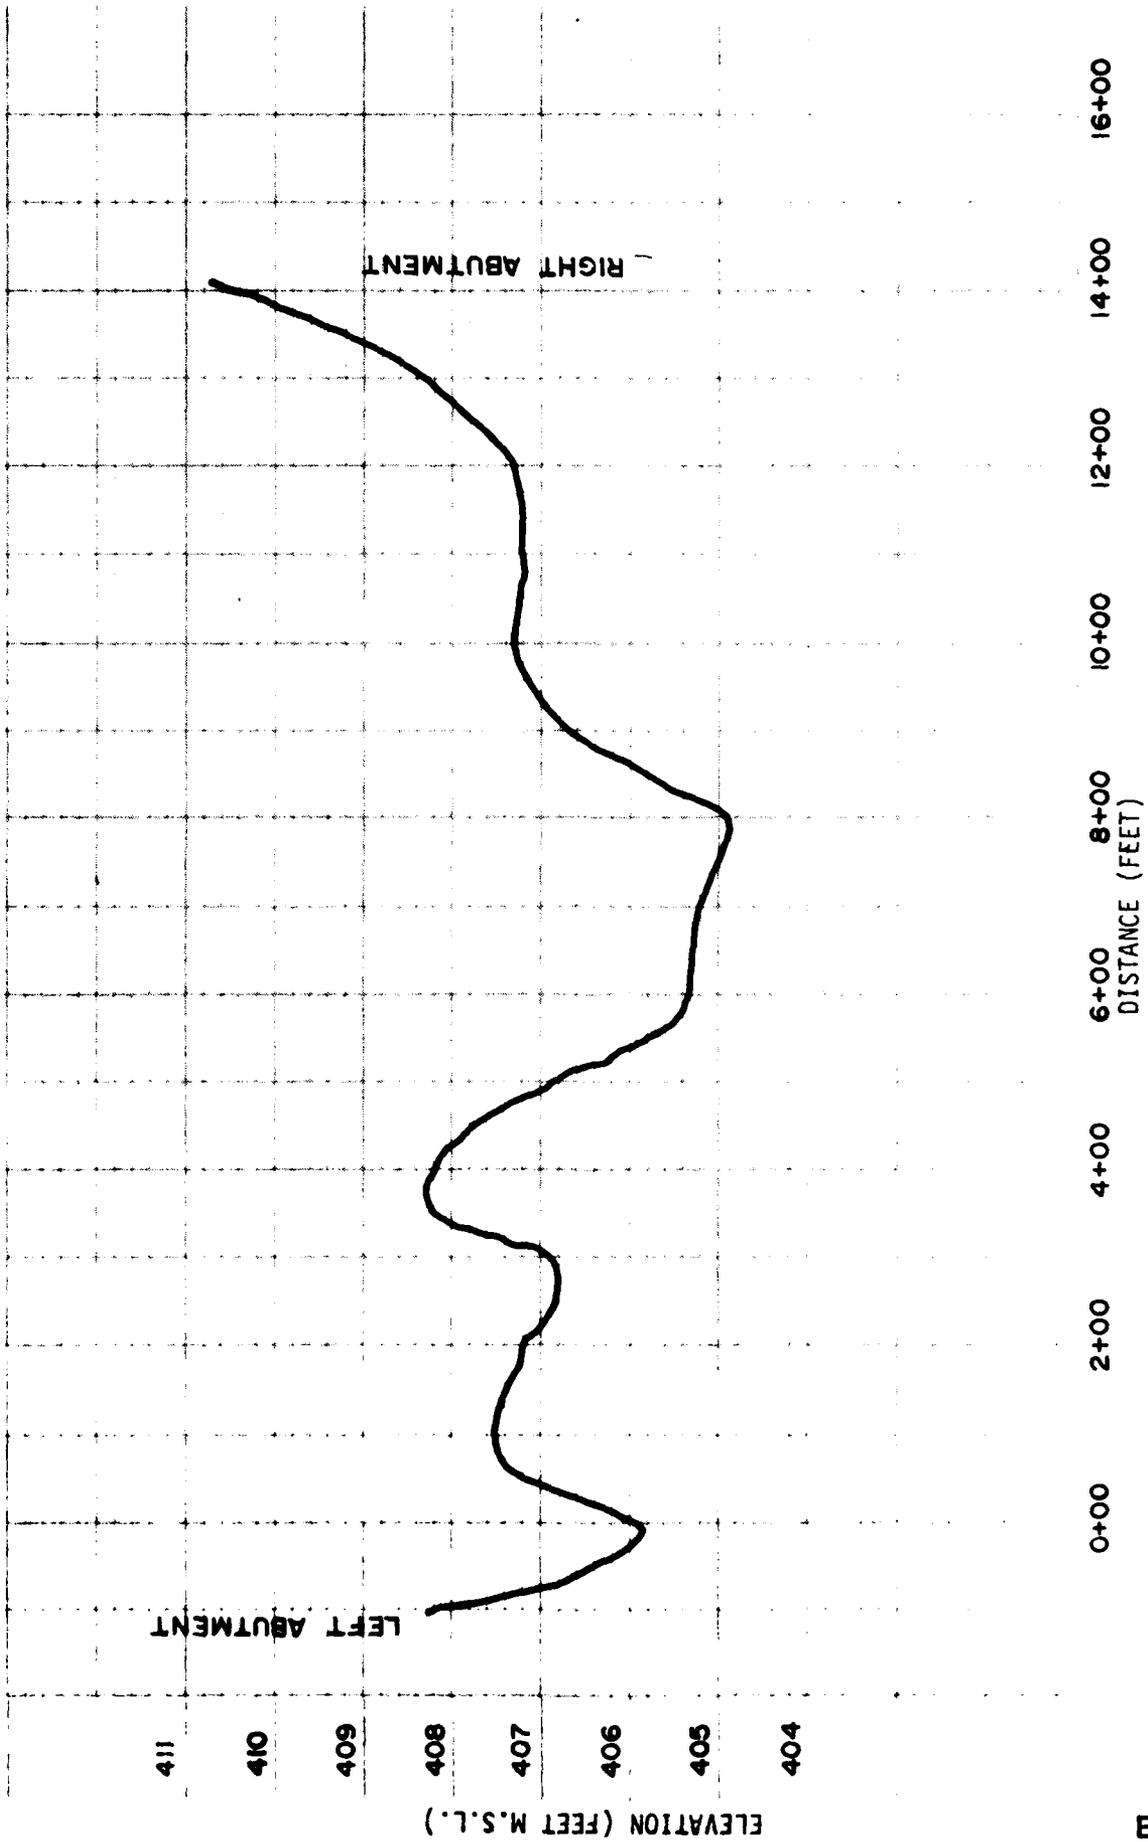
3 LIBIXH

The embankment appears to be in poor condition. The vertical alignment of the crest is not uniform and the crest elevation varies from 404.9 to 410.7. There is no apparent reason for this variation in elevation other than the fact that it was constructed that way. A profile of the crest can be seen on Exhibit 3 of Appendix B.
