17. DISTRIBUTION STATEMENT (of the abstract entered in Block 20, if different from Report) 6 National Dam Safety Program. Spring Lake Dam (MO 31180), Mississippi - Kaskaskia - St. Louis Basin, Cape Girardeau County, Missouri. Phase I Inspection Report.

MARCH, 1981

PHASE I INSPECTION REPORT  
NATIONAL DAM SAFETY PROGRAM  
SPRING LAKE DAM  
MISSOURI INVENTORY NO. 31180

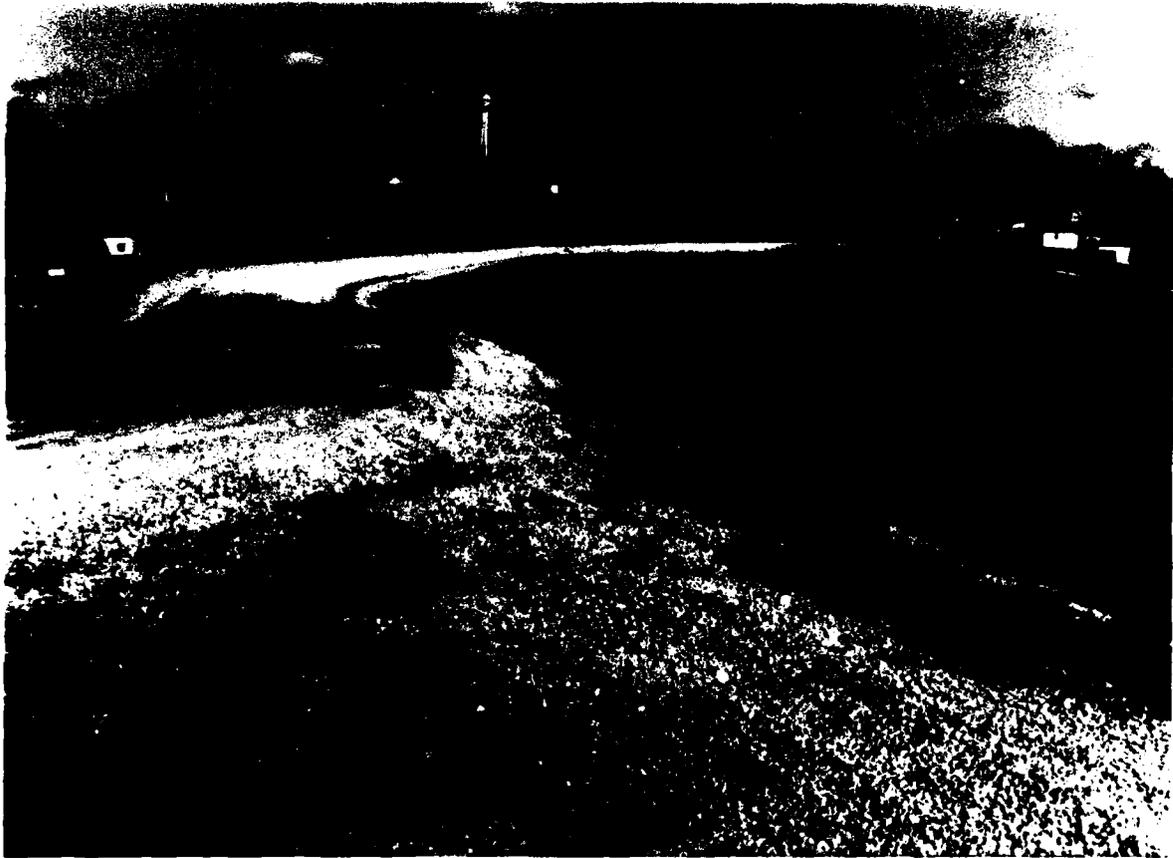
PHOTOGRAPH 1. OVERVIEW OF SPRING LAKE DAM

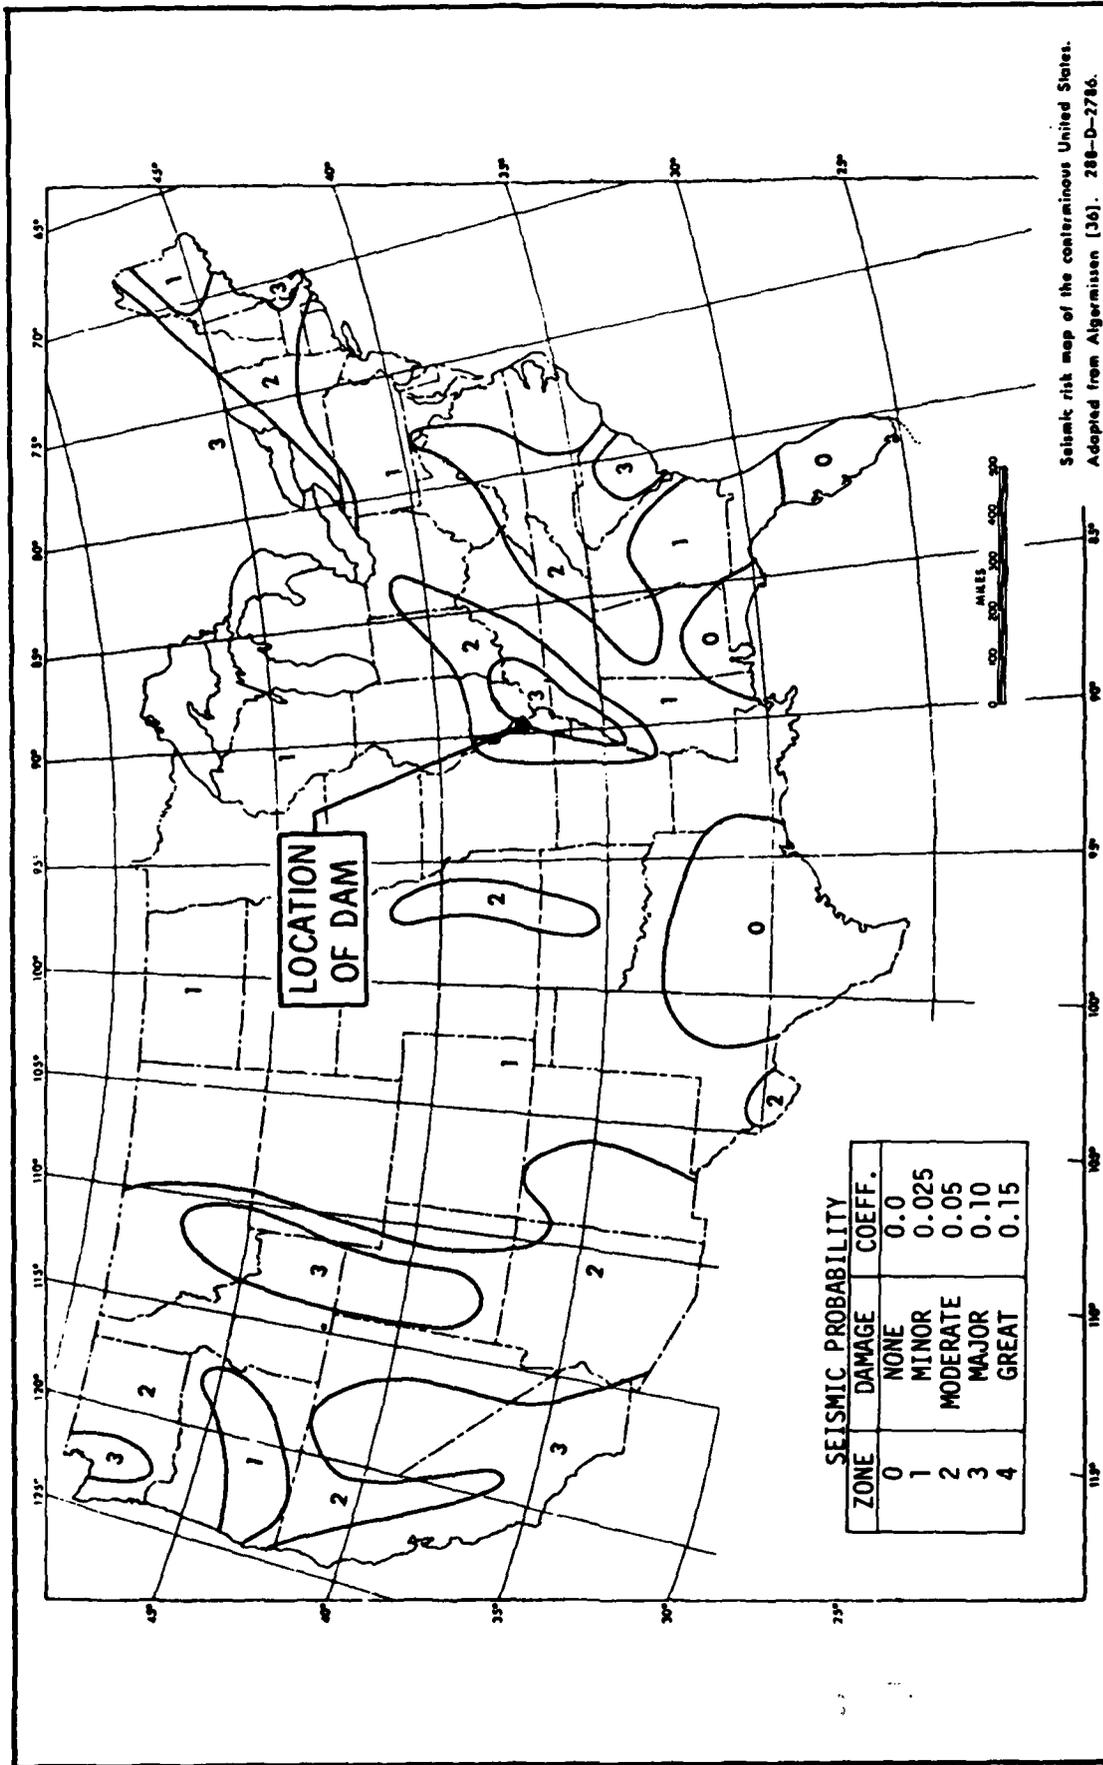
**SEISMIC ZONE MAP OF CONTIGUOUS STATES  
SPRING LAKE DAM MO 31180**

This dam is located in Seismic Zone 3, as shown on Plate 3 of Appendix A. Zone 3 delineates areas in which major damage would result from the expected seismic activity in this area. An accurate slope stability analysis with seismic loading cannot be made because of the lack of original design data and soil strength parameters. It should be noted that due to the relatively steep embankment slopes in the event of potential seismic loading, the slopes may become unstable and suffer some damage. The extent of damage would depend upon the intensity and duration of the seismic occurrence. It is recommended that stability analyses be made for the dam and spillway structures using the appropriate seismic loadings.

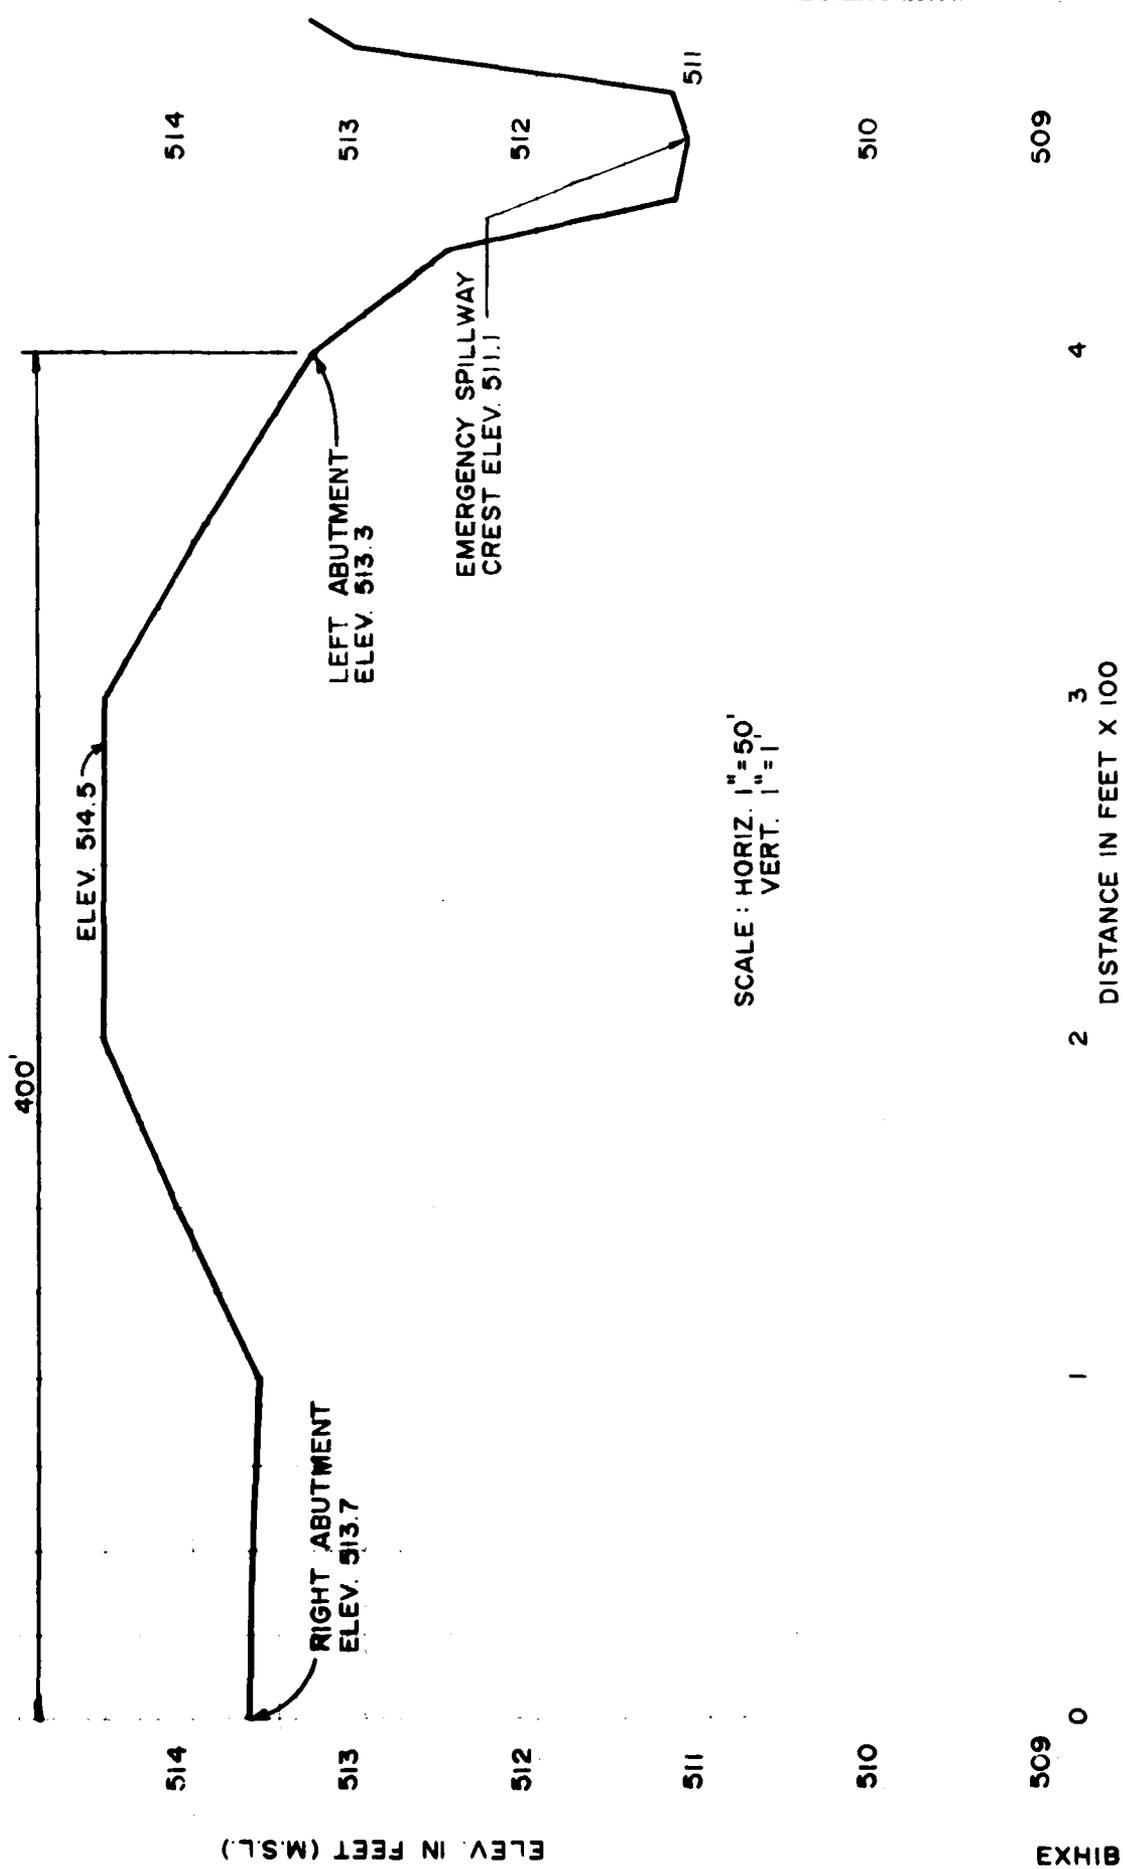
EXHIBIT 3

The embankment appears to be in fair condition. The horizontal alignment of the embankment (though curved) is good. The vertical alignment is erratic (see Exhibit 3 of Appendix C). It is believed this irregularity was primarily the result of grading for the roadway which extends across the crest of the dam. (See Photo 2 of Appendix C).
