BROWN LAKE DAM

CAPE GIRARDEAU COUNTY, MISSOURI

MO 31223

PHASE 1 INSPECTION REPORT

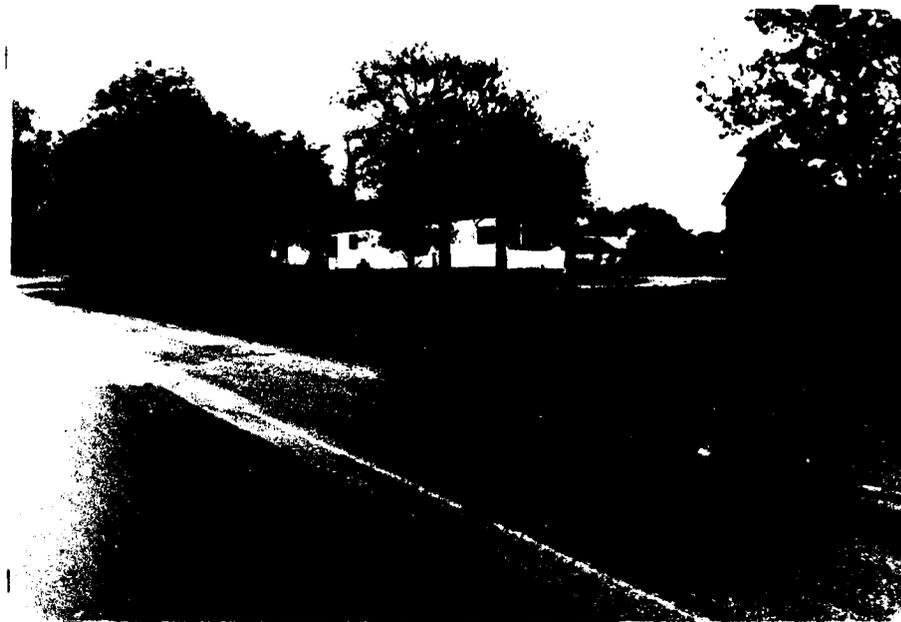
PHOTO NO. 22 - TRAILER LOCATED APPROX. 0.5 MILES DOWN-
STREAM OF THE DAM. HOUSE IN THE BACK-
GROUND.

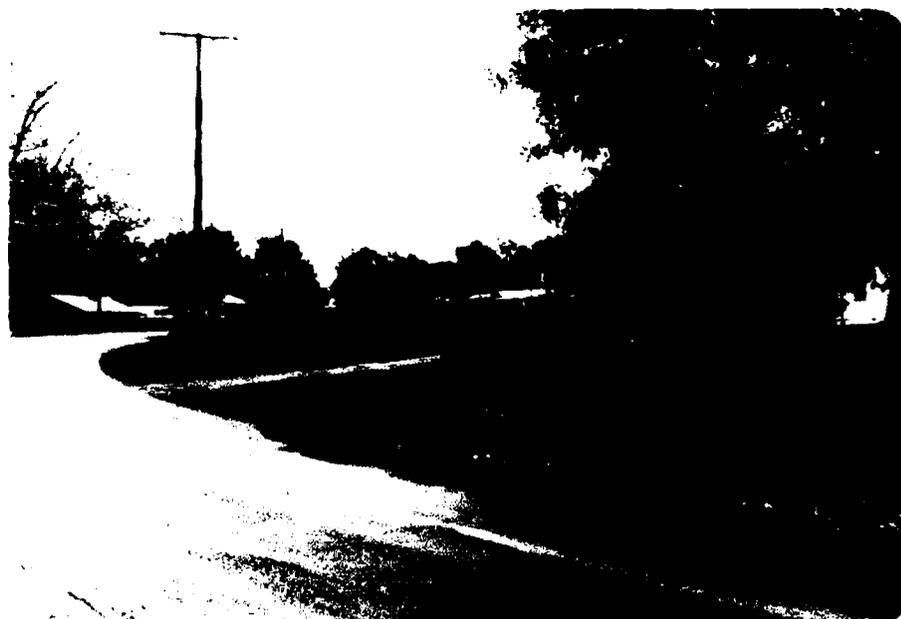
PHOTO NO. 23 - LOOKING NORTHEAST AT HOUSE BEHIND THE
TRAILER IN PHOTO NO. 22.

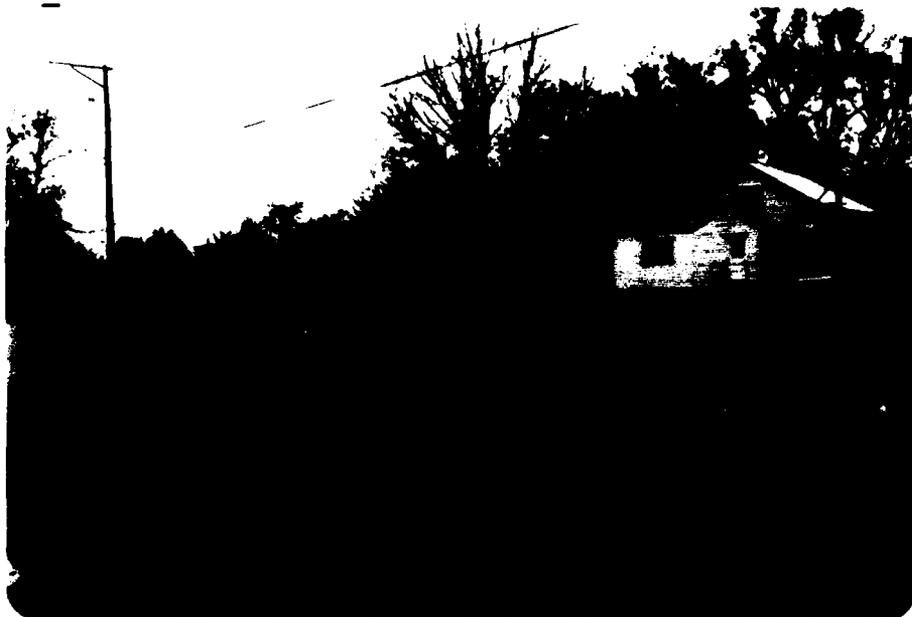
PHOTO NO. 24 - CHURCH LOCATED 0.8 MILES DOWNSTREAM OF DAM.
