**LAKE KAH-TAN-DA DAM
PERRY COUNTY, MISSOURI
MO 30838**

**PHASE 1 INSPECTION REPORT
NATIONAL DAM SAFETY PROGRAM**

APRIL, 1981

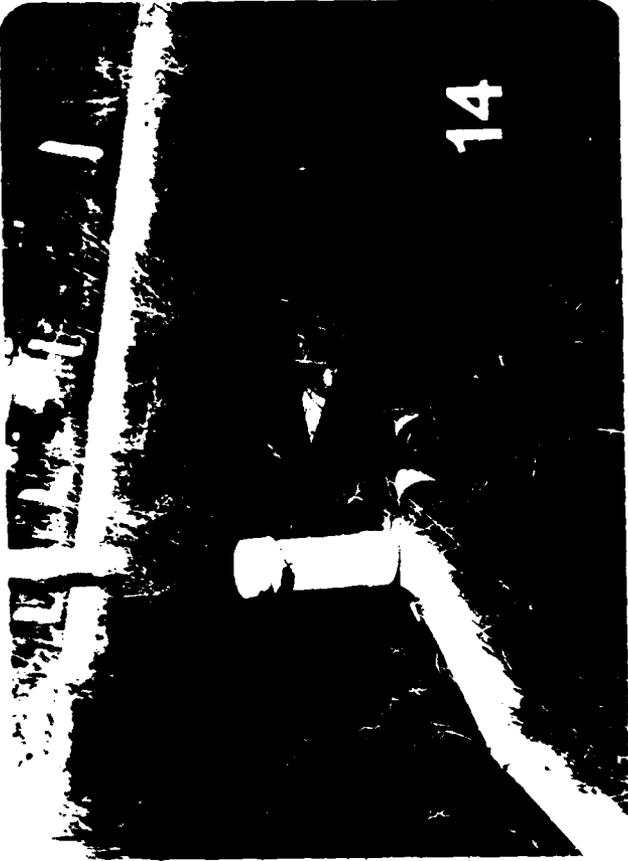
14

There is no emergency spillway. There are also no draindown facilities. An attempt was made to draw down the lake for shoreline repairs last year with a siphon system. The system consisted of four 4 1/2 in. plastic pipes embedded about 1 ft below the crest of the dam. Flexible plastic corrugated pipes were attached to the intake and discharge ends. The attempts to draw down the lake failed when the flexible discharge pipes failed under the pressure (see Photo 14). The owner indicated that this system has since been removed (after the inspection visit).

12.	Approach area to spillway looking upstream from bridge.
13.	Spillway outlet area looking downstream from bridge.
14.	Siphon system (downstream end); note flexible corrugated discharge pipe.
