TWIN LAKE DAM
MERCER COUNTY, MISSOURI
MO 10476

PHASE 1 INSPECTION REPORT
NATIONAL DAM SAFETY PROGRAM

PREPARED BY: HOSKINS-WESTERN-SONDEREGGER, INC.
FOR: STATE OF MISSOURI

JULY, 1978

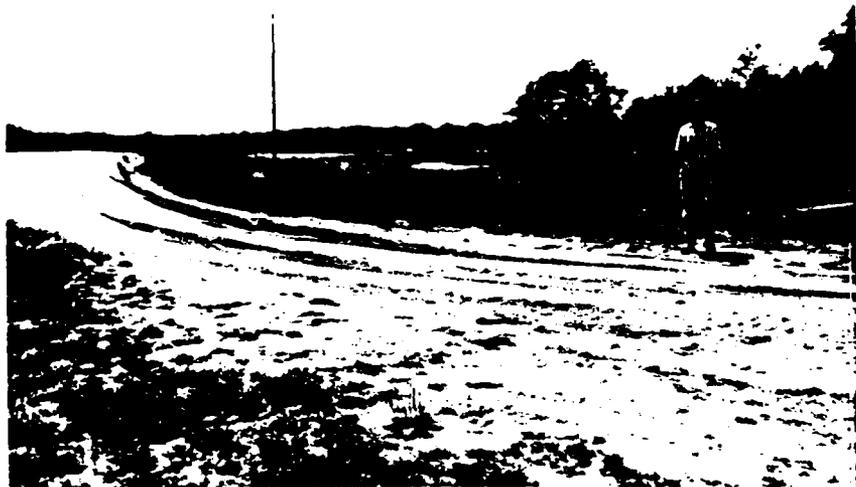
(2) A secondary spillway is cut into glacial till on the right (west) abutment. The access road to the dam provides the control section for this spillway with a crest elevation of 962±. A small farm pond is located near the south end of the exit channel for this spillway (about 165 ft. downstream from C of dam). The crest elevation of the embankment for the farm pond is 960 feet ± with the water level at about 958±. The north end of a large sewage lagoon (700 feet ± long-north to south and 365 feet ± wide-east to west) is located immediately east and down slope from the farm pond. The crest elevation of the dike around the lagoon is at 957 feet ±. Water surface in the lagoon is at elevation 954 feet ±. Two smaller lagoons are located southeast of the large lagoon. The water surface in these lagoons is reported to be 2 feet and 6 feet lower than the large lagoon. Rough measurements and sketches of the secondary spillway and adjoining ponds are shown in Appendix C.

Rough measurements along the centerline of the secondary spillway indicate that most flows will be carried around the right end of Twin Lake Dam and discharged eastward into a small drainageway passing between the roadway along the toe of the dam and the dike forming the sewage lagoon. It appeared that high flows of sustained duration could cause significant erosion along the toe of Twin Lake Dam and along the base of the lagoon dike.

PHOTO NO. 3
LOOKING DOWN RIGHT
SPILLWAY FROM 140'
NORTH OF CENTERLINE
OF DAM

(2) Measures should be installed to insure that discharge through the right spillway will not endanger the stability of the Twin Lake Dam or the adjoining sewage lagoon.

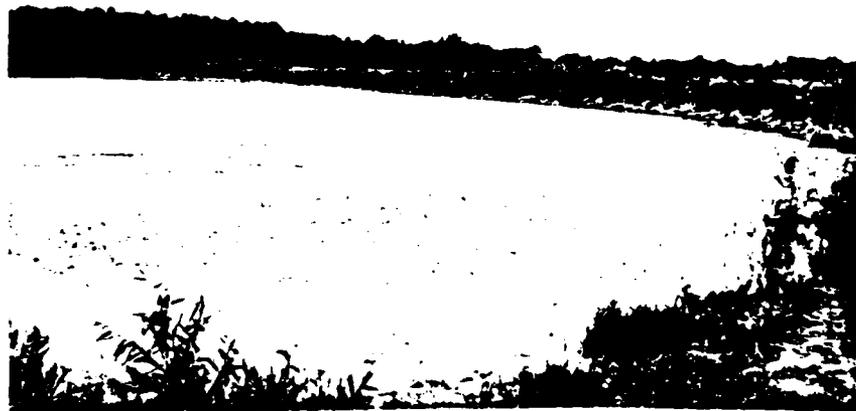
b. Dam. The dam looks very good. The upstream slope is riprapped to an elevation about 3 feet below the crest of the dam. The riprap appeared to be in good shape. No slips or significant erosion were noted on the upstream face. The crest and downstream slope is well vegetated with grass and well maintained. Materials on the surface of the dam consist of lean clay and sandy clay (CL and SC). No slides, significant erosion, or deformations were noted on the downstream slope.

PHOTO NO. 4
UPSTREAM SLOPE
FROM RIGHT SPILLWAY

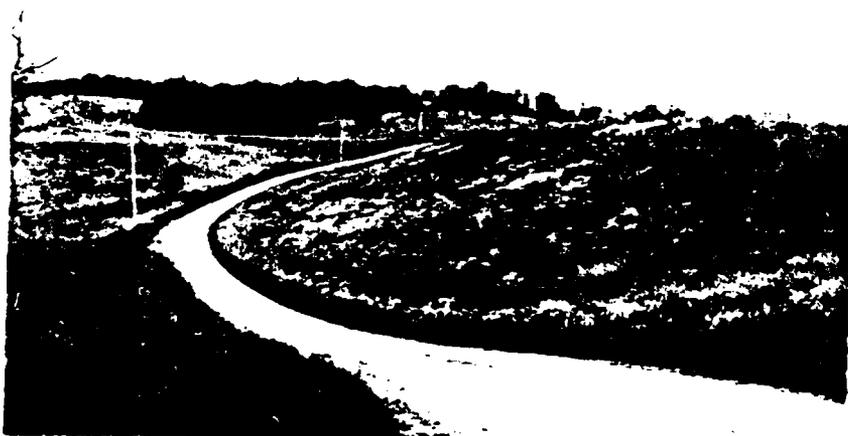
PHOTO NO. 7
DOWNSTREAM SLOPE
OF DAM FROM LEFT
ABUTMENT

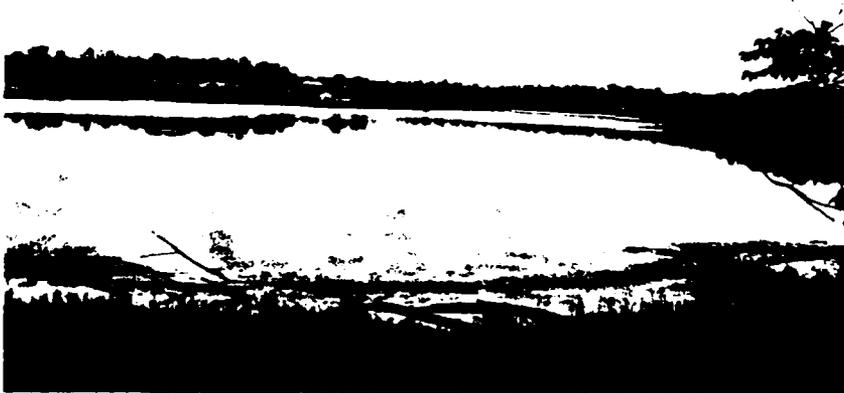
d. Reservoir Area. Some erosion was observed along the east shoreline 300 to 400 feet upstream from the dam. No significant erosion was noted on the remainder of the shoreline. No slides or slips were noted around the shoreline.

PHOTO NO. 9
LAKE FROM
LEFT ABUTMENT

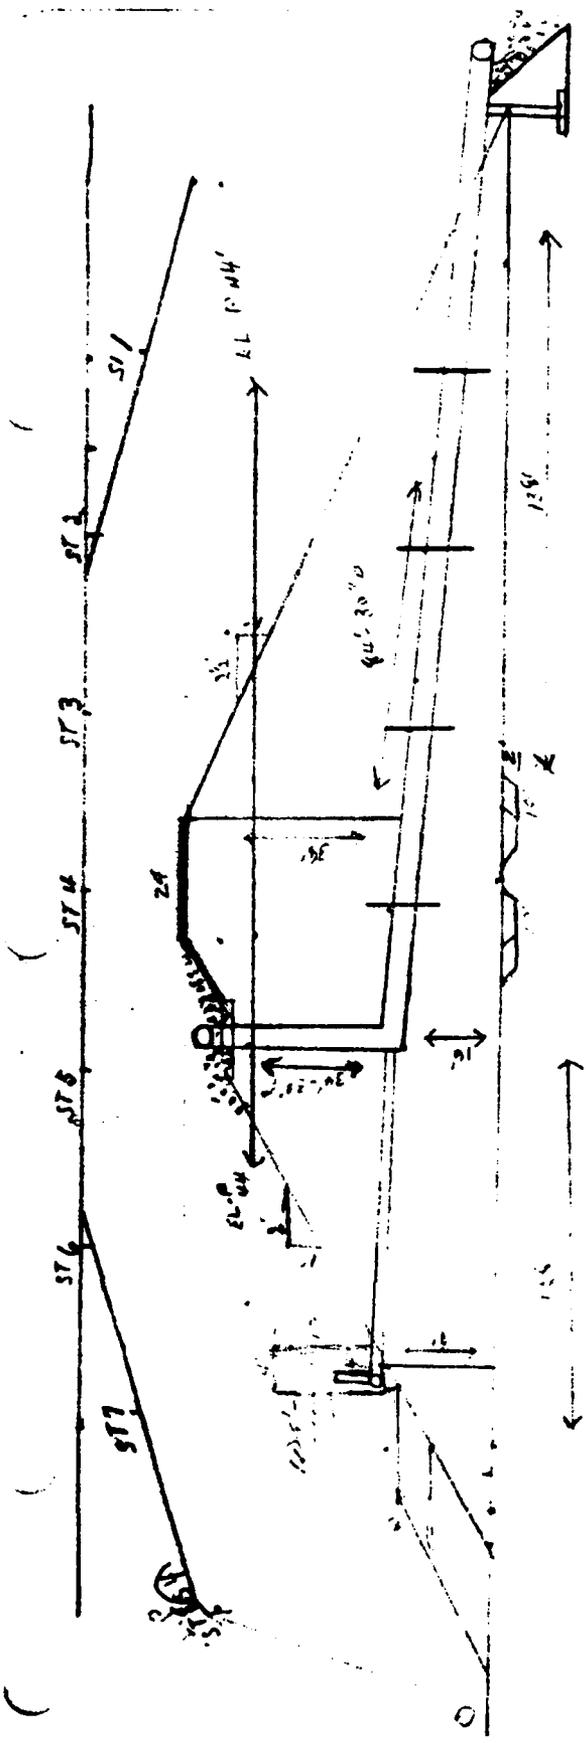
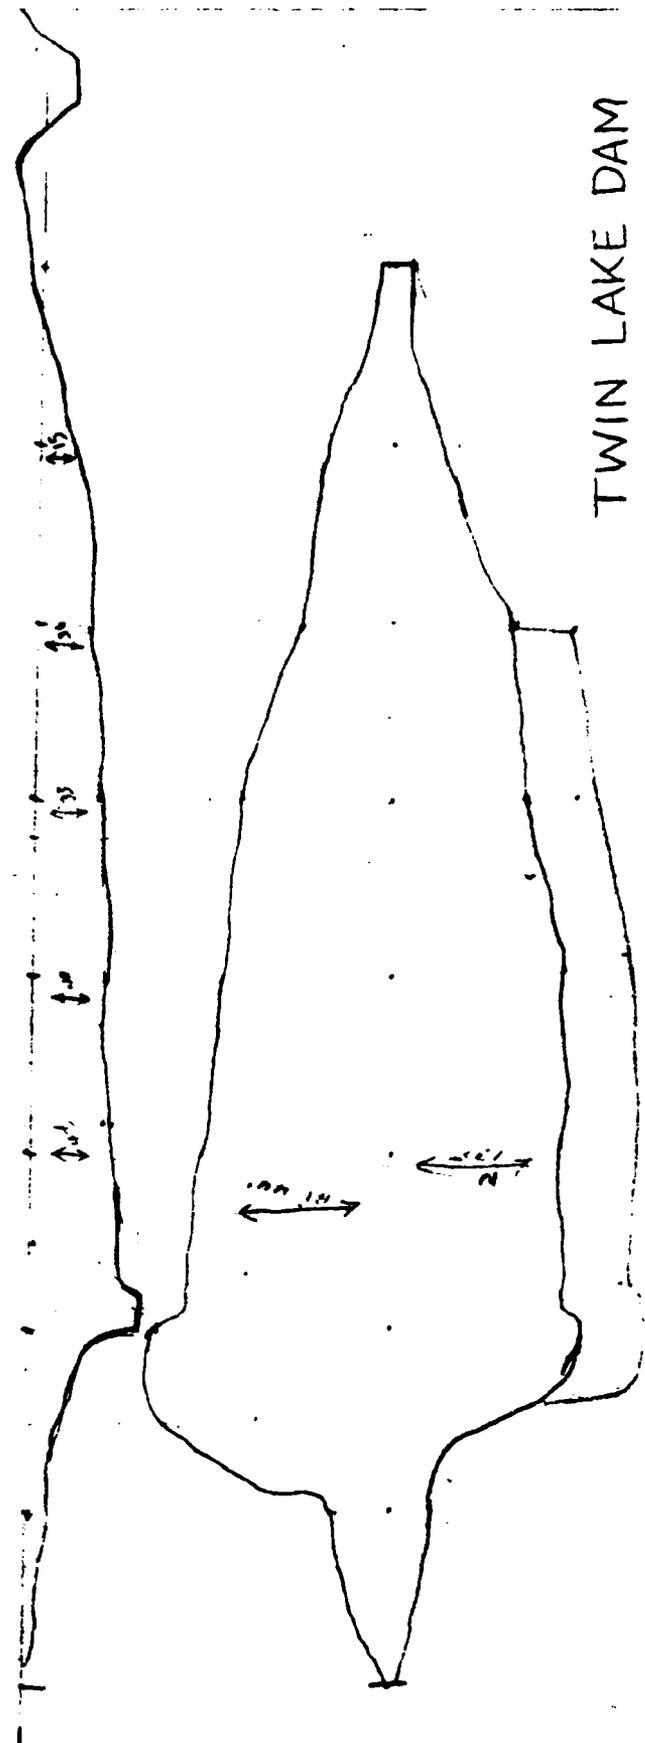
TWIN LAKE DAM
 PLAN AND CROSS SECTION
 FURNISHED BY OWNER

Rough measurements of the centerline profile and a typical cross section of the dam indicate that it was constructed according to Lane Western recommendations. Measured sections are shown in Appendix C.
