CLINTON RESERVOIR DAM

INVENTORY No. NY 212

PHASE I INSPECTION REPORT
NATIONAL DAM SAFETY PROGRAM

JULY 1981

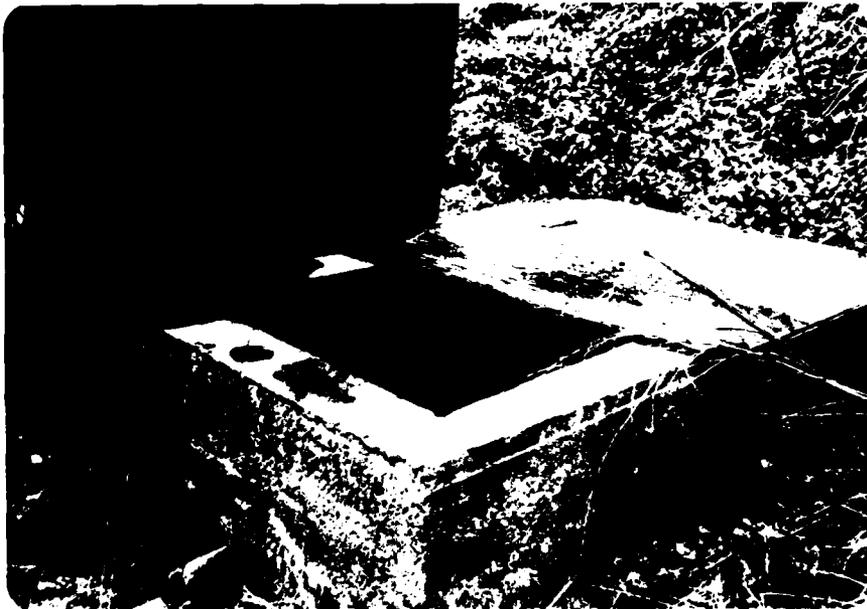
12. Spring box located just beyond the toe of slope.

(5) Seepage NONE OBSERVED. (A DEVELOPED SPRING
WITH CONCRETE SPRING BOX LOCATED AT TOE OF
CENTER OF DAM SUPPLIES WATER TO NEARBY
