REPORT DOCUMENTATION PAGE		READ INSTRUCTIONS BEFORE COMPLETING FORM
1. REPORT NUMBER	2. GOVT ACCESSION NO.	3. RECIPIENT'S CATALOG NUMBER
	AD A105781	
4. TITLE (and Subtitle) Phase I Inspection Report Potic Reservoir Dam Lower Hudson River Basin, Greene County, N.Y. Inventory No. 307		5. TYPE OF REPORT & PERIOD COVERED Phase I Inspection Report National Dam Safety Program

**LOWER HUDSON RIVER BASIN
TOWN OF COXSACKIE
GREENE COUNTY, NEW YORK**

**POTIC RESERVOIR DAM
NY 00307**

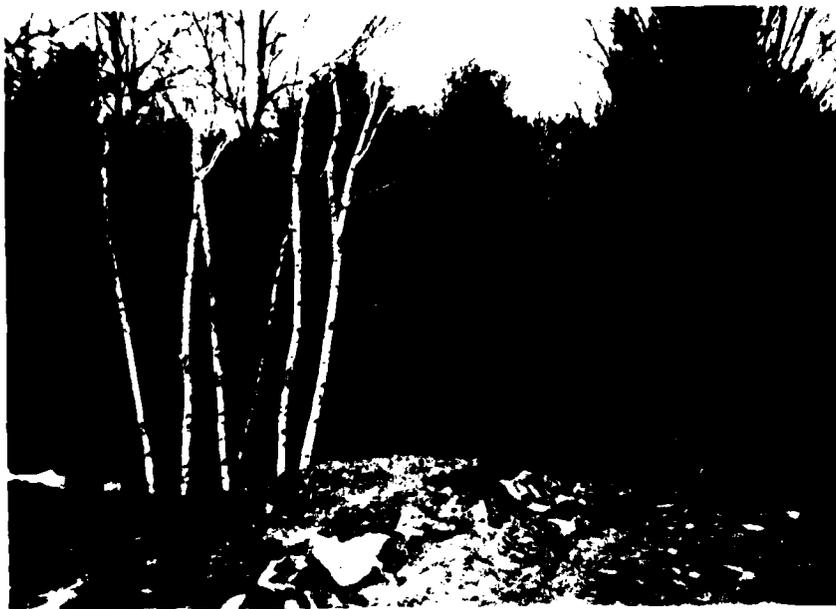
A-2B Downstream slope of dam looking from area recently filled
with rock and construction debris - 4/9/81

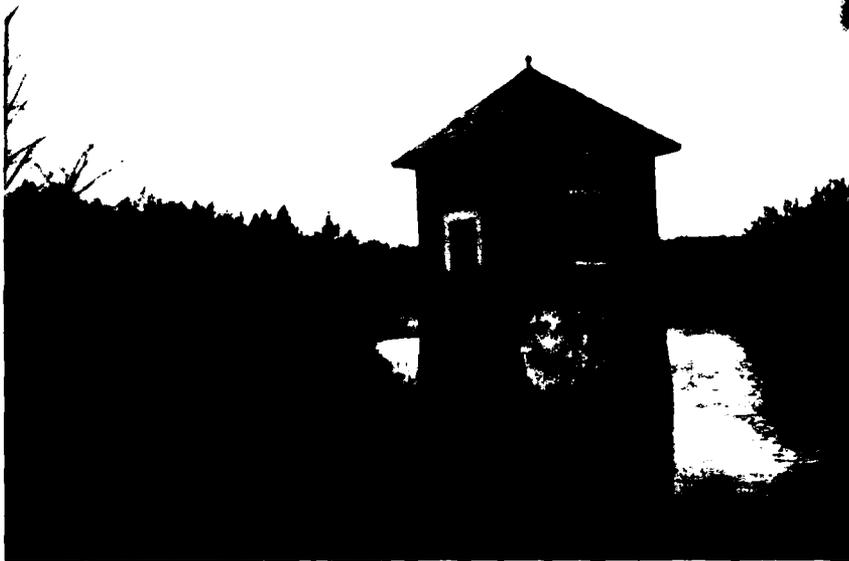
The gate house for the dam is a brick structure with a wood-framed, slate-shingled roof. The gate house was in good condition. The wooden parts of the gate house, however, could use a coat of paint. Inside the gate house there are 2 hand crank, bevel gear floor stand controls for the 2 slide gates at the bottom of the control tower (see Photo A-6A). Both of these control mechanisms were well lubricated, operable, and in good condition. The upstream gate was closed and the downstream gate was open at the time of inspection. The uppermost gate stem guide for the downstream gate is broken and detached from the stem.

The service bridge is a concrete walkway with steel pipe railings spanning from the gate house to the top of dam. The bridge deck and its supports are in good condition. The railings, however, are loose and are rusting in spots.

A-5B Gate house and service bridge - 4/9/81

- 9) Repair the uppermost gate stem guide on the downstream gate in the intake structure.
 - 10) Develop and implement effective routine operation and maintenance procedures for the dam and its appurtenances. The sluice gates and blowoff valve should be exercised regularly.

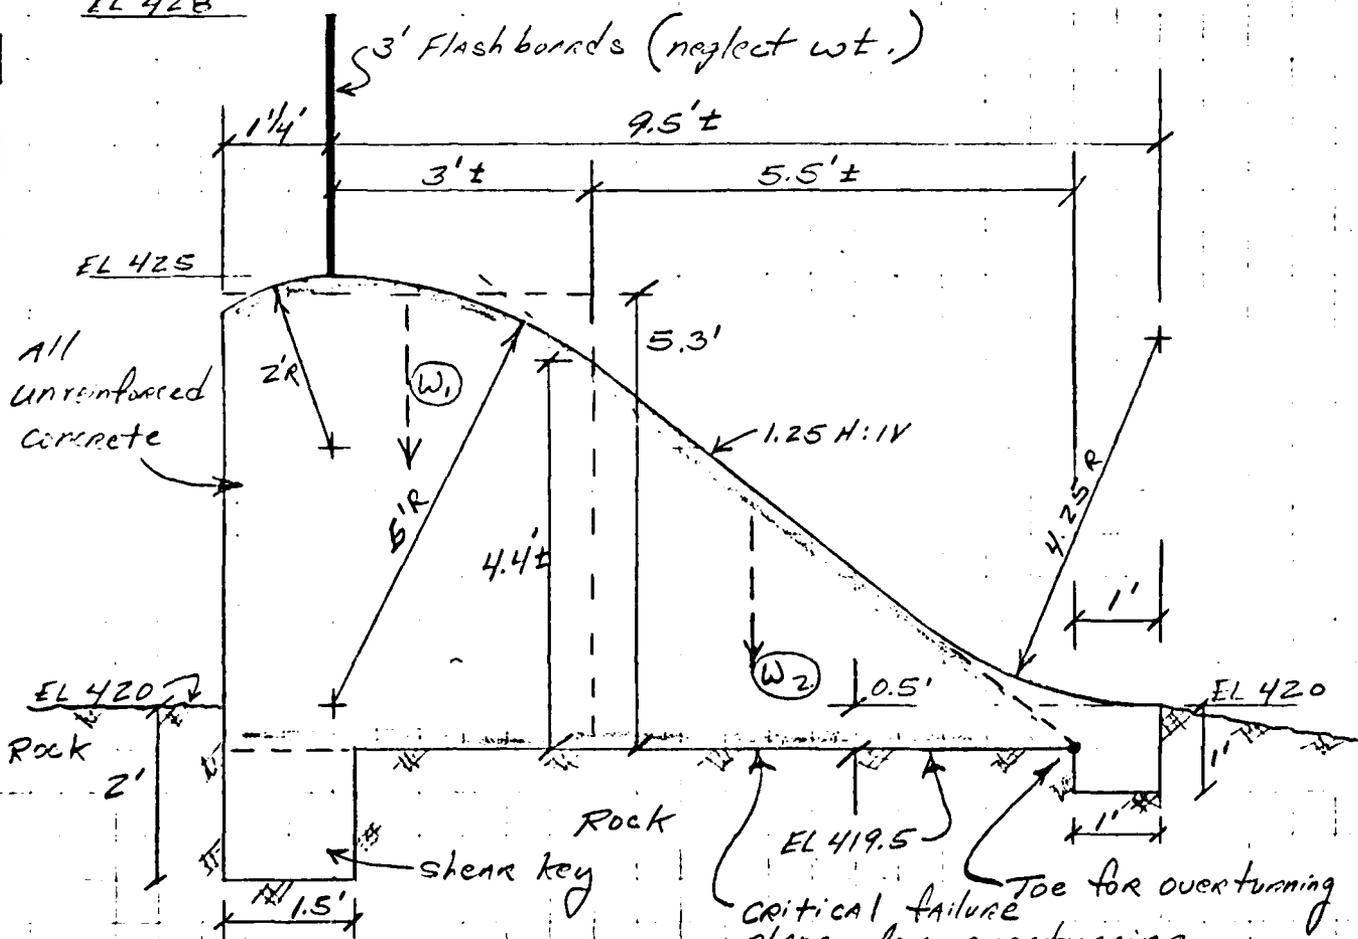
CROSS SECTION FOR ANALYSIS (typical section to left of bend point, see Photos A-7B & A-8B & dwg. Appendix G-3)

Since section unreinforced, wt. & pullout not w/s shear key could not resist overturning w/o cracking concrete at top of shear key. ∴ critical plane for overturning failure is horiz. plane thru w/s shear key at elevation of rock contact at base of structure. Choose toe at extension of d/s face to base.

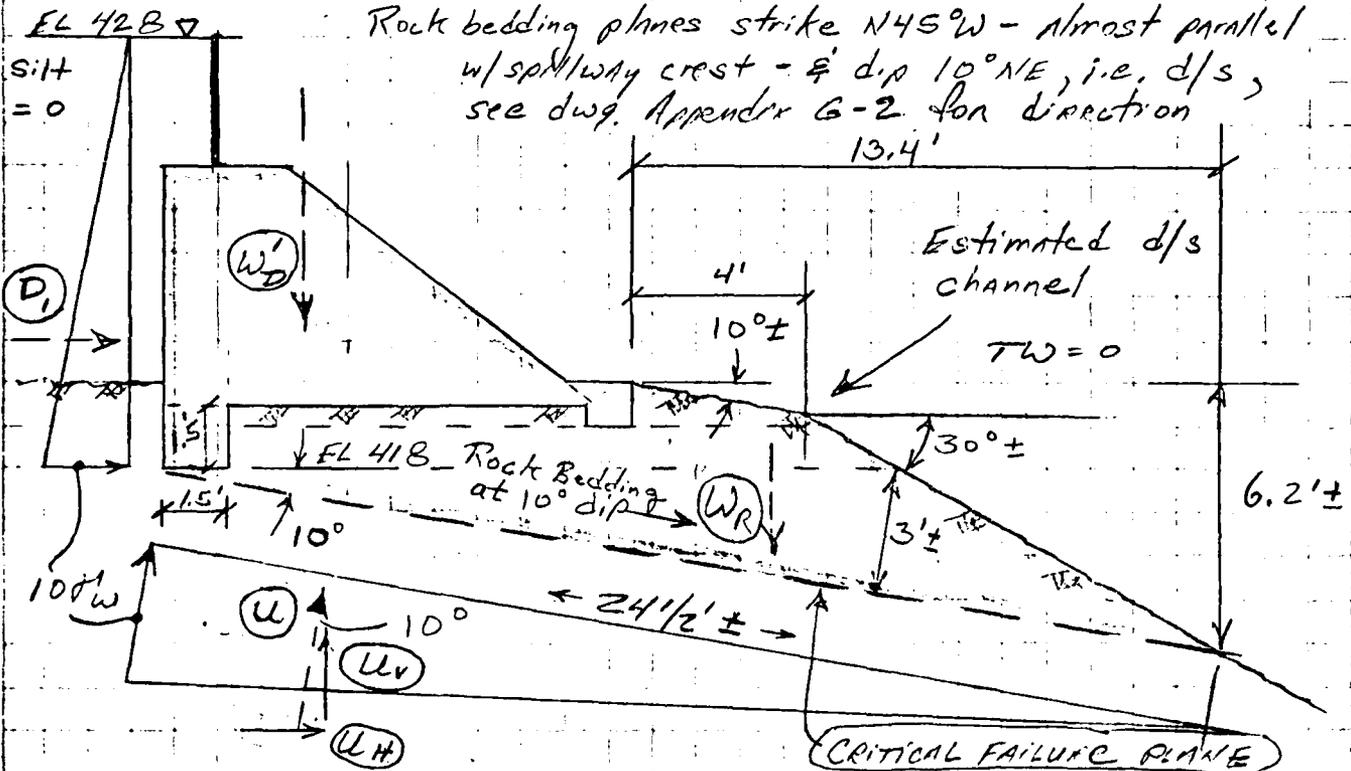
CASE 1 - SLIDING

Assumed Failure Plane from heel along rock bedding plane at 10° dip d/s until plane daylights.

Horiz. Resisting Force = $R_s = \sum V \tan(\phi - \alpha)$ when $C = \text{cohesion} = 0$ where $\alpha = 10^\circ$ (Reference 1)

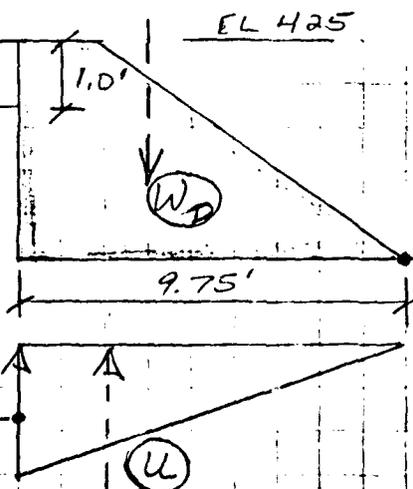
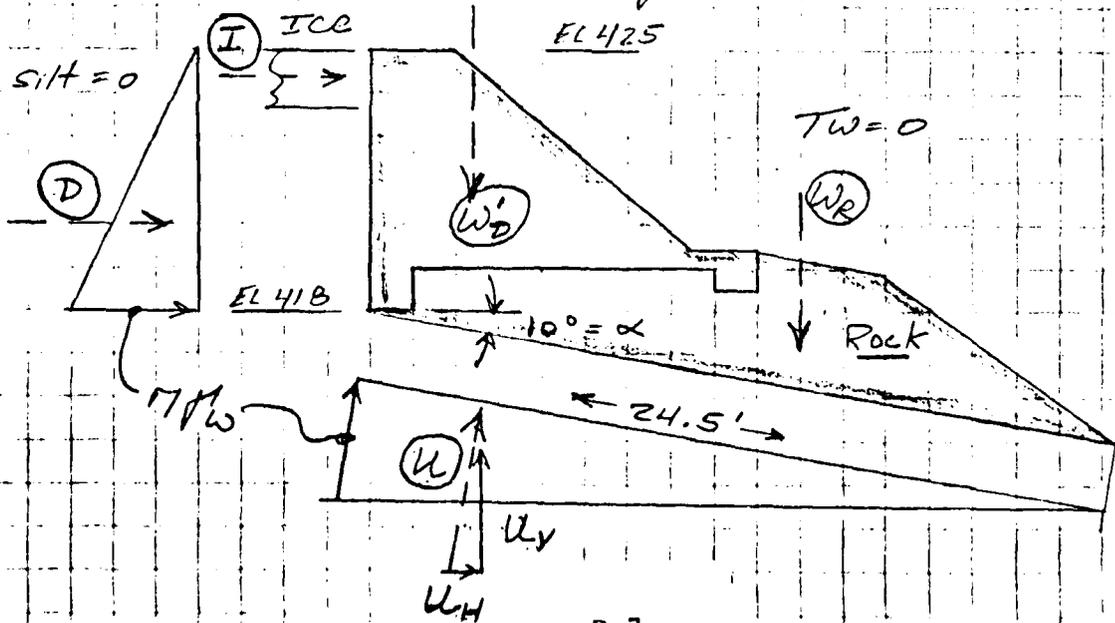
CASE 2 - SLIDING Use same critical failure plane (rock bedding plane) & theory as CASE 1, sheet 3

$d = \frac{-5.17}{3.53} = -1.46' \times \frac{b}{9.75} = -0.15b \text{ unstable}$
