**KLONDIKE LAKE DAM  
ST. CHARLES COUNTY, MISSOURI  
MO 30019**

**PHASE 1 INSPECTION REPORT  
NATIONAL DAM SAFETY PROGRAM**

KLONDIKE LAKE DAM - MISSOURI INVENTORY NO. 30019

AUGUST 1980

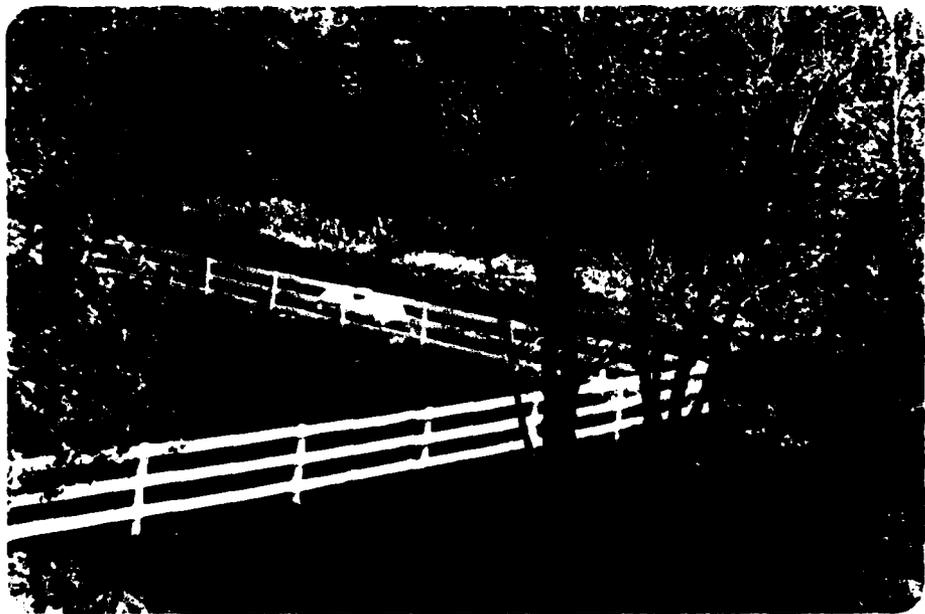
1. Evidence of seepage, soft and wet ground near the toe of the center of the dam; soft ground and flowing water at the intersection of the toe of the dam and the right abutment; and running and standing water and cattails downstream of the toe of the dam was observed. Uncontrolled seepage could develop into a piping condition that can lead to failure of the dam. Saturation of the soil adjacent to the dam can weaken the foundation and impair the stability of the dam.

A marshy area (see Photo 10) as evidenced by cattails and standing and flowing water, was observed downstream of the toe of the dam. It appeared that most of the water within the marsh was discharged to the area by a spring located downstream of the dam. Flow from the spring was estimated to be less than 2 gpm. Although there was no visible flow, the soil in the area between the downstream toe of the dam and the spring outlet (see Photo 9) was soft and damp. Some minor seepage was also evident along the right abutment, with water flowing from an area located about one-third of the distance between the downstream toe and the crest of the dam. The flow appeared to be less than 0.5 gpm.

NO. 10: MARSHY AREA DOWNSTREAM OF DAM

(1) Provide some means of controlling seepage evident in the area adjacent to the downstream toe near the center of the dam and at the junction of the embankment and the right abutment. Uncontrolled seepage can lead to a piping condition which could result in the failure of the dam. Drainage of the areas affected by seepage including elimination of the marshy area just downstream of the dam should be one of the objectives of the seepage control measures since saturation of the soil weakens the foundation which could impair the stability of the dam.
