STATE OF MISSOURI
BRANSON DAM
BRANSON COUNTY, MISSOURI
1958

PHASE 1 INSPECTION REPORT NATIONAL DAM SAFETY INSPECTION

17. DISTRIBUTION STATEMENT (of the abstract entered in Block 20, if different from Report) 6 National Dam Safety Program. Buick Mine Tailings Dam (MO 30162), White River Basin, Reynolds County, Missouri. Phase I Inspection Report.

BUICK MINE TAILINGS DAM

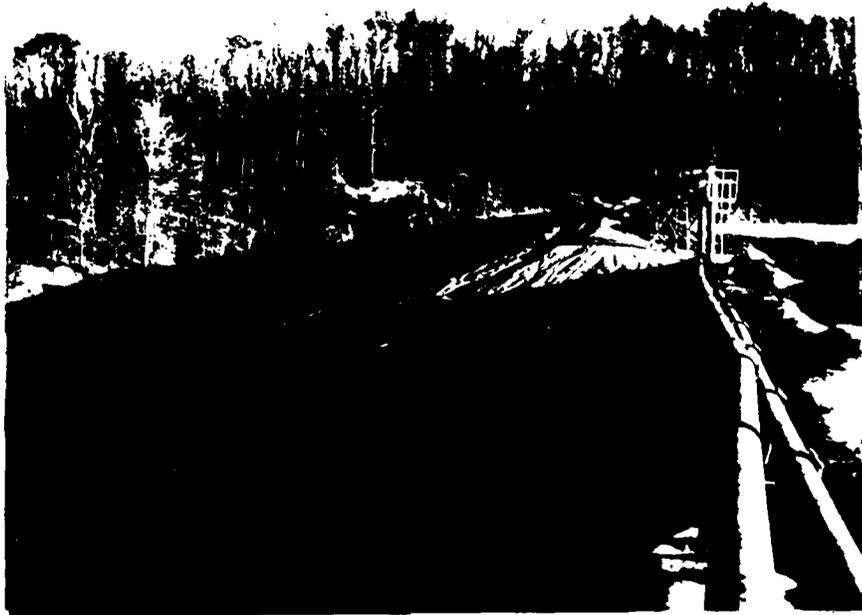
2. Cyclone depositing tailings on the downstream face of the dam. Pipes in the foreground carry unsorted tailings from the mill to the cyclone, and fine tailings from the cyclone to be discharged into the reservoir. Looking southeast along crest of dam.

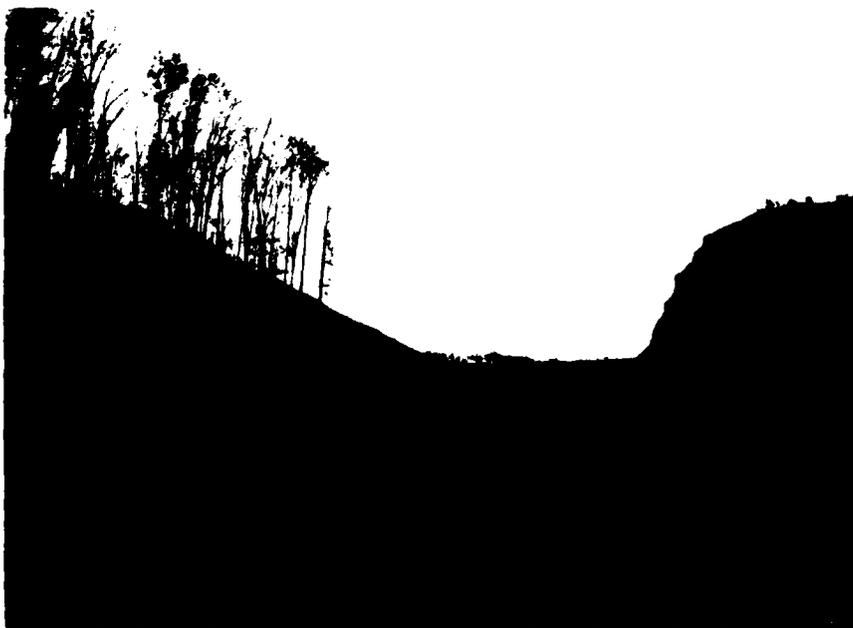
The temporary spillway and decant system pass through the ridge south of the dam. Both the spillway and decant system appear to be in good repair and do not appear subject to significant erosion.

8. Spillway cut through hillside to the south of the dam and reservoir. Soil embankment at far end of (upstream) is 1 ft lower than crest of dam. Decant line runs beneath the fill placed on the floor of this cut. Looking northwest (upstream in spillway channel).

1. Evaluate methods of increasing the height of the dam crest and/or increasing the spillway capacity to store and pass 100 percent of the PMF, without overtopping the embankment. This recommendation may have already been satisfied by the normal construction progress. The spillway should be protected to prevent erosion.

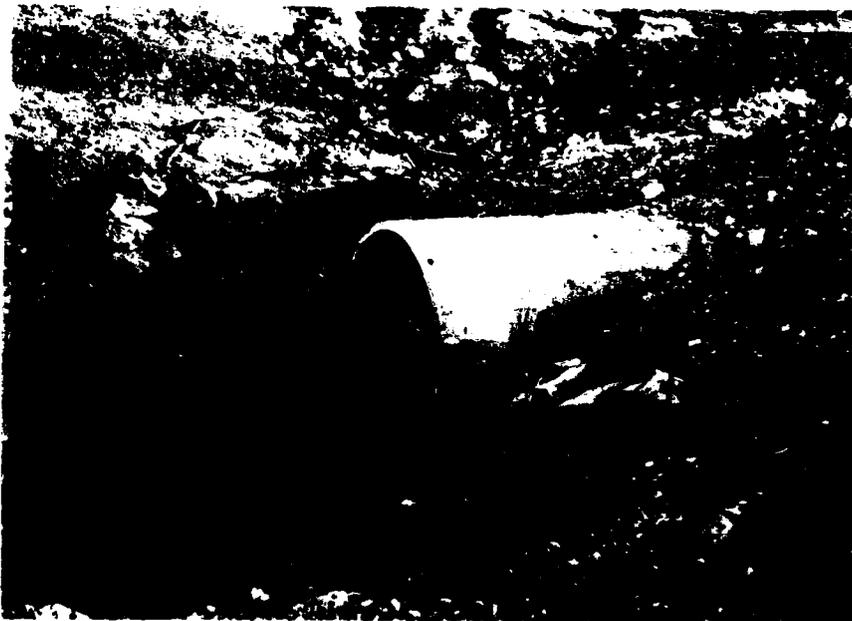
10. Trash rack at inlet to decant line. Looking east.
