PHASE I INSPECTION REPORT  
NATIONAL DAM SAFETY INSPECTION

**DESOTO MINING COMPANY  
PIT AND PLANT "A" DAM  
Washington County, Missouri  
Missouri Inventory No. 30468**

**Phase I Inspection Report**

Name of Dam	Desoto Pit and Plant "A" Dam
State Located	Missouri
County Located	Washington
Stream	Turkey Creek
Date of Inspection	5 June 1980

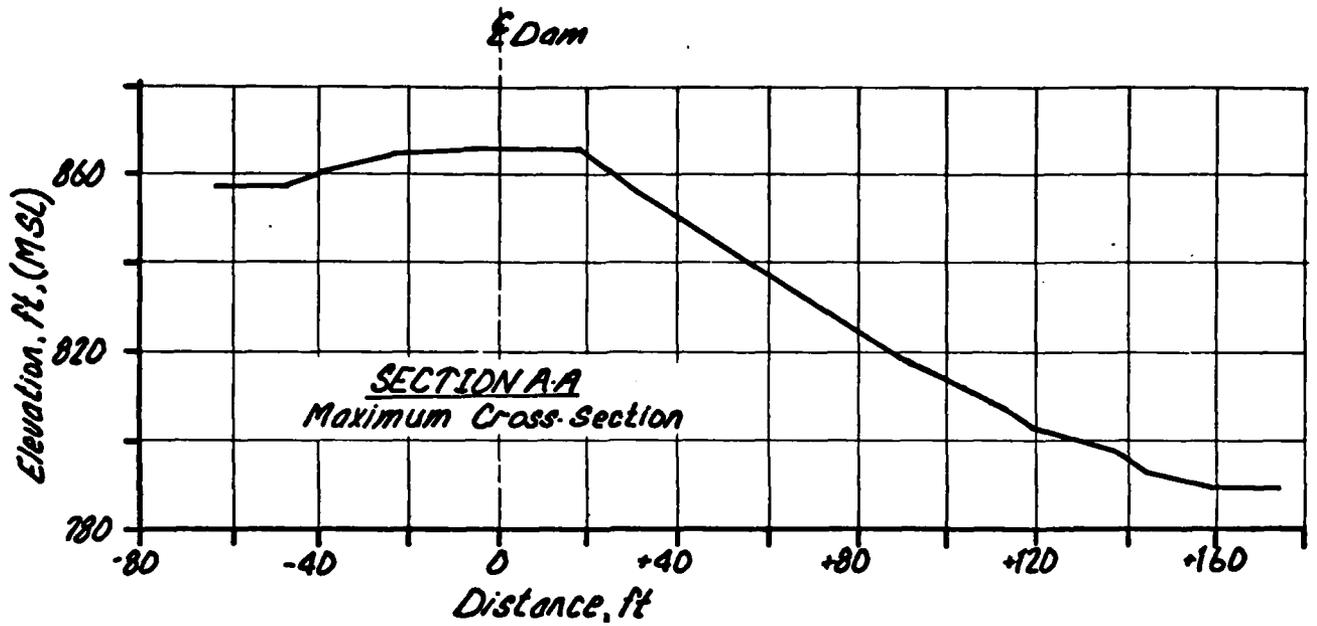
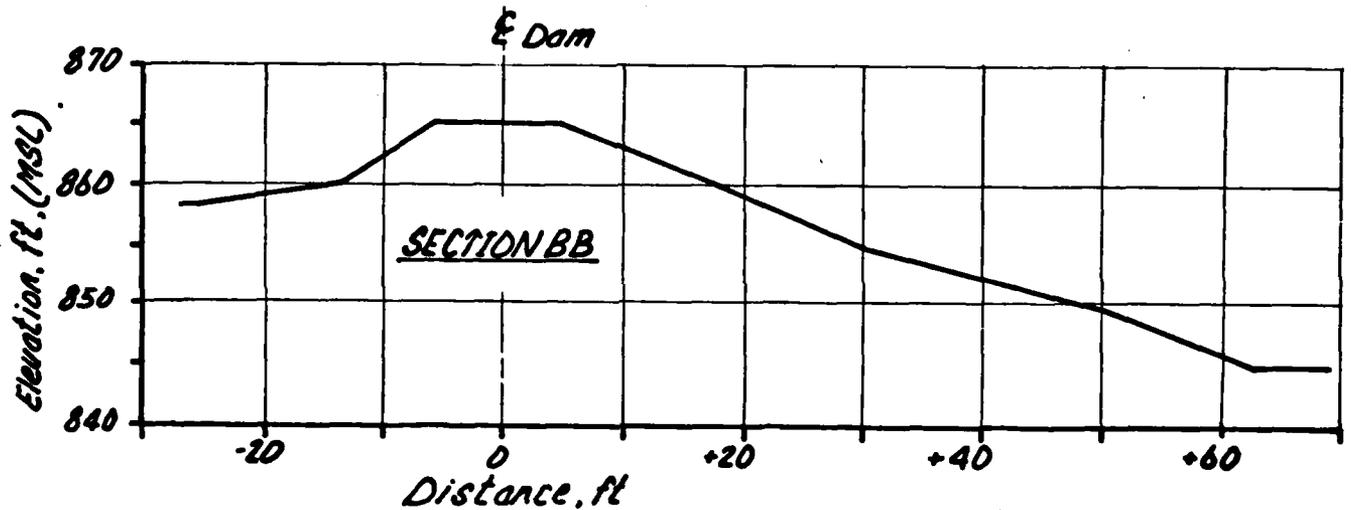
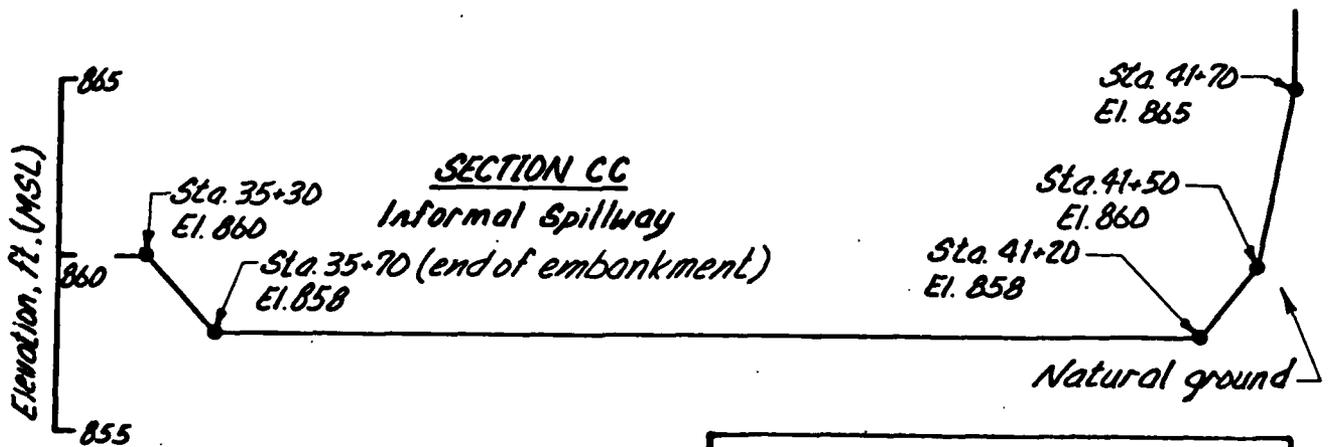
<b>CROSS-SECTIONS OF DAM &amp; SPILLWAY</b>	
<b>DESOTO MINING CO PIT &amp; PLANT 'A'</b>	
<b>MO. 30468</b>	<b>FIG 3B</b>

3. Spillway. There is no formal designed spillway at this facility. The term "informal spillway" has been assigned to the low area to the south of the south end of the dam (see Figs. 3a and 3b). This overflow area has a moderate to high erosion potential as the stoney clay residual soil is only vegetated by grass, brush and small trees. This soil has been observed to be highly erodible when stripped of vegetation and exposed to high flow velocities.

- d. Overtopping potential. The lack of a designed, formal spillway and discharge channel indicate a deficiency at this facility. It is recommended that a hydrologic analysis be conducted to facilitate the design of a spillway and discharge channel adequate to pass an appropriate design flood.

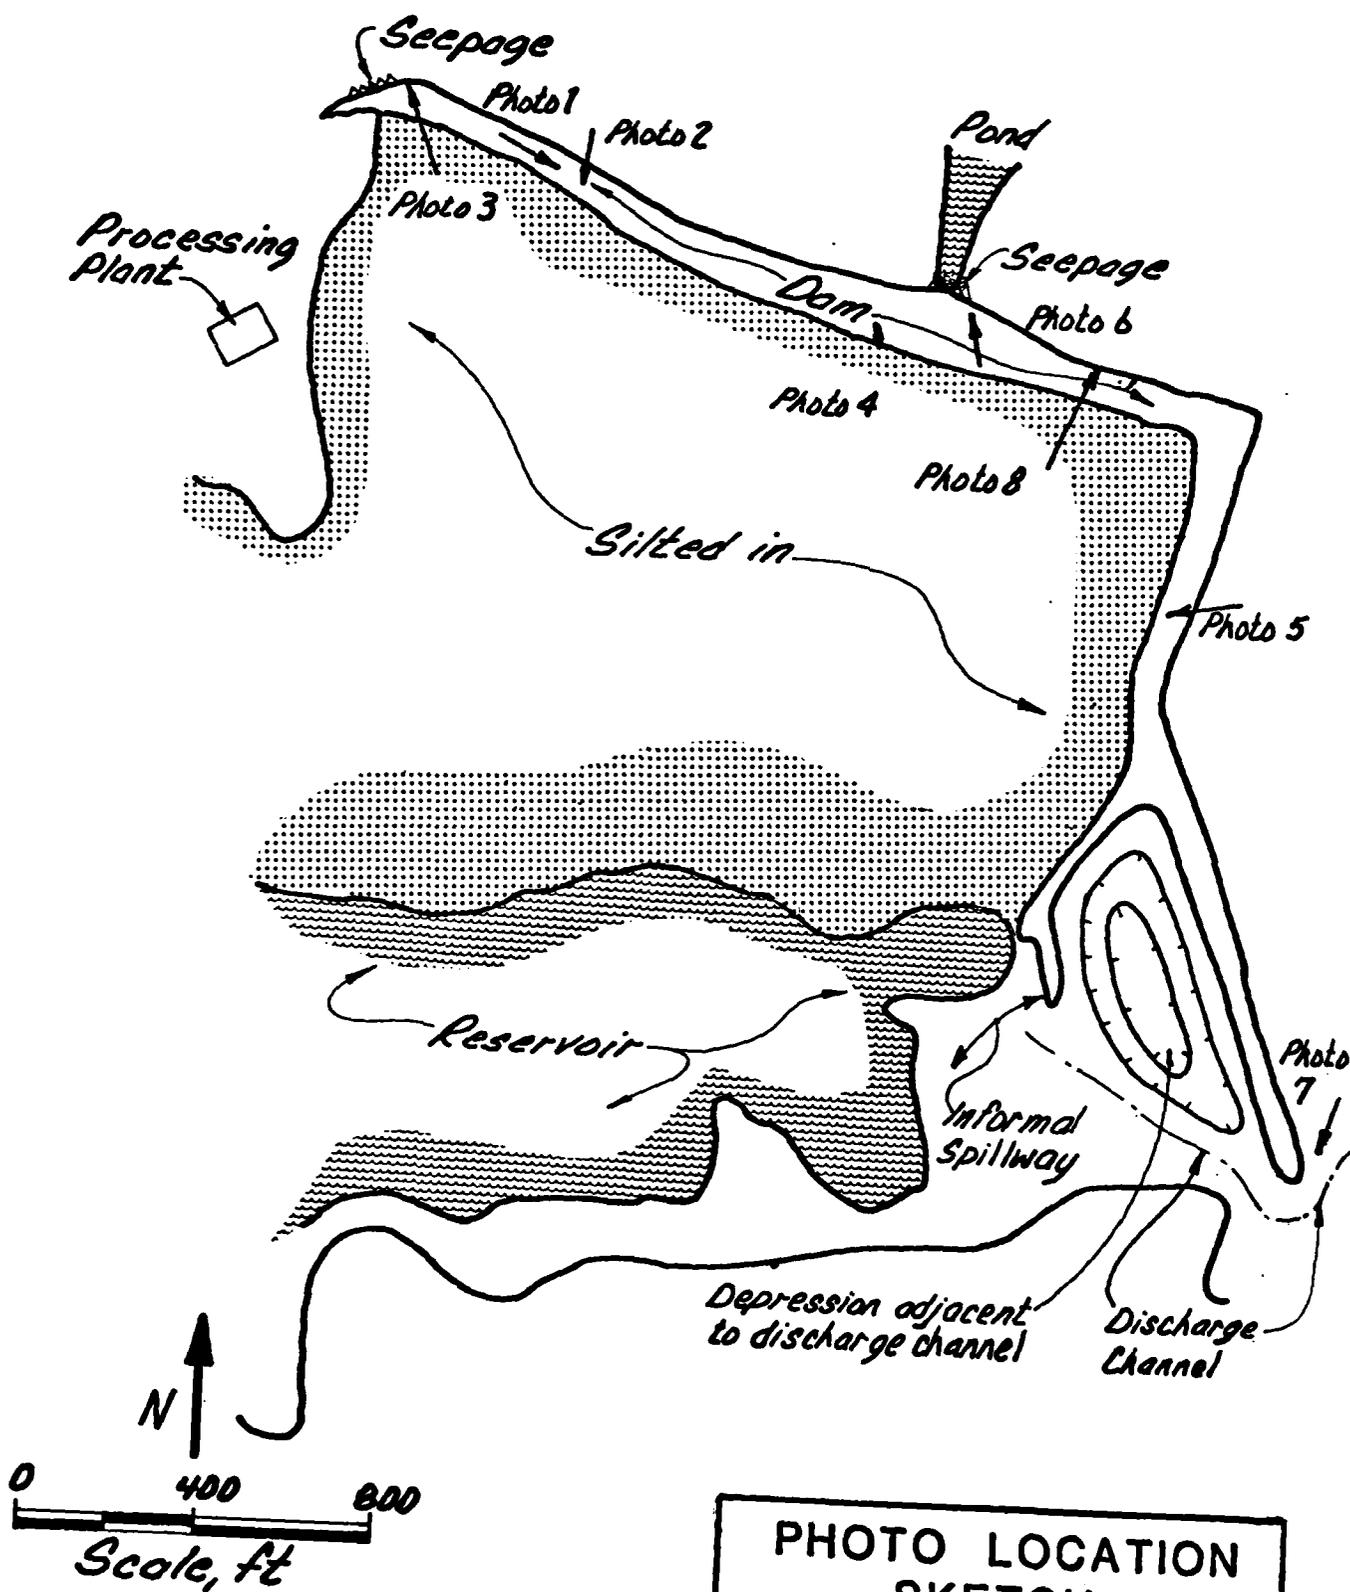
<b>PHOTO LOCATION SKETCH</b>	
DESOTO MINING CO PIT & PLANT 'A'	
MO. 30468	Fig. A-1

Seepage was noted at the two locations shown on Fig. A1, Appendix A. Clear water was observed seeping near the left abutment at approximately 3 to 5 gal/min. The seepage into the pond at the toe of this dam appeared to come from the sides of the pond rather than the dam.
