CHAIN OF LAKES DAMS
WAYNE COUNTY, MISSOURI

MISSOURI INVENTORY NOS. 30347
30348
31032

PHASE I INSPECTION REPORT
NATIONAL DAM SAFETY PROGRAM

MAY 1978

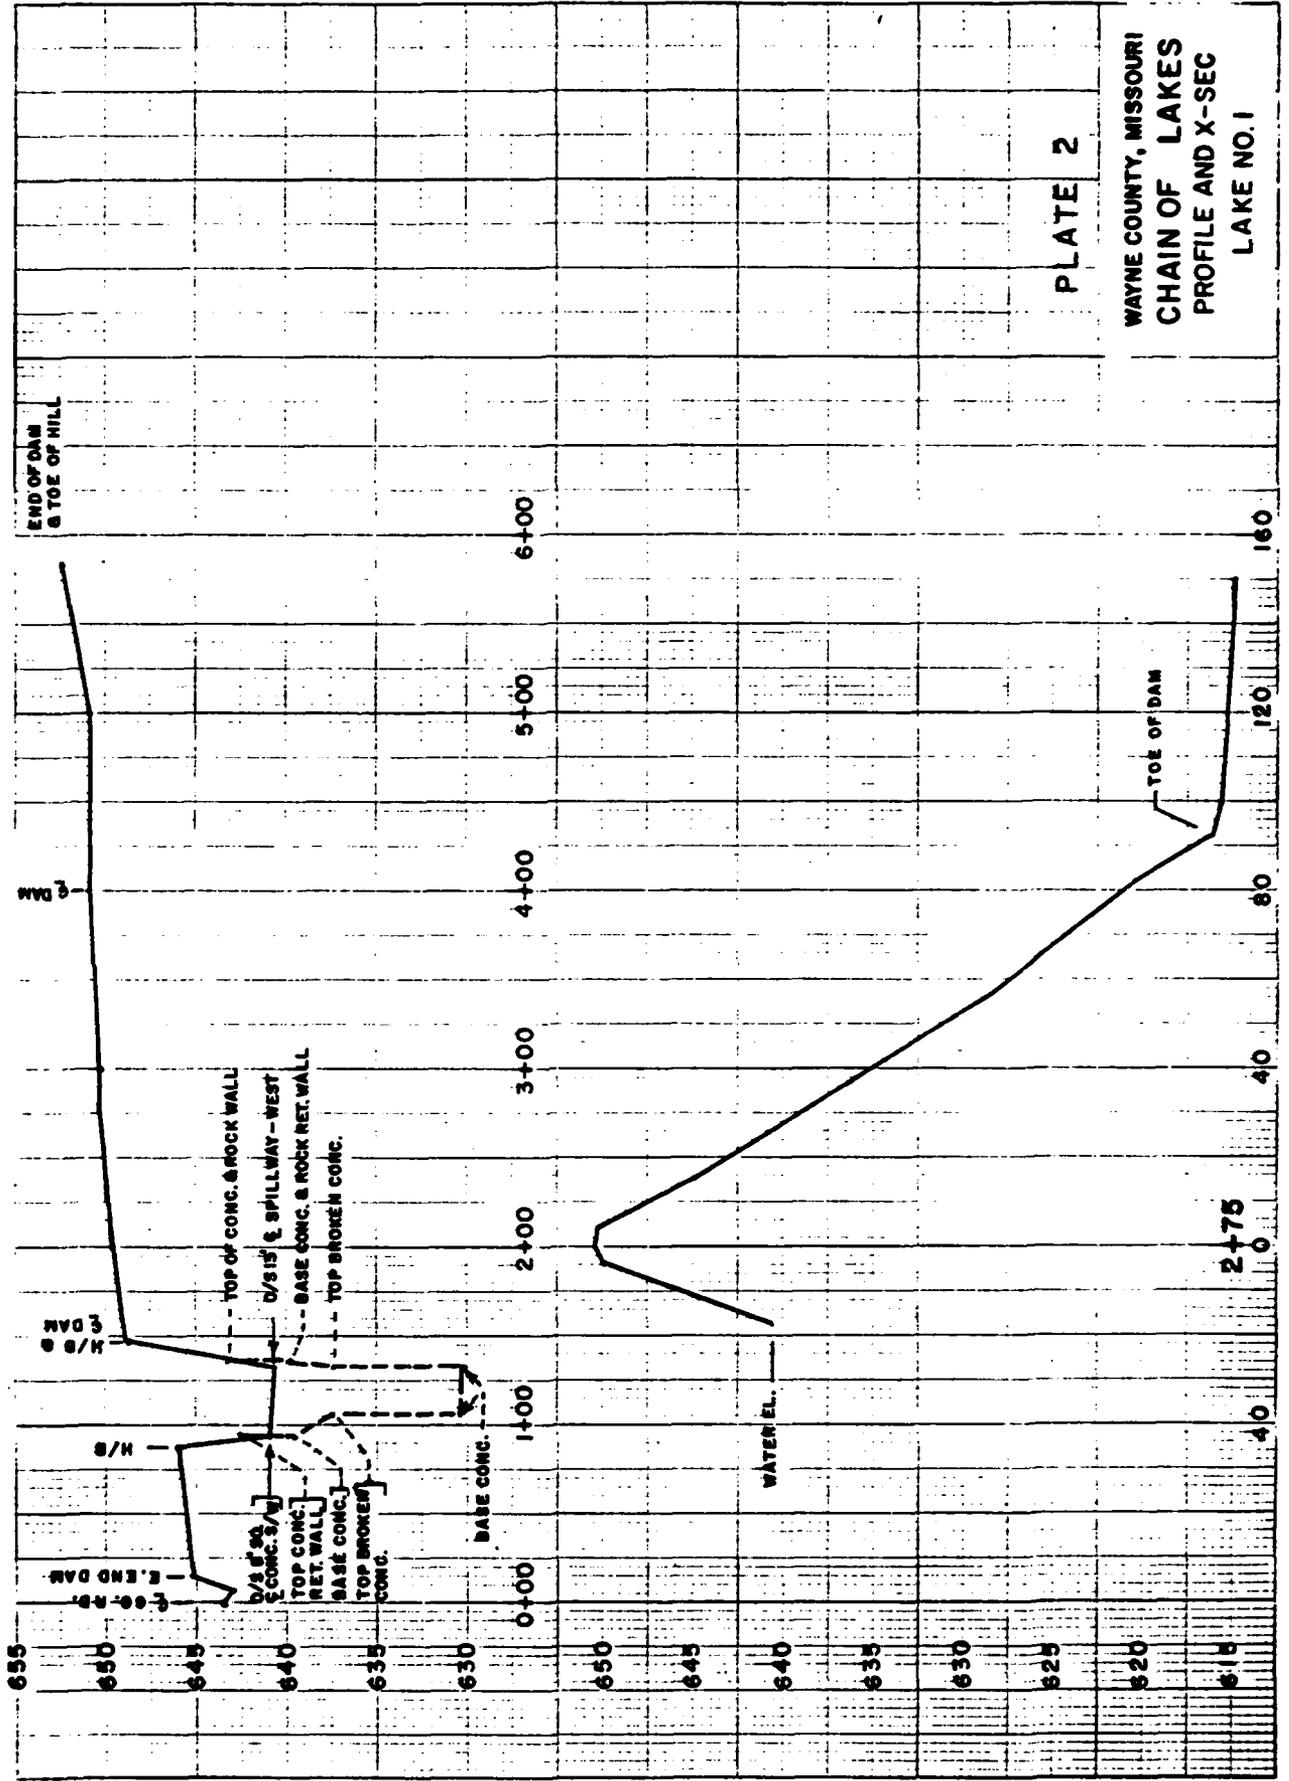
PLATE 2

Embankment cross-sections at the maximum height section for each dam are shown on Plates 2 through 4. In a few areas, the embankment slopes are considerably steeper than the section shown. One animal burrow was noted near the crown of dam No. 2. No burrows were noted below pool level at any of the dams but some could be present and masked by vegetation.

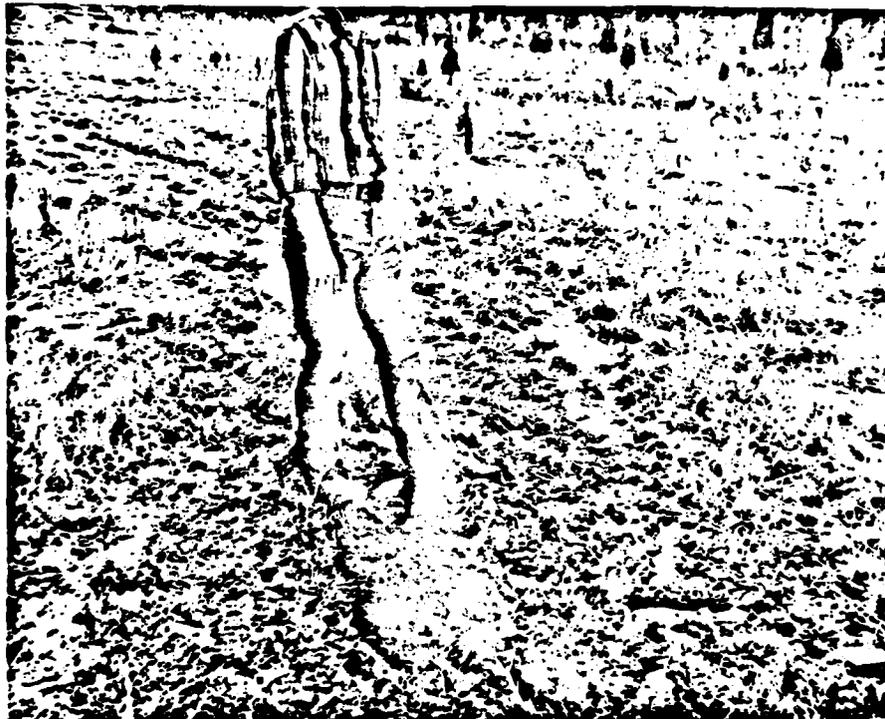
PHOTO 12 Dam No. 2
Seepage area at toe

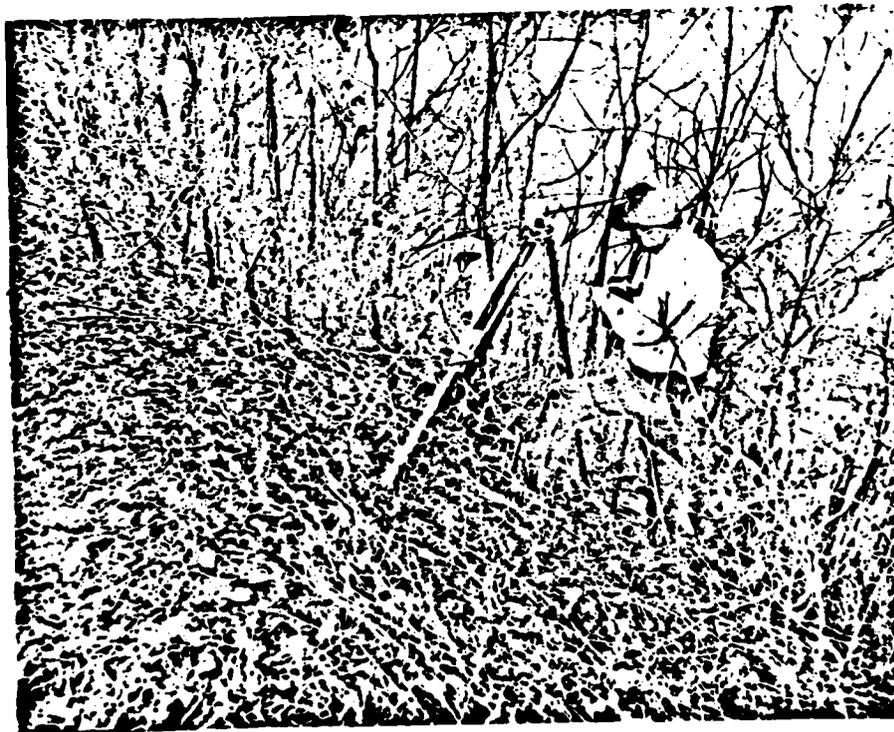
PHOTO 18

All three dams have brush and scattered trees growing on them and dam No. 3, in particular, has a dense covering of brush preventing detailed inspection. Most of the trees at all three dams are less than eight inches in diameter. These root systems constitute a potential seepage hazard. The vegetation also provides animal habitat which increases the likelihood of animal burrows.

Dam No. 3
Downstream face

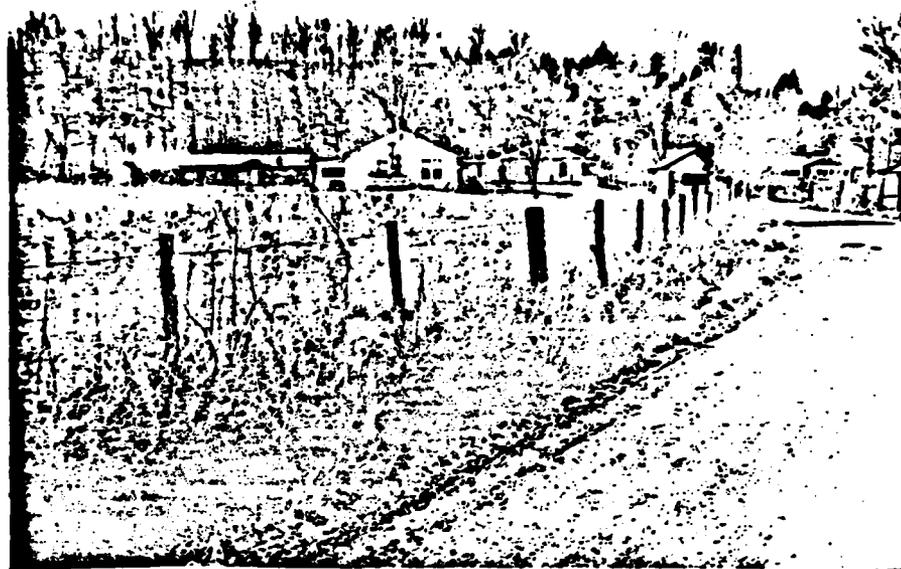
PHOTO 19

Housing along creek, downstream
