NO NAME 548 - PFIZER INC. DAM  
WASHINGTON COUNTY, MISSOURI  
MO 30705

# PHASE I INSPECTION REPORT NATIONAL DAM SAFETY PROGRAM

SUBJECT: Pfizer Inc. Dam Phase I Inspection Report

Name of Dam	No Name 548 - Pfizer Inc. Dam
State	Missouri
County	Washington
Stream	Tributary to Mill Creek
Date of Inspection	20 March 1979

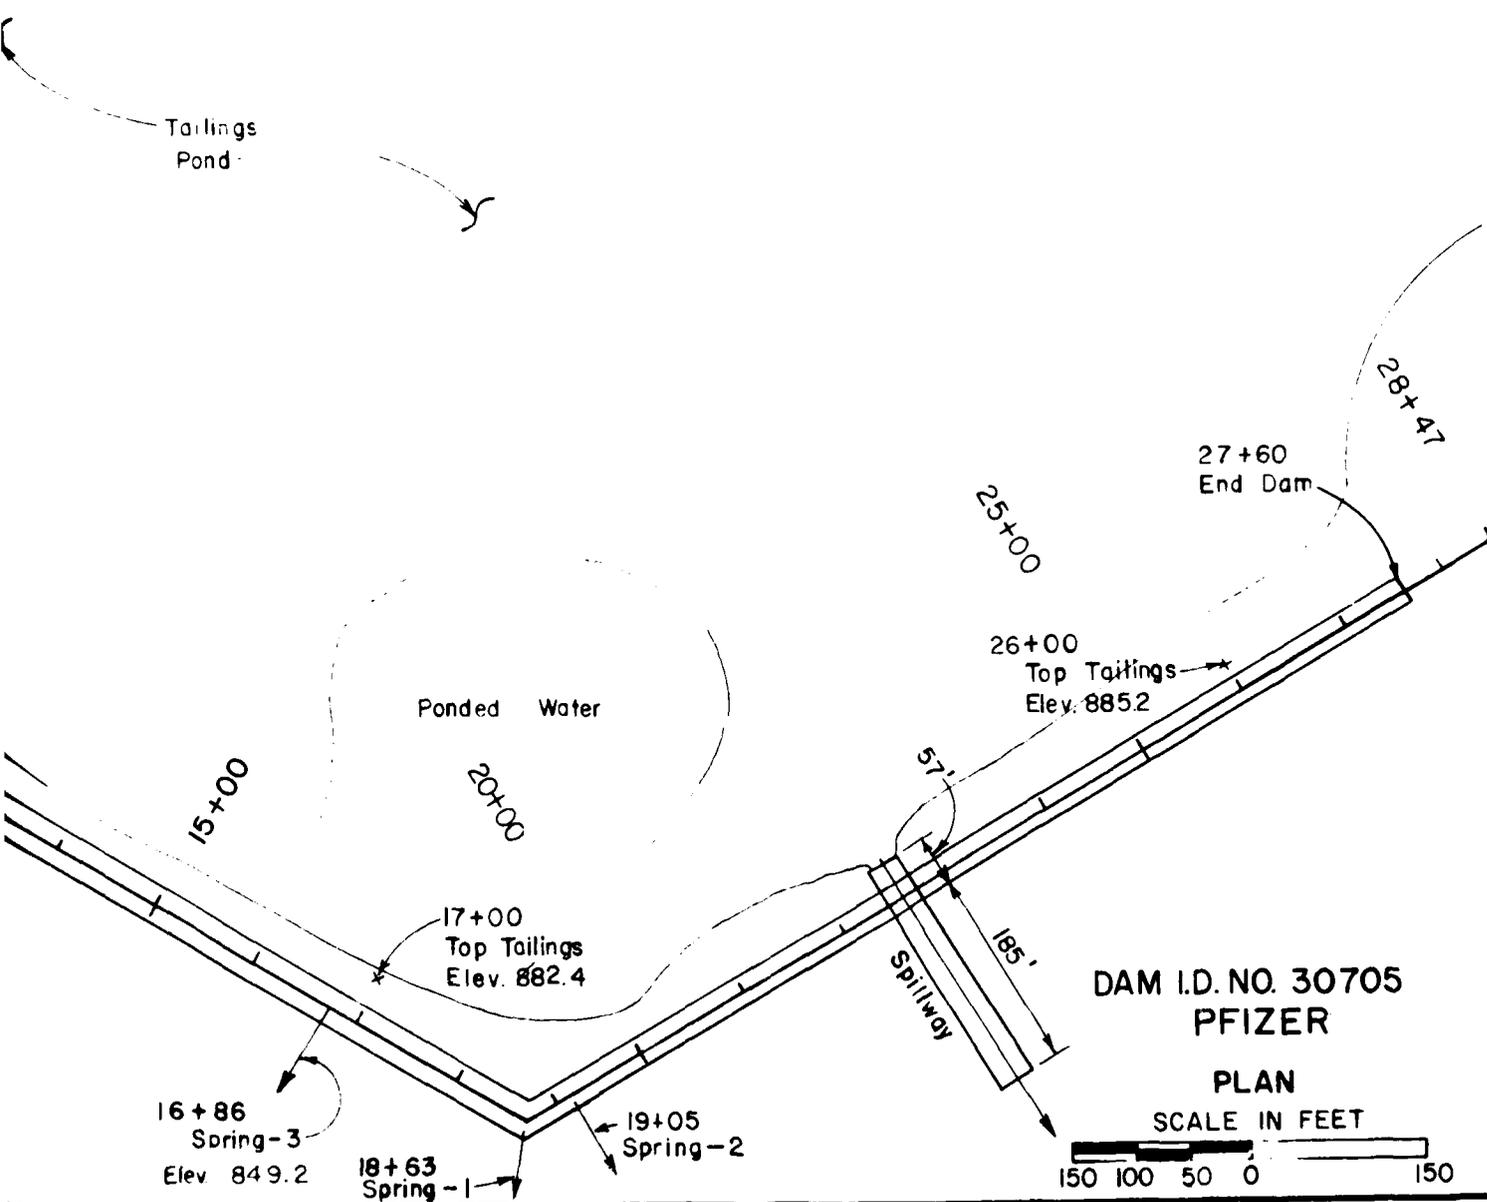
PLATE 3

Three springs were observed to be emerging from the toe of the dam. These springs are located immediately to the south of the spillway, as shown in Plate 3. Spring Nos. 1 and 2 were observed on the date of inspection on 20 March, and Spring No. 3 was noted during a brief visit on 27 March. It was observed during the brief visit that the ponded water on the tailings surface had encroached on the upstream gravel face of the dam due to rain which fell between 20 and 27 March. Spring No. 3 was located at the downstream toe, immediately opposite the ponded water. This spring was apparently being fed by the ponded water. The flow from all three springs was clear. The ground surface at Spring No. 1 was soft. The estimated quantity of flow from the springs is as follows:

d. Appurtenant Structures. The only appurtenant structure at this dam is the open channel spillway through the embankment near the left abutment at Station 22+65 (see Plate 3). The channel is in clayey soils and no erosion protection is provided. Erosion of the channel is taking place in the upstream direction and is encroaching on the toe of the dam.
