**BURTON-DUENKE DAM #4
CAMDEN COUNTY, MISSOURI
MO 31713**

**PHASE 1 INSPECTION REPORT
NATIONAL DAM SAFETY PROGRAM**

PHASE I INSPECTION REPORT
NATIONAL DAM SAFETY PROGRAM
BURTON-DUENKE DAM #4

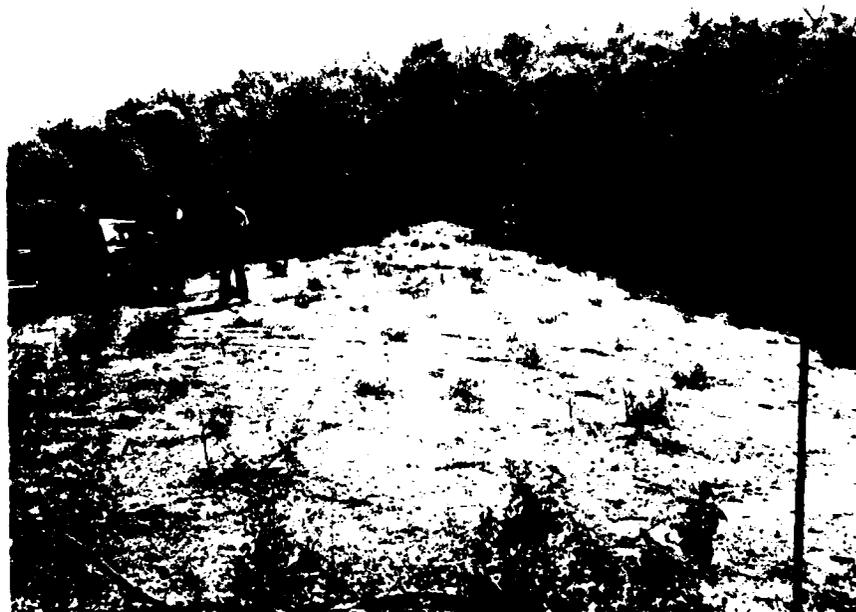
PHOTO 4 : CREST OF DAM LOOKING EAST

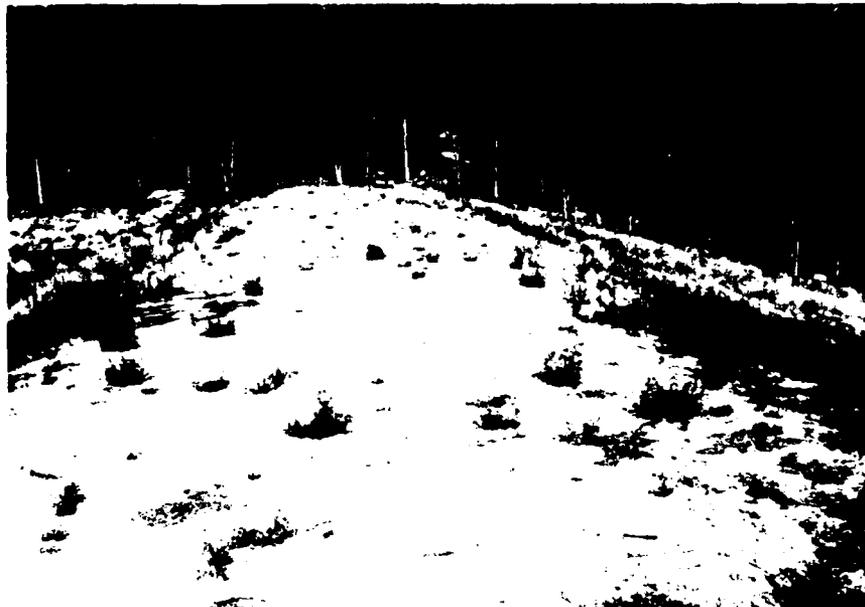
PHOTO 7 - CREST OF DAM LOOKING WEST

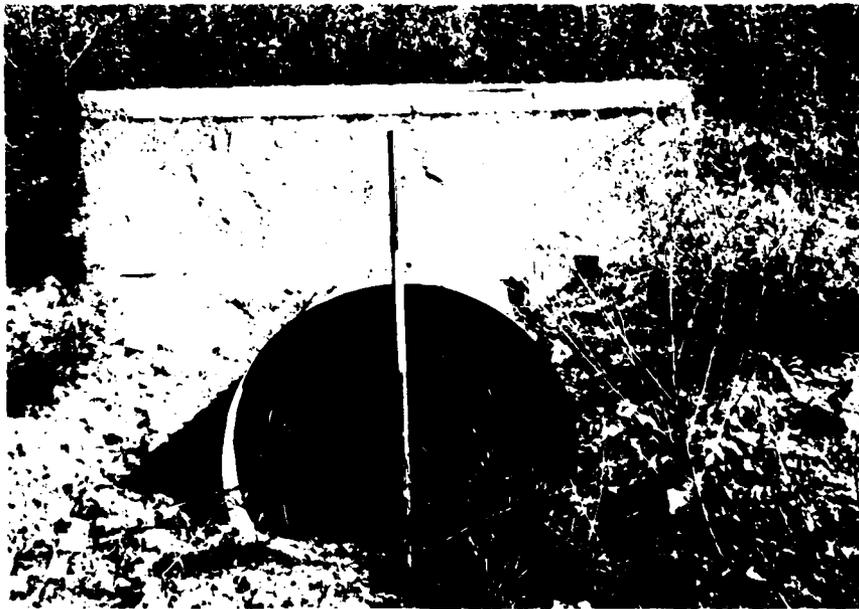
c. Appurtenant Structures. The spillway is the only appurtenant structure observed by the inspection team. The alignment of the spillway pipe was observed to dogleg to the left when viewed from the upstream end. There is a concrete headwall (8 feet wide, 5.5 feet high and 0.6 feet thick) at the pipe inlet. There was no trash rack at the pipe inlet.

There was approximately 2 to 3 inches of sediment in the pipe at the upstream end. About 6 feet and 4 feet of the outside of the pipe was observed at the upstream and downstream ends, respectively. One joint in the pipe was observed and was in good condition with no apparent movement. The survey made during the inspection showed the spillway pipe outlet to be about 2 feet higher than its inlet which appeared to be the way it was constructed. There is no evidence of leakage into, out of, or around the pipe. The pipe appears to be in good condition with no rust observed. The pipe discharges into a ditch which is approximately 3-1/2 feet wide and 2 feet deep. The ditch ends about 75 feet below the pipe outlet where discharge is released to the hillside north of the left abutment. There is no erosion downstream of the pipe outlet.

PHOTO 8 : SPILLWAY PIPE INLET

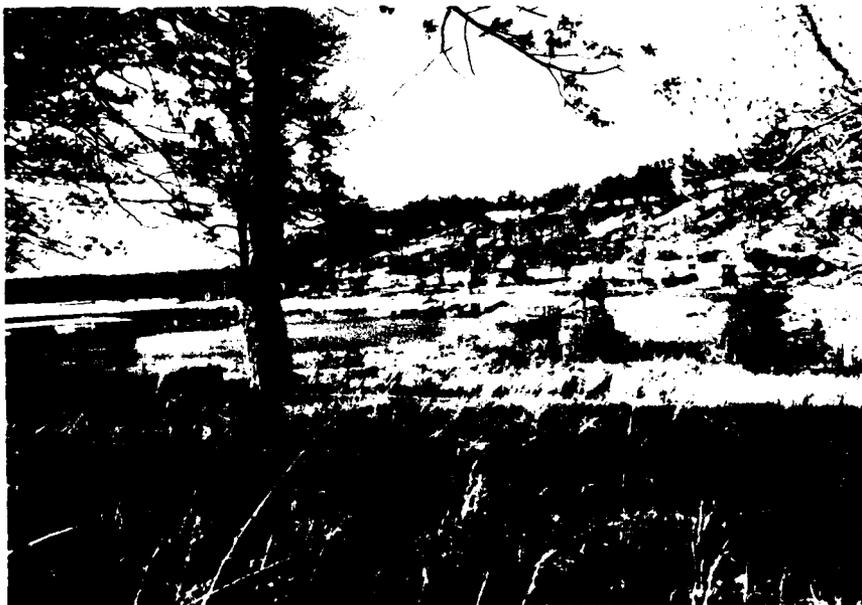
PHOTO 16: VALLEY DOWNSTREAM OF DAM
