TENNESSEE STATE DEPT OF CONSERVATION NASHVILLE DIV 0--ETC F/G 13/13
NATIONAL PROGRAM OF INSPECTION OF NON-FEDERAL DAMS, TENNESSEE. --ETC(U)
SEP 81 W E BUSH DACW62-81-C-0056

REPORT DOCUMENTATION PAGE		READ INSTRUCTIONS BEFORE COMPLETING FORM
1. REPORT NUMBER	2. GOVT ACCESSION NO. AD-A108 473	3. RECIPIENT'S CATALOG NUMBER
4. TITLE (and Subtitle) National Program of Inspection of Non-Federal Dams, Tennessee. Grand Valley Dam No. 1 (Inventory Number 06924) near Hickory Valley, TN, Hardeman County, TN, Hatchie River Basin		5. TYPE OF REPORT & PERIOD COVERED Phase 1 Investigation Report

PHASE I INSPECTION
GRAND VALLEY DAM NO. 1
HARDEMAN COUNTY, TENNESSEE

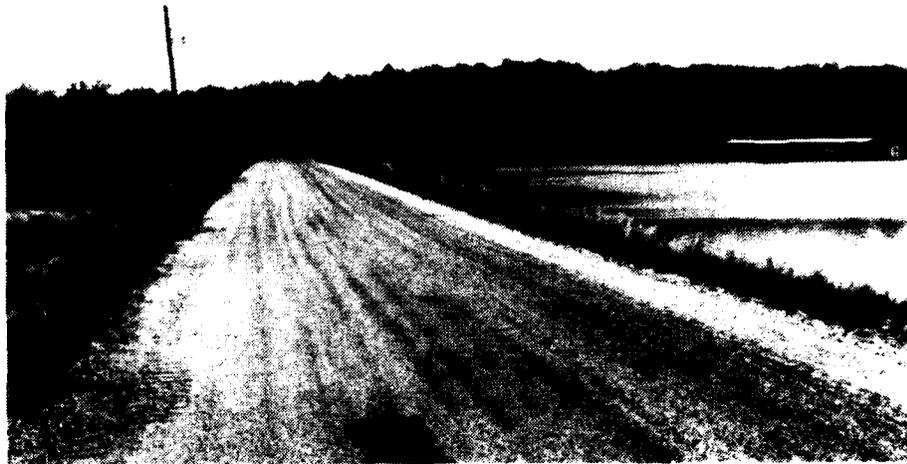
1. Top of Grand Valley Dam No. 1.

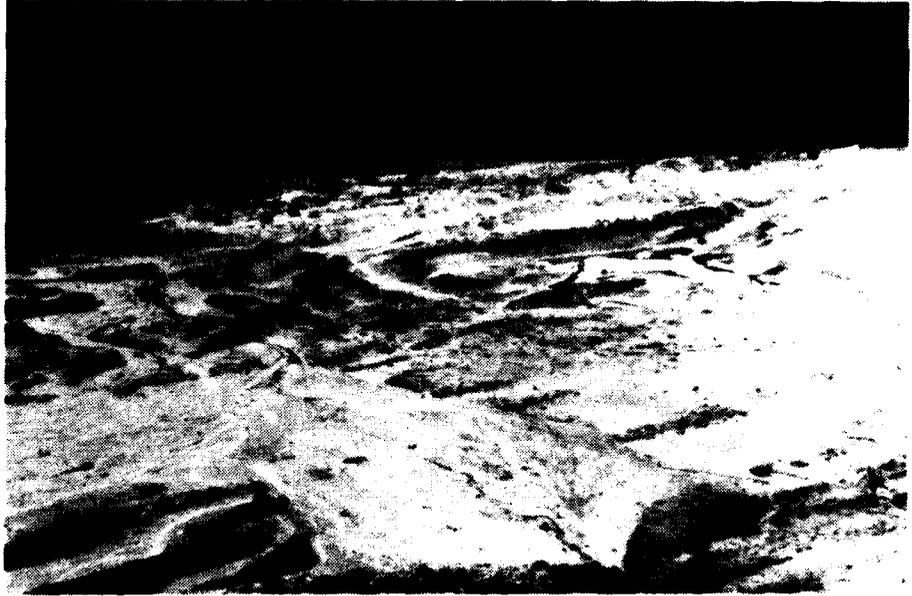
7. Wet area at toe of downstream slope, Grand Valley Dam No. 1. Note flowing water.

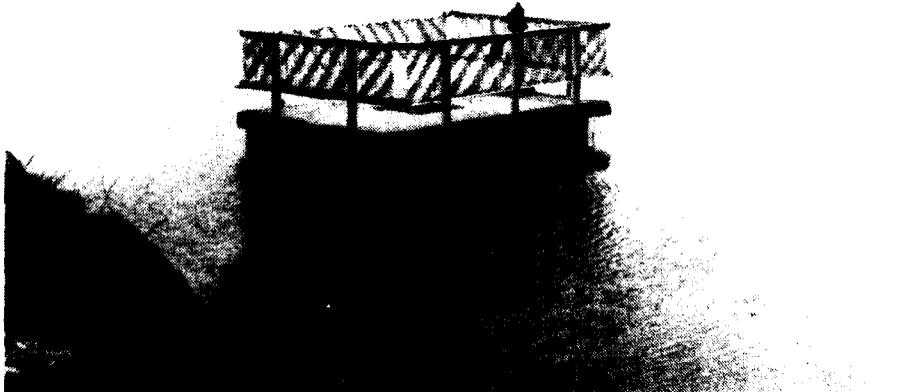
3.1.4 Spillways - The service spillway intake structure is a concrete box riser with weir openings on two sides. The 42 inch outlet pipe is corrugated metal and is cantilevered about six feet over the plunge pool at the exit end. No structure was observed to support this section of pipe as it is undermined by the plunge pool. No leakage was observed between the pipe and the soil at the discharge end. Approximately 40 feet from the outlet back toward the dam, the ground has caved in over the pipe. This hole is approximately five feet in diameter at ground level. An auger hole bored

8. Service spillway, Grand Valley Dam No. 1.

The outlet pipe back of the discharge pipe should be exposed beyond the sink hole that has developed over it, the leak in the pipe repaired and a soil cement backfill placed immediately around the pipe with a well-compacted backfill above it.

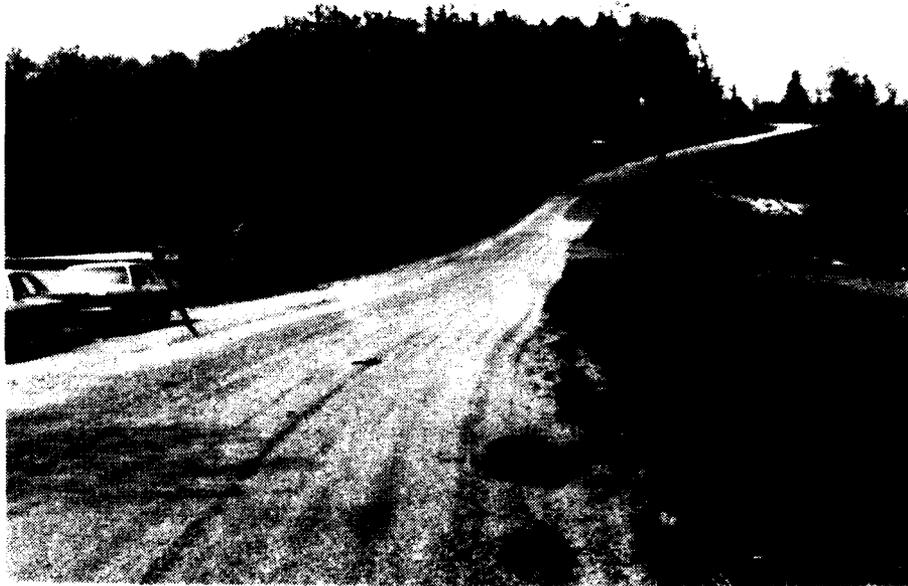
9. Low area at top of dam near left abutment used as emergency spillway.

No emergency spillways have been constructed in either abutment. The present emergency spillway was constructed as a low area in the top of the dam. Flows exceeding the capacity of the service spillway and storage will flow over this low section near the left abutment. The entrance channel is the upstream slope approximately 3:1 and the control section is the paved road section across the top of the dam. The exit channel is the backslope of the dam would be subject to extreme erosion if used. The backslope in the vicinity of the spillway has already experienced a slippage failure. The vegetative cover is fescue and wild grass and it provides an ineffective cover against erosion. The emergency drawdown facility is a pipe in the intake structure with a gate valve. It is not believed the lake can be completely drained with this facility. The facilities were not operated during this inspection. The owner stated that the gate had been opened last year without difficulty.
