1. REPORT NUMBER		2. GOVT ACCESSION NUMBER		3. RECIPIENT'S CATALOG NUMBER	
4. TITLE (and Subtitle) Phase I Inspection Report Cortlandt Lake Dam Lower Hudson River Basin, Westchester County, N.Y. Inventory No. 85		5. TYPE OF REPORT & PERIOD COVERED Phase I Inspection Report National Dam Safety Program

**LOWER HUDSON RIVER BASIN
CORTLANDT LAKE DAM
WESTCHESTER COUNTY, NEW YORK
INVENTORY NO. N.Y. 85
PHASE I INSPECTION REPORT
NATIONAL DAM SAFETY PROGRAM**

PHASE I INSPECTION REPORT
NATIONAL DAM SAFETY PROGRAM
CORTLANDT LAKE DAM
I.D. NO. NY85
LOWER HUDSON RIVER BASIN
WESTCHESTER COUNTY, NEW YORK

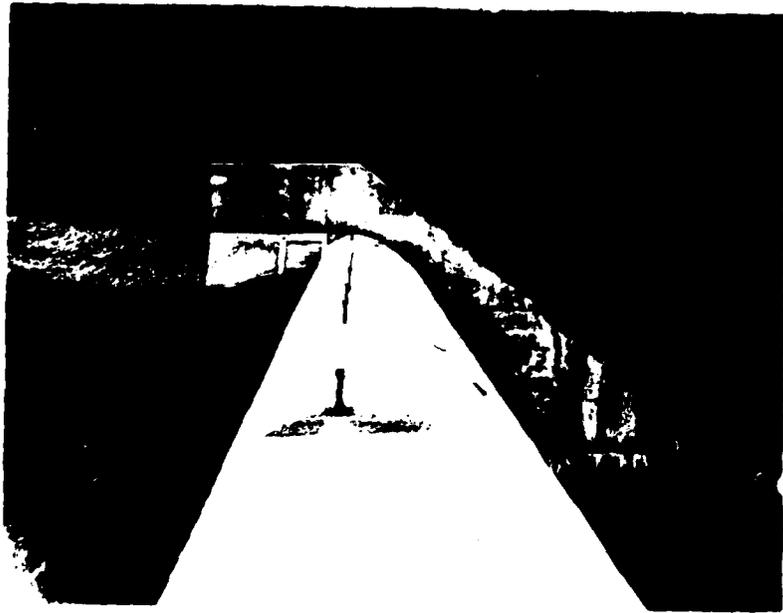
1959 PHOTO
CREST OF SPILLWAY WITH FLASHBOARD PINS IN PLACE
NOTE WOOD COVER OVER CIRCULAR HOLE IN WINGWALL

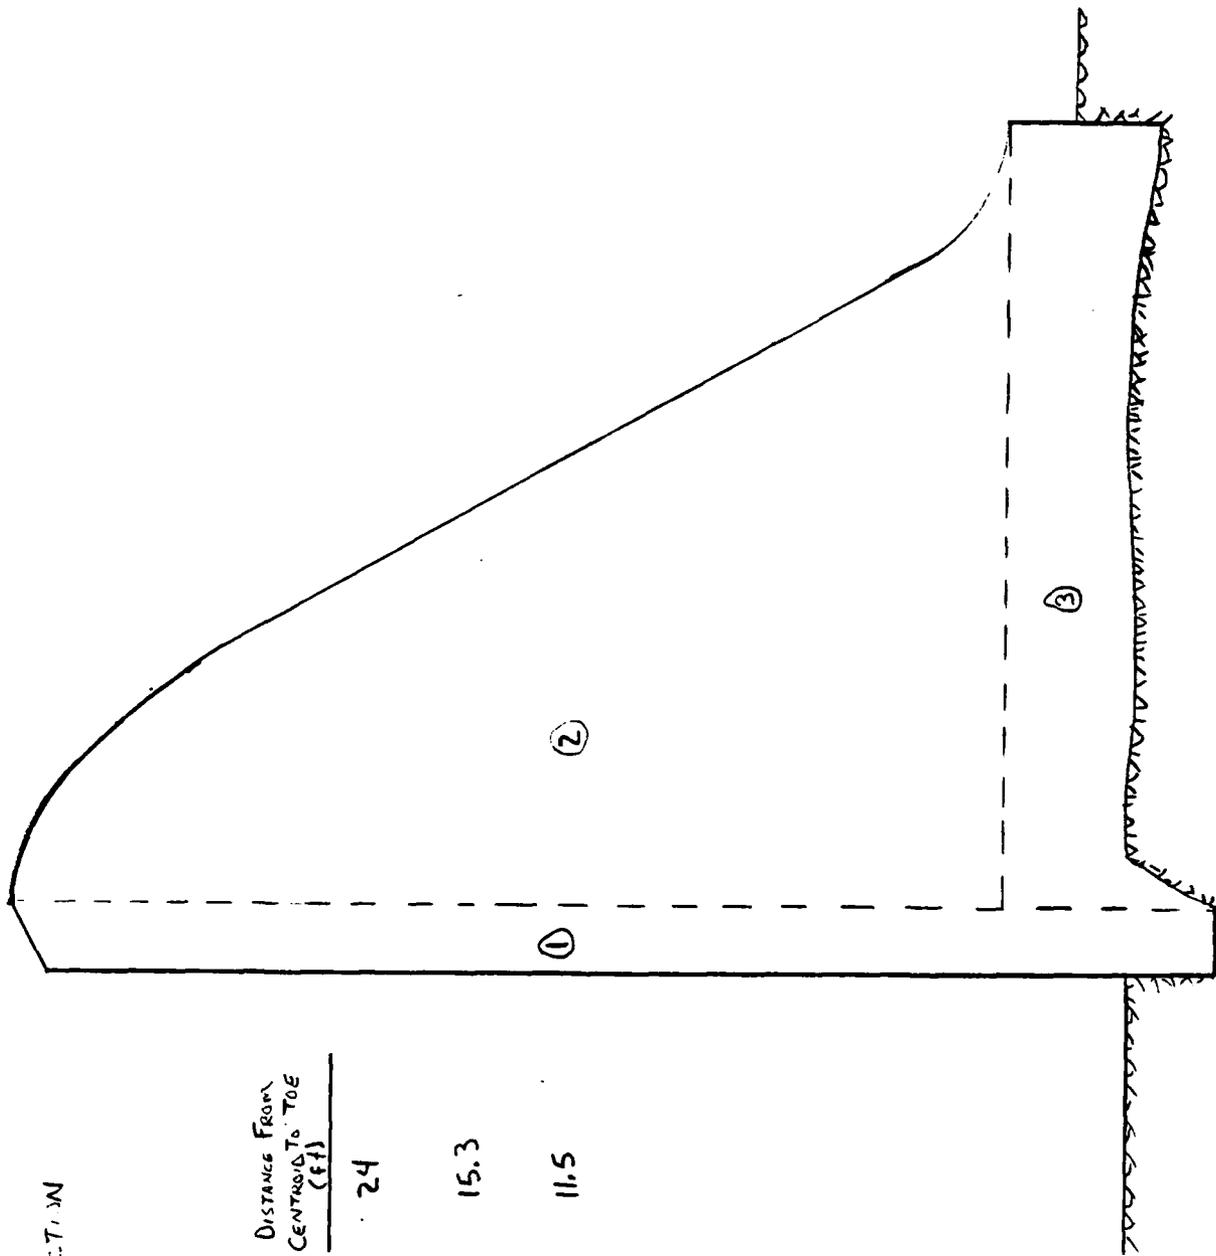
STRUCTURAL STABILITY ANALYSIS

The analysis indicates that the dam is unstable. The fact that the factors of safety are below 1.0 for normal loading conditions shows that actual loading and uplift conditions are less severe than those which were assumed for the analysis. The analysis, in accordance with the Corps of Engineers' "Recommended Guidelines", assumed full uplift pressure under the upstream toe decreasing to tailwater pressure under the downstream toe. However, safety factors were below recommended values even when zero uplift pressure was assumed. Therefore, the structure must be considered to be marginally stable at best.

Further investigations are required to better assess the stability of the dam. Subsurface explorations and concrete cores are required to obtain information about the uplift forces acting on the dam and about the condition of the dam and its foundation. Revised stability analyses
