# DERRY ROD AND GUN CLUB DAM

NDI ID NO. PA-518

PHASE I INSPECTION REPORT

NATIONAL DAM INSPECTION PROGRAM

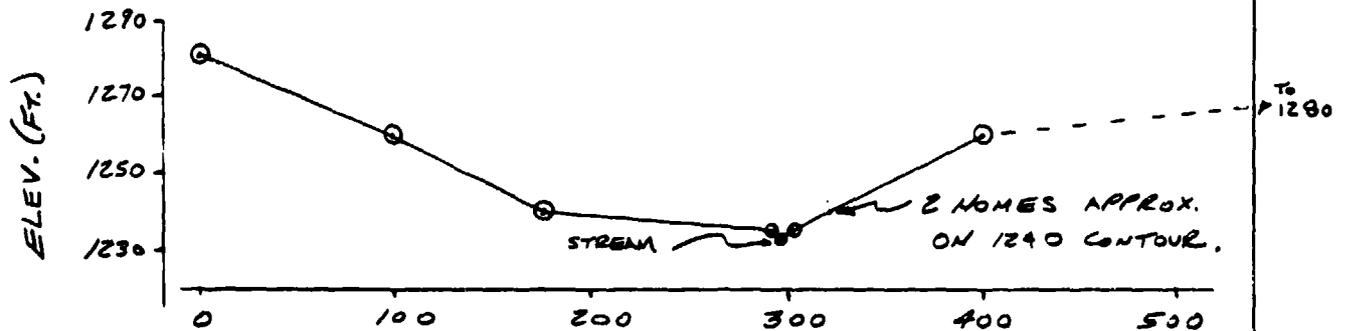
REACH No. 2 PROFILE:

MANNING'S CHANNEL ( $n$ ) = 0.05  
 MANNING'S OVERBANK ( $n$ ) = 0.06  
 REACH LENGTH = 5,500 FT.  
 AVERAGE SLOPE = 0.04
