BEL-AIR LAKE DAM

NDI I.D. PA-0066

PHASE I INSPECTION REPORT
NATIONAL DAM INSPECTION PROGRAM

D'APPOLONIA CONSULTING ENGINEERS

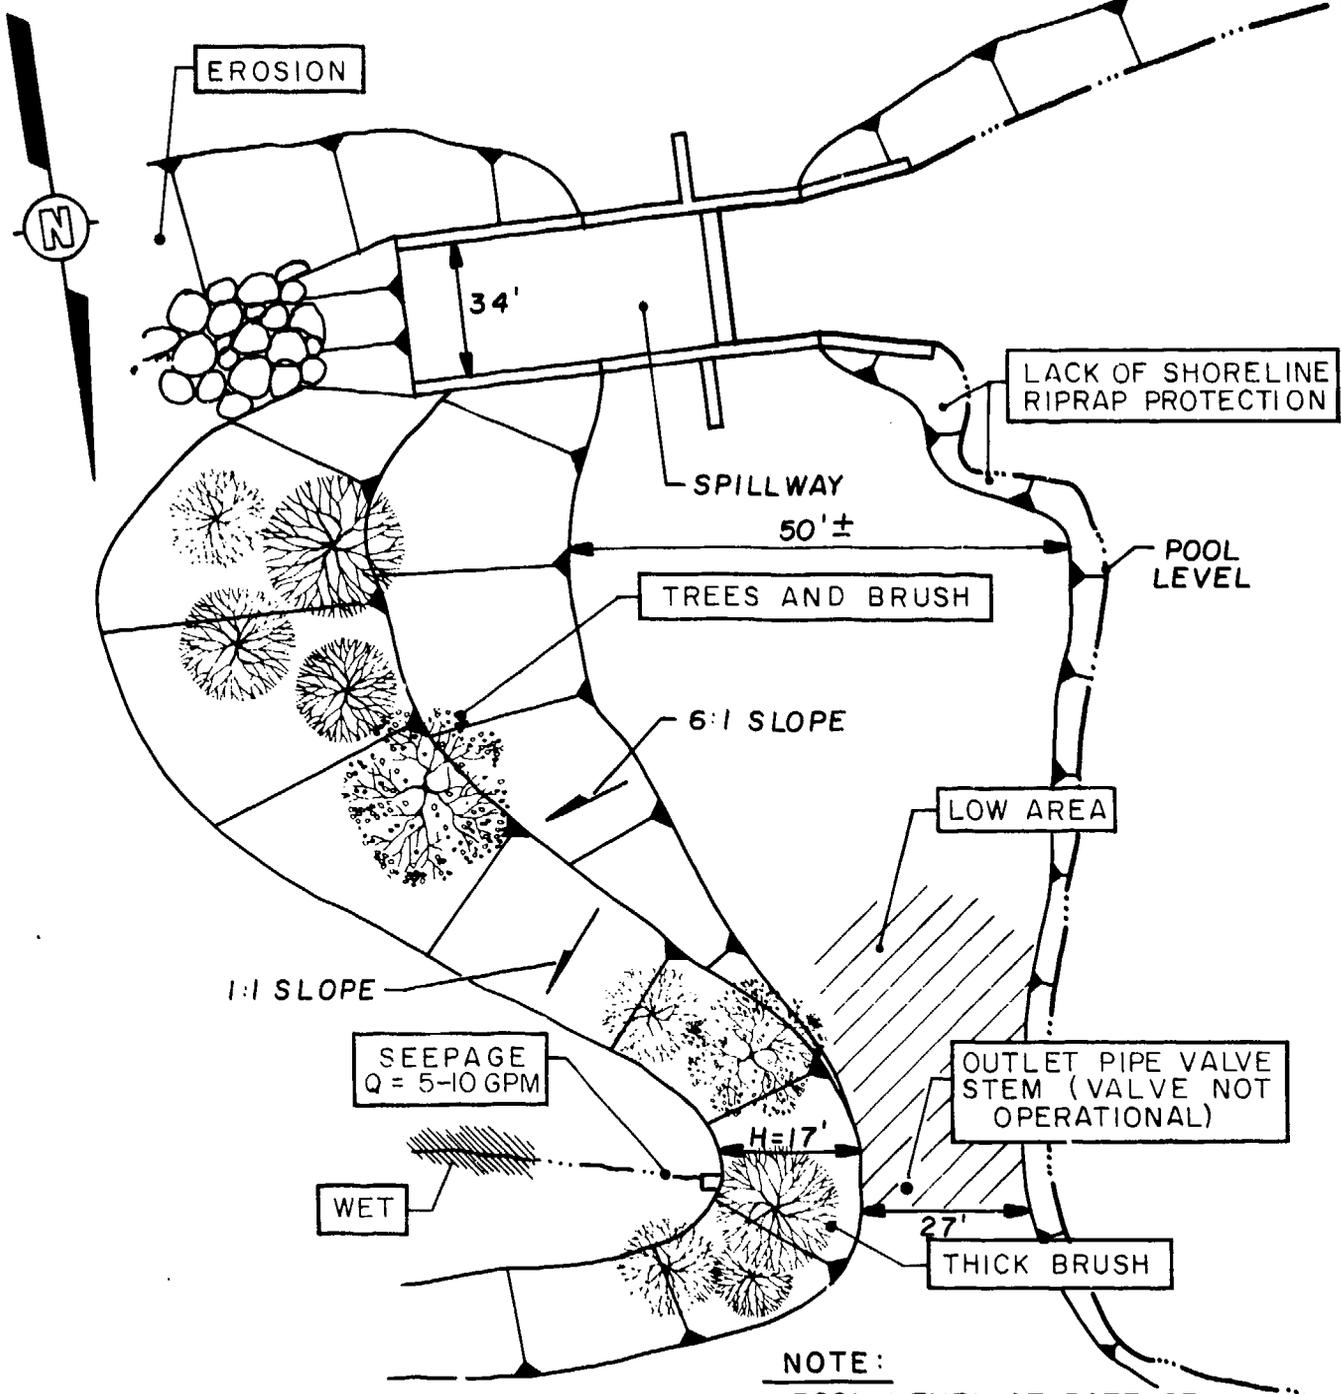
PLATE 5
 BEL-AIR LAKE DAM
 GENERAL PLAN
 FIELD INSPECTION NOTES
 FIELD INSPECTION DATE: MAR. 24, 1981

NOTE:
 POOL LEVEL AT DATE OF INSPECTION: AT SPILLWAY CREST.
