LOOMIS LAKE DAM

NDI No. PA 00048
PennDER NO. 58-127
Dam Owner: Irving N. Loomis, Sr.

PHASE I INSPECTION REPORT NATIONAL DAM INSPECTION PROGRAM

Loomis Lake Dam, Susquehanna County, Pennsylvania
NDI No. PA 00048, PennDER No. 58-127
Unnamed Tributary to Hop Bottom Creek
Inspected 29 October 1980

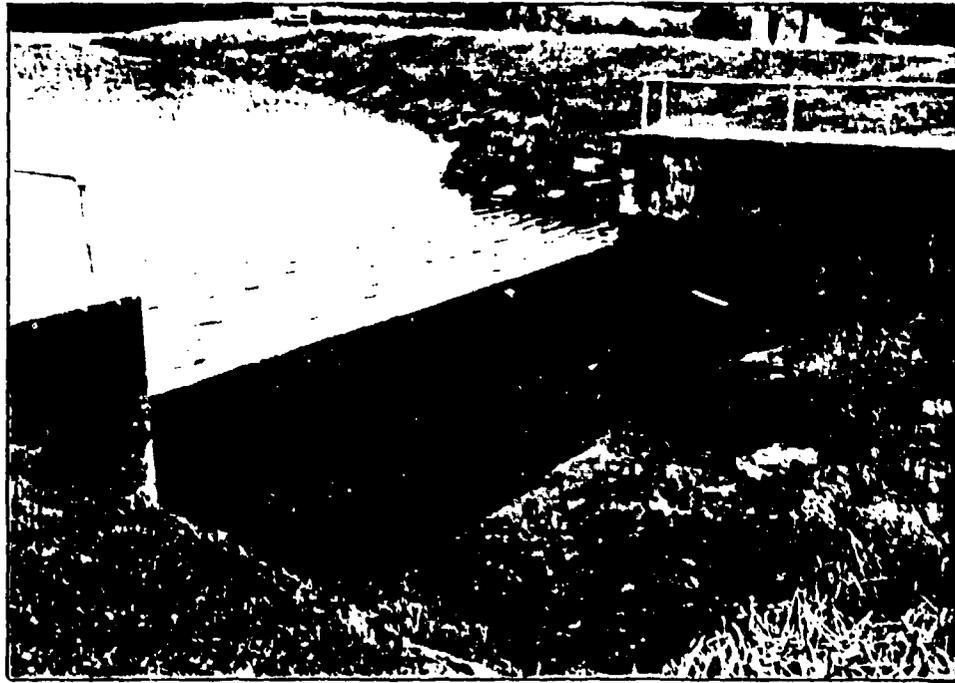
VISUAL EXAMINATION OF	OBSERVATIONS	REMARKS OR RECOMMENDATIONS
CONCRETE WEIR	Small amount of seepage between ogee spillway and training wall; estimated flow rate of 3 g.p.m.	Additional clay fill upstream of weir and/or repair of the joint material between the weir and training wall may reduce seepage. Observe seepage in future inspections and record the condition observed.

PHOTO 1. View of Spillway Crest from Right Abutment

- 3) Repair the seep area at the left junction of the spillway weir and left training wall by placing additional clay fill upstream of the weir and repairing of the joint filler. The seep should then be monitored during future inspections of the dam.

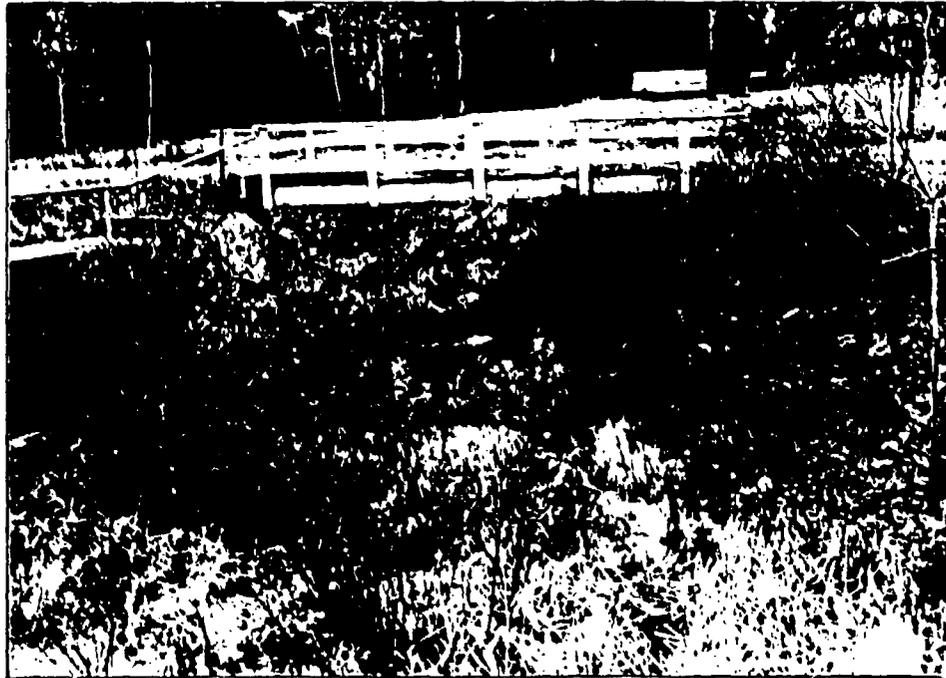
- 3) Cattails and debris were observed in the spillway discharge channel.
 - 4) The bridge over the spillway discharge channel has badly fractured concrete and rock foundation supports.

Bridge over spillway channel with no piers in channel; however, bridge abutments and underlying rock are badly fractured.

The township has responsibility for the bridge and piers. Repairs are reportedly planned for the bridge.

PHOTO 2. View of Township Road Bridge over Spillway Outlet Channel

- 10) Replace the wood cover on the valve pit for the abandoned outlet works or fill in with earth.
- 11) Coordinate with the township to expedite repairs to the abutment supports of the bridge over the channel.
