DECKERS DAM

**NDI ID NO. PA-00299
DER ID NO. 64-203**

**PHASE I INSPECTION REPORT
NATIONAL DAM INSPECTION PROGRAM**

**Geo-Technical Services, Inc.
CONSULTING ENGINEERS & GEOLOGISTS
851 S. 19th Street
Harrisburg, Pennsylvania 17104**

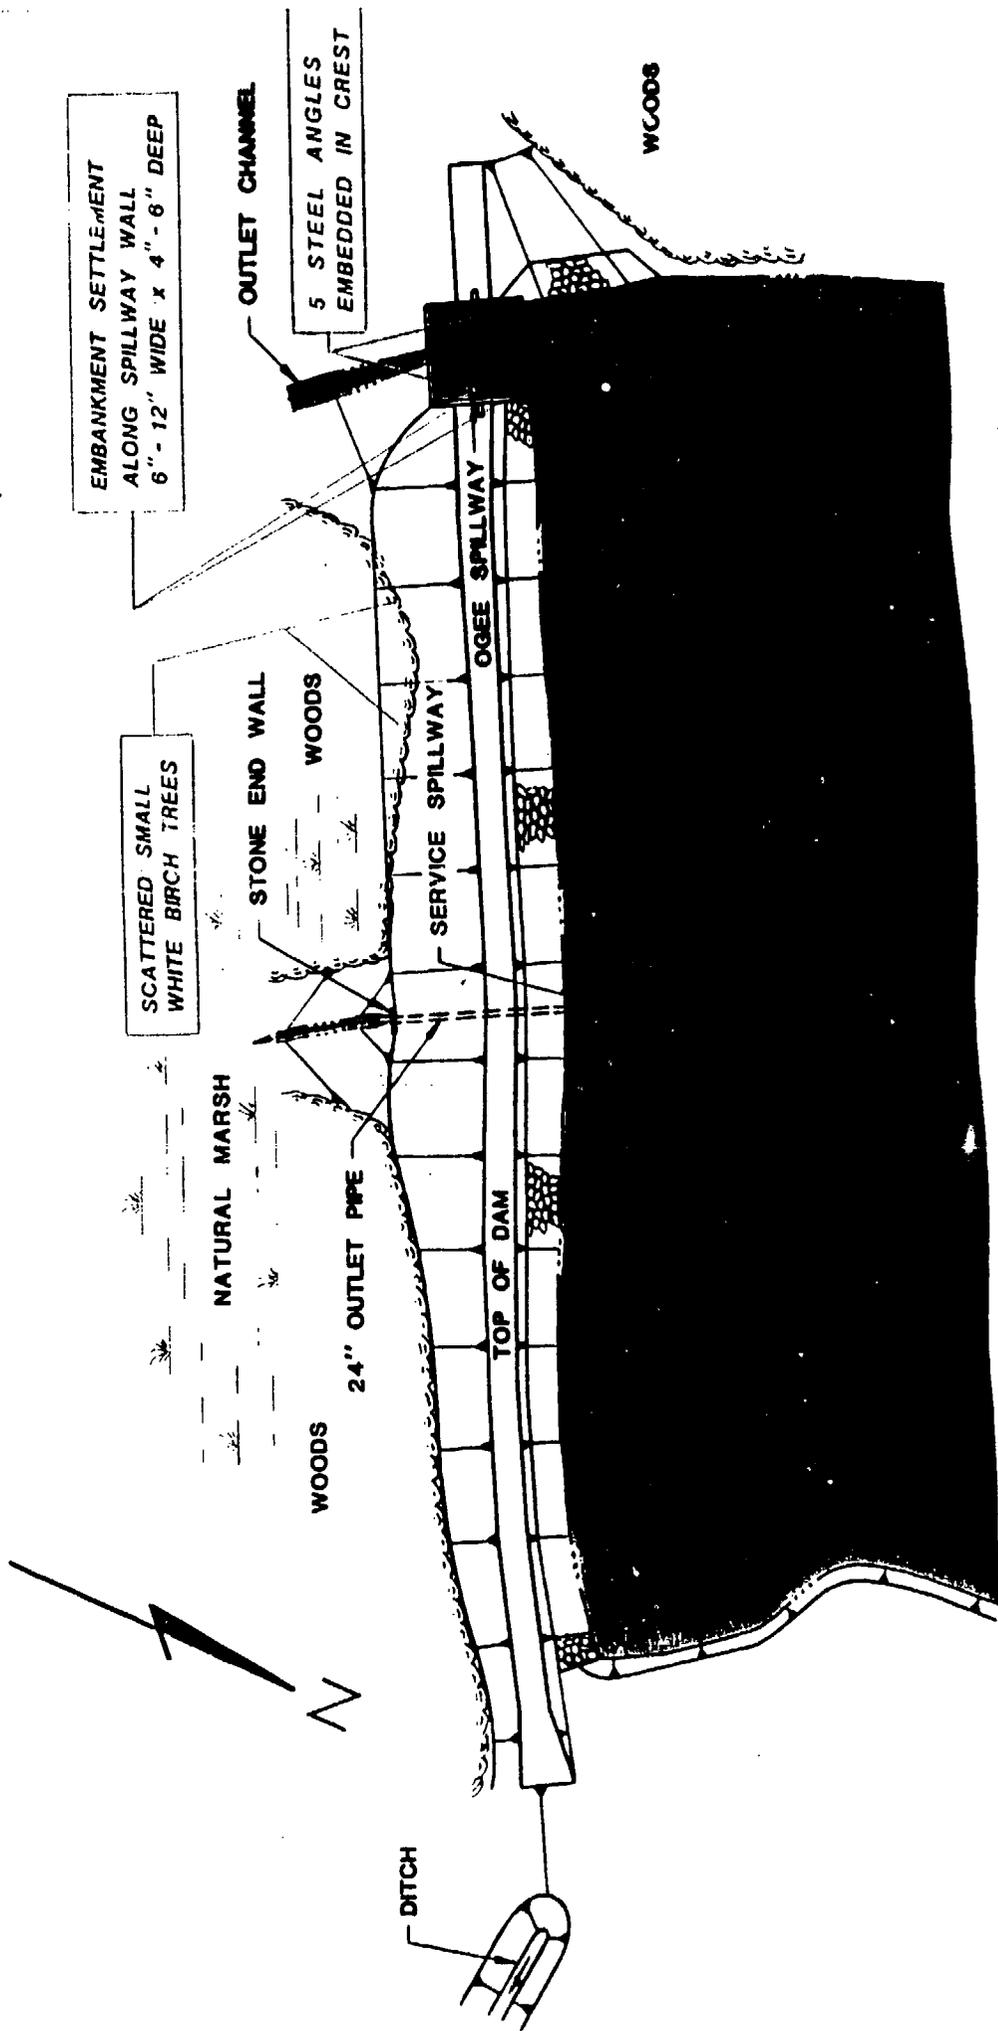
<u>Feature and Location</u>	<u>Observed Deficiencies</u>
Downstream slope of dam, right half.	Scattered small trees on the lower part of the slope.
Crest of dam, near spillway endwall.	4 to 6 inch embankment settlement near contact with wall.
Emergency Spillway crest.	Five 4-inch structural steel angles are embedded in the crest. These protrusions may trap debris during floods and obstruct spillway flow.

EMBANKMENT SETTLEMENT
ALONG SPILLWAY WALL
6" - 12" WIDE x 4" - 6" DEEP

SCATTERED SMALL
WHITE BIRCH TREES

- (1) Locate and operate the outlet works valve. Observe conditions at the toe of the dam and in the streambed of Seeley Brook during pressure flow through the outlet works. Take appropriate action as necessary.
- (2) Remove trees and brush from the downstream slope and toe of the dam.
- (3) Fill depressions along the left spillway walls.
- (4) Remove the protruding portion of the steel angles from the top of the spillway crest and seed the spillway outlet channel.
