DELAWARE RIVER BASIN
TRIBUTARY TO WYOMISSING CREEK, BERKS COUNTY
PENNSYLVANIA
NDI NO. PA.01146
DER NO. 6-467

STANFORD AVENUE STORMWATER RETENTION POND

OWNER: SPRING TOWNSHIP
PHASE I INSPECTION REPORT
NATIONAL DAM INSPECTION PROGRAM

July 1981

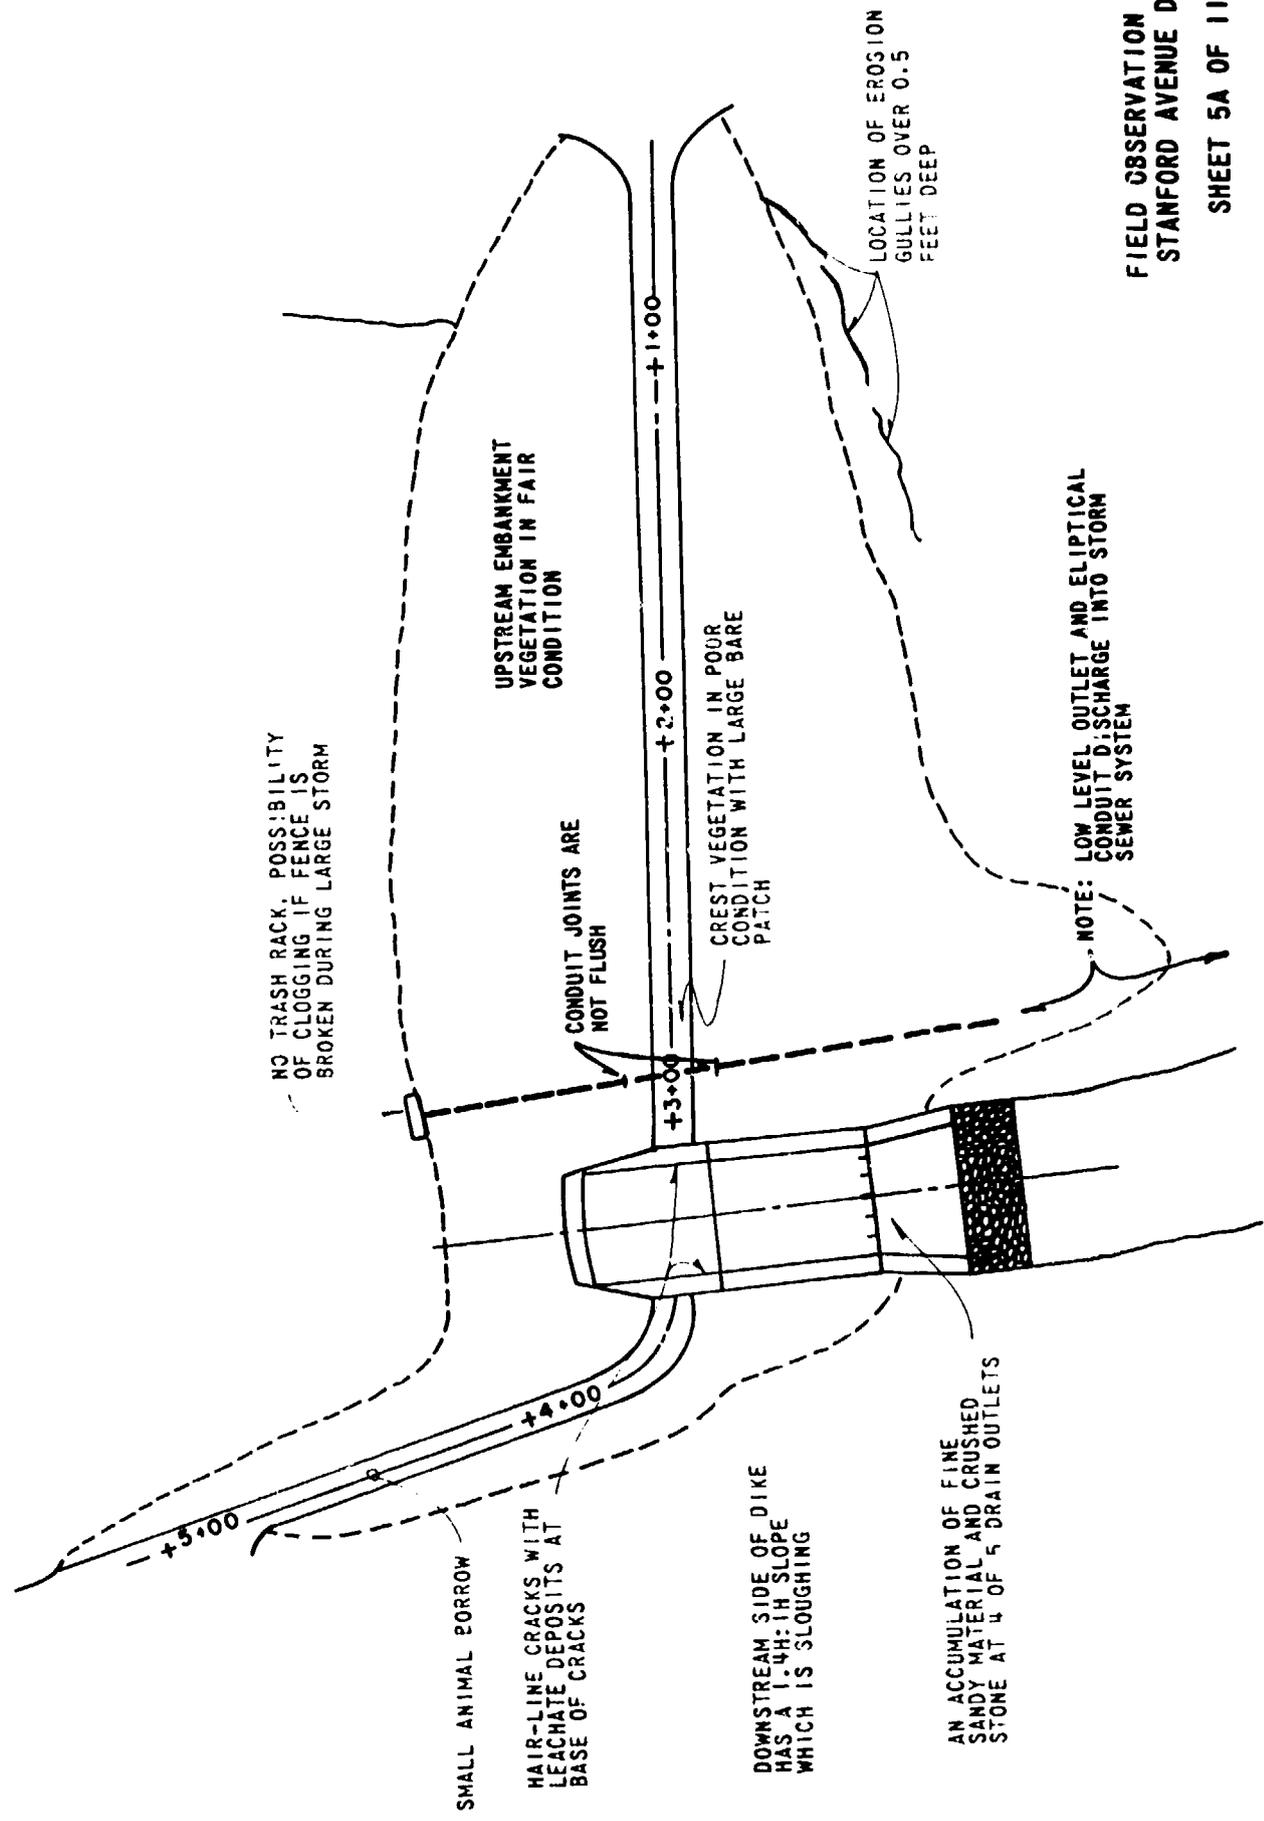
SHEET 5B OF 11

NO TRASH RACK, POSSIBILITY OF CLOGGING IF FENCE IS BROKEN DURING LARGE STORM

UPSTREAM EMBANKMENT VEGETATION IN FAIR CONDITION

CREST VEGETATION IN POOR CONDITION WITH LARGE BARE PATCH

HAIR-LINE CRACKS WITH LEACHATE DEPOSITS AT BASE OF CRACKS
