MINE No. 51 - POND 3

BETHLEHEM MINES CORPORATION
ELLSWORTH - BUTLER DIVISION

PHASE I INSPECTION REPORT
NATIONAL DAM INSPECTION PROGRAM

JULY 1981

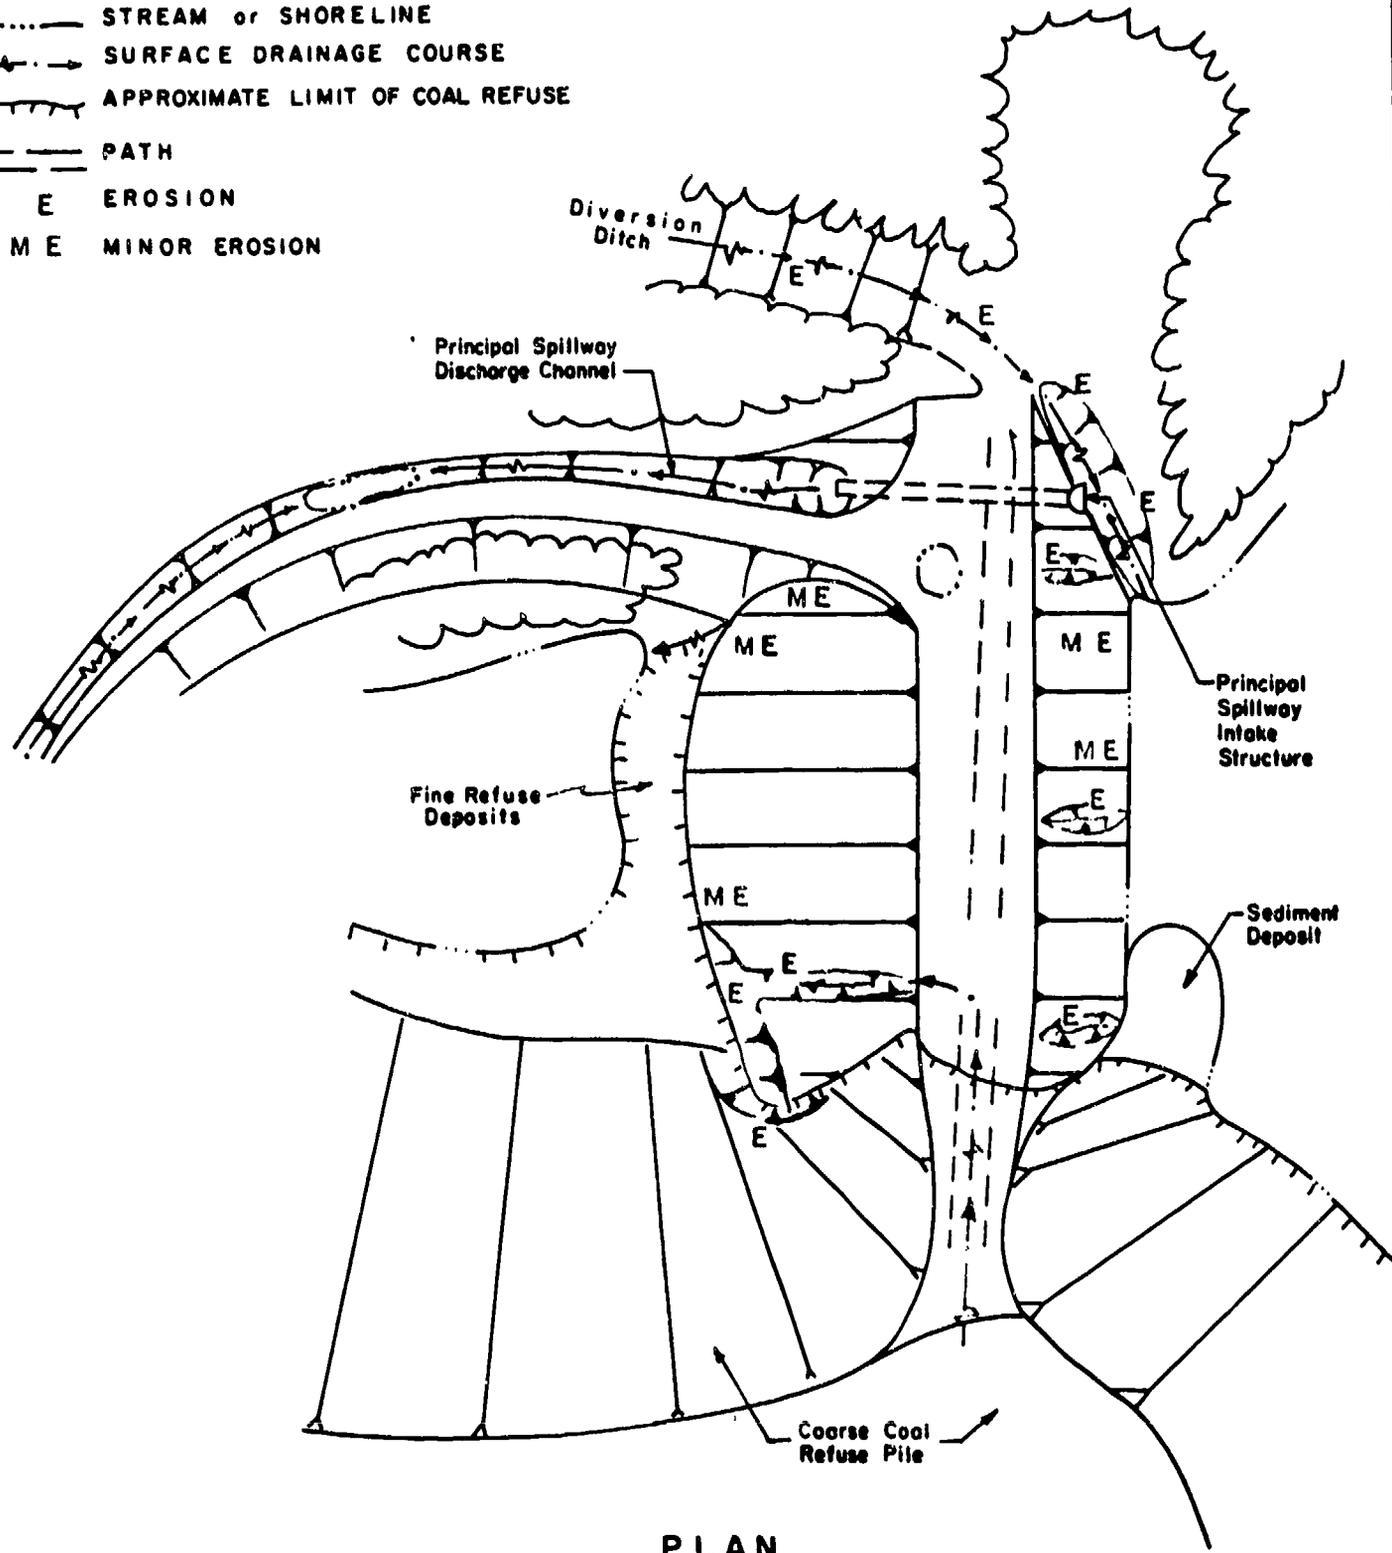
DATE: JULY 1981		MINE No. 51— POND 3 NATIONAL DAM INSPECTION PROGRAM	FIELD SKETCH
SCALE: NONE			
DR: JF	CK: JEB	ACKENHEIL & ASSOCIATES CONSULTING ENGINEERS GEO SYSTEMS, INC. 1000 BANKSVILLE RD./PITTSBURGH, PA. 15216	
DWG. NO. 80138H-1

The left downstream groin was ill-defined as the intersection of the embankment and the coarse coal refuse deposit. Considerable erosion has occurred, and steep slopes were observed in the refuse materials.

The embankment crest and slopes were severely eroded at several locations by uncontrolled surface runoff. Locally steep slopes and associated sloughing were observed in the erosional gullies. Vegetal cover was sparse.

(1) Repairing sloughing and erosion of the embankment crest, slopes and groins.

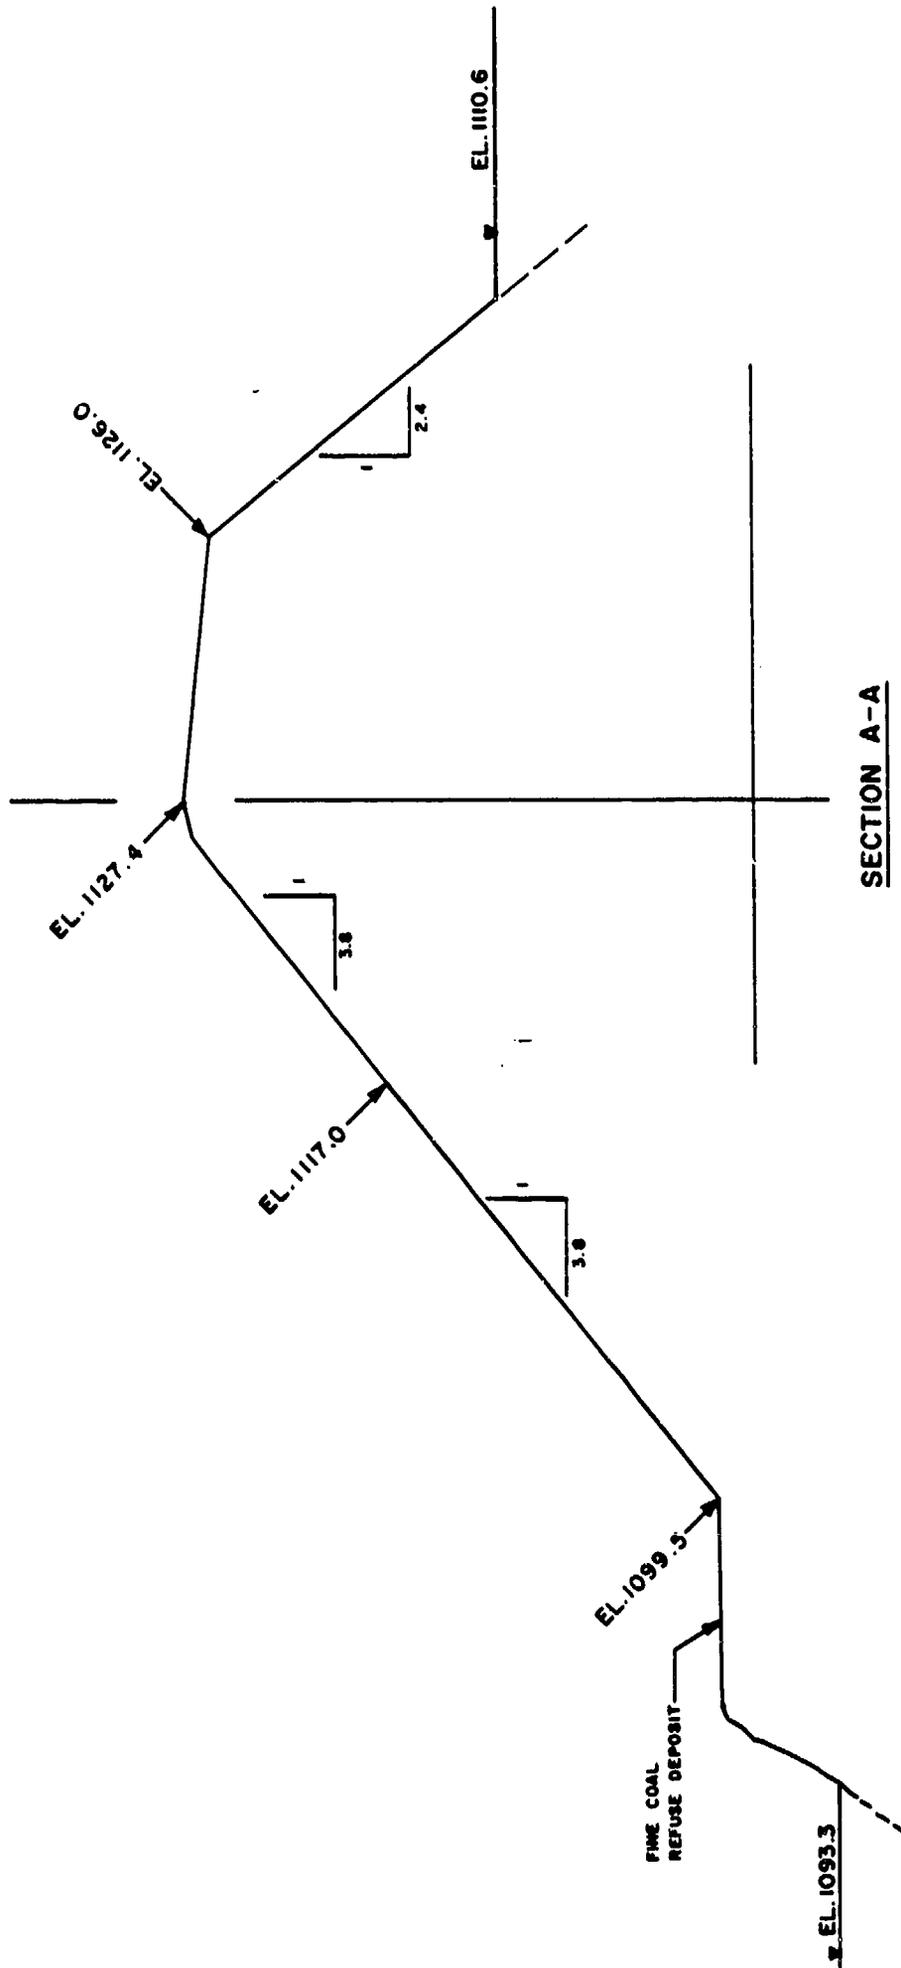
SECTION A-A

(1) Embankment: The field inspection disclosed no evidence of a high ground water level in the embankment. There was no pronounced "line of seepage"; and no significant bulges, surface sloughs, or cracking were observed. Field measurements indicated a relatively flat downstream slope of 3.8H:1V.
