LABELLE SLURRY POND 3

JONES & LAUGHLIN STEEL CORPORATION
VESTA-SHANNOPIN COAL DIVISION

PHASE I INSPECTION REPORT
NATIONAL DAM INSPECTION PROGRAM

JULY 1981

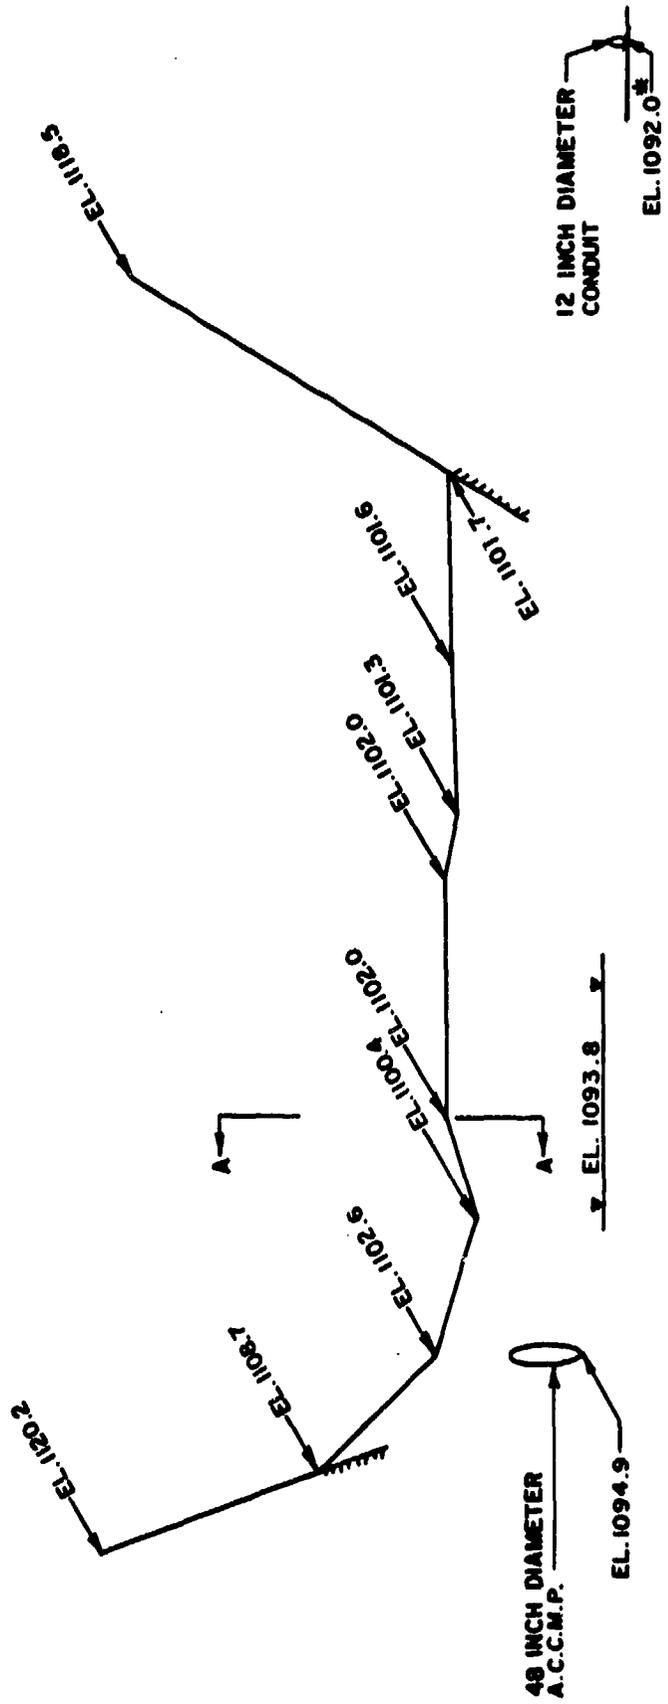
DATE: JULY 1981	LABELLE SLURRY POND 3	FIELD PROFILE
SCALE: AS SHOWN	NATIONAL DAM INSPECTION PROGRAM	
DR: JF	CK: JEB	ACKENHEIL & ASSOCIATES CONSULTING ENGINEERS GEO SYSTEMS, INC. 1000 BARKSVILLE RD./PITTSBURGH, PA. 15216
DWG. NO. 80138A-3

CREST PROFILE
 (LOOKING DOWNSTREAM)
 SCALE:
 HORIZ. 1" = 200'
 VERT. 1" = 10'
