# PATSY'S LAKE DAM

NDI ID NO. PA-565

PHASE I INSPECTION REPORT

(10) NATIONAL DAM INSPECTION PROGRAM

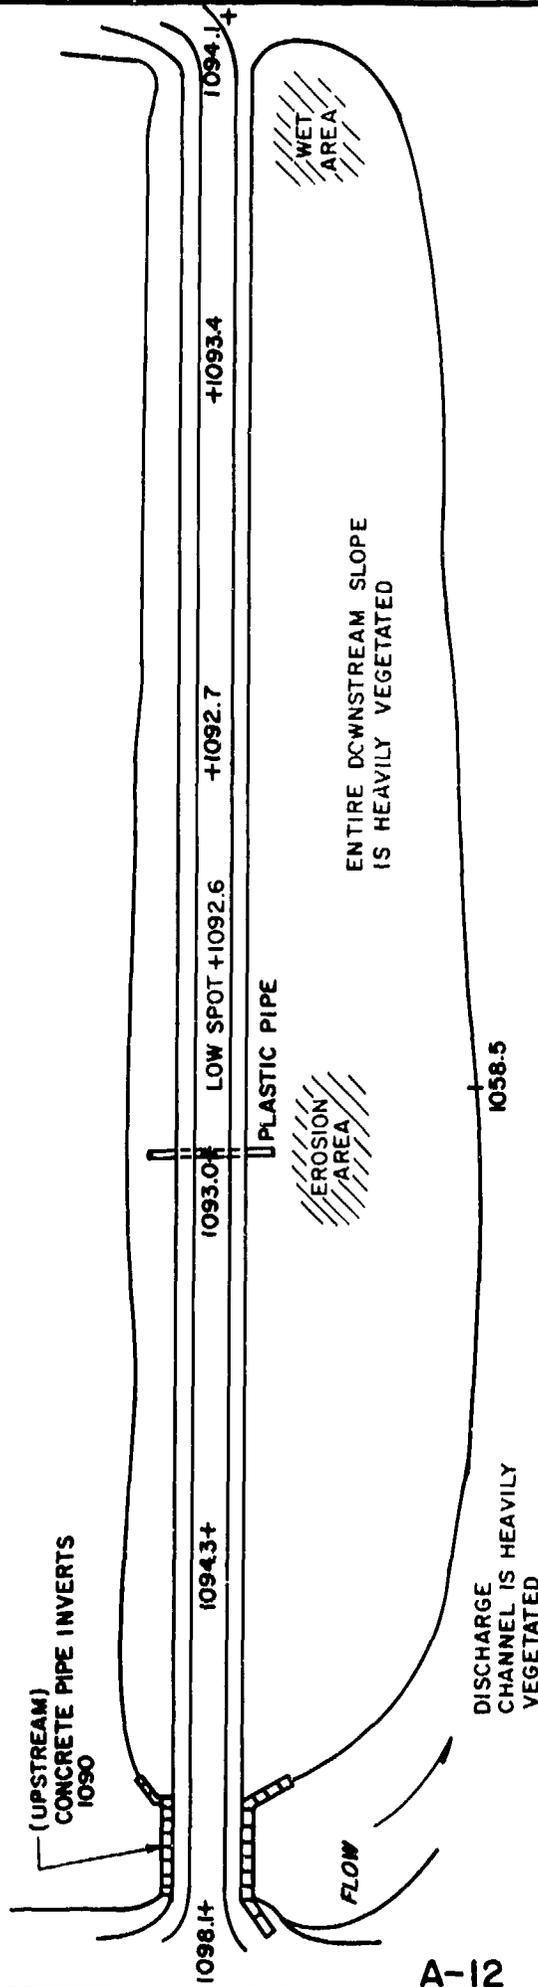
b. Dam. The dam appears to be in poor condition. Maintenance is considered fair. From a brief survey conducted during the inspection, it was noted that a low spot exists on the embankment crest, approximately 250 feet from the left abutment. A major erosion area was observed on the downstream slope of the dam, at the location of the plastic pipe, which exists through the embankment. The erosion was due to a break in the waterline, which is used to pump reservoir water to a coal cleaning plant, located downstream of the dam. It was noted during the May 12, 1981 inspection that the erosion area had been filled. It was reported by the owner that the erosion area was repaired by employees of the cleaning plant.

1098.1+ 1094.3+ 1093.0+ LOW SPOT +1092.6 +1092.7 +1093.4 1094.1+
