# CONTEE MAIN SETTLING POND DAM

PHASE I INSPECTION REPORT  
NATIONAL DAM INSPECTION PROGRAM

JULY 1981

CONTEE MAIN SETTLING POND DAM  
PRINCE GEORGES COUNTY, MARYLAND  
NDI I.D. No. MD 81

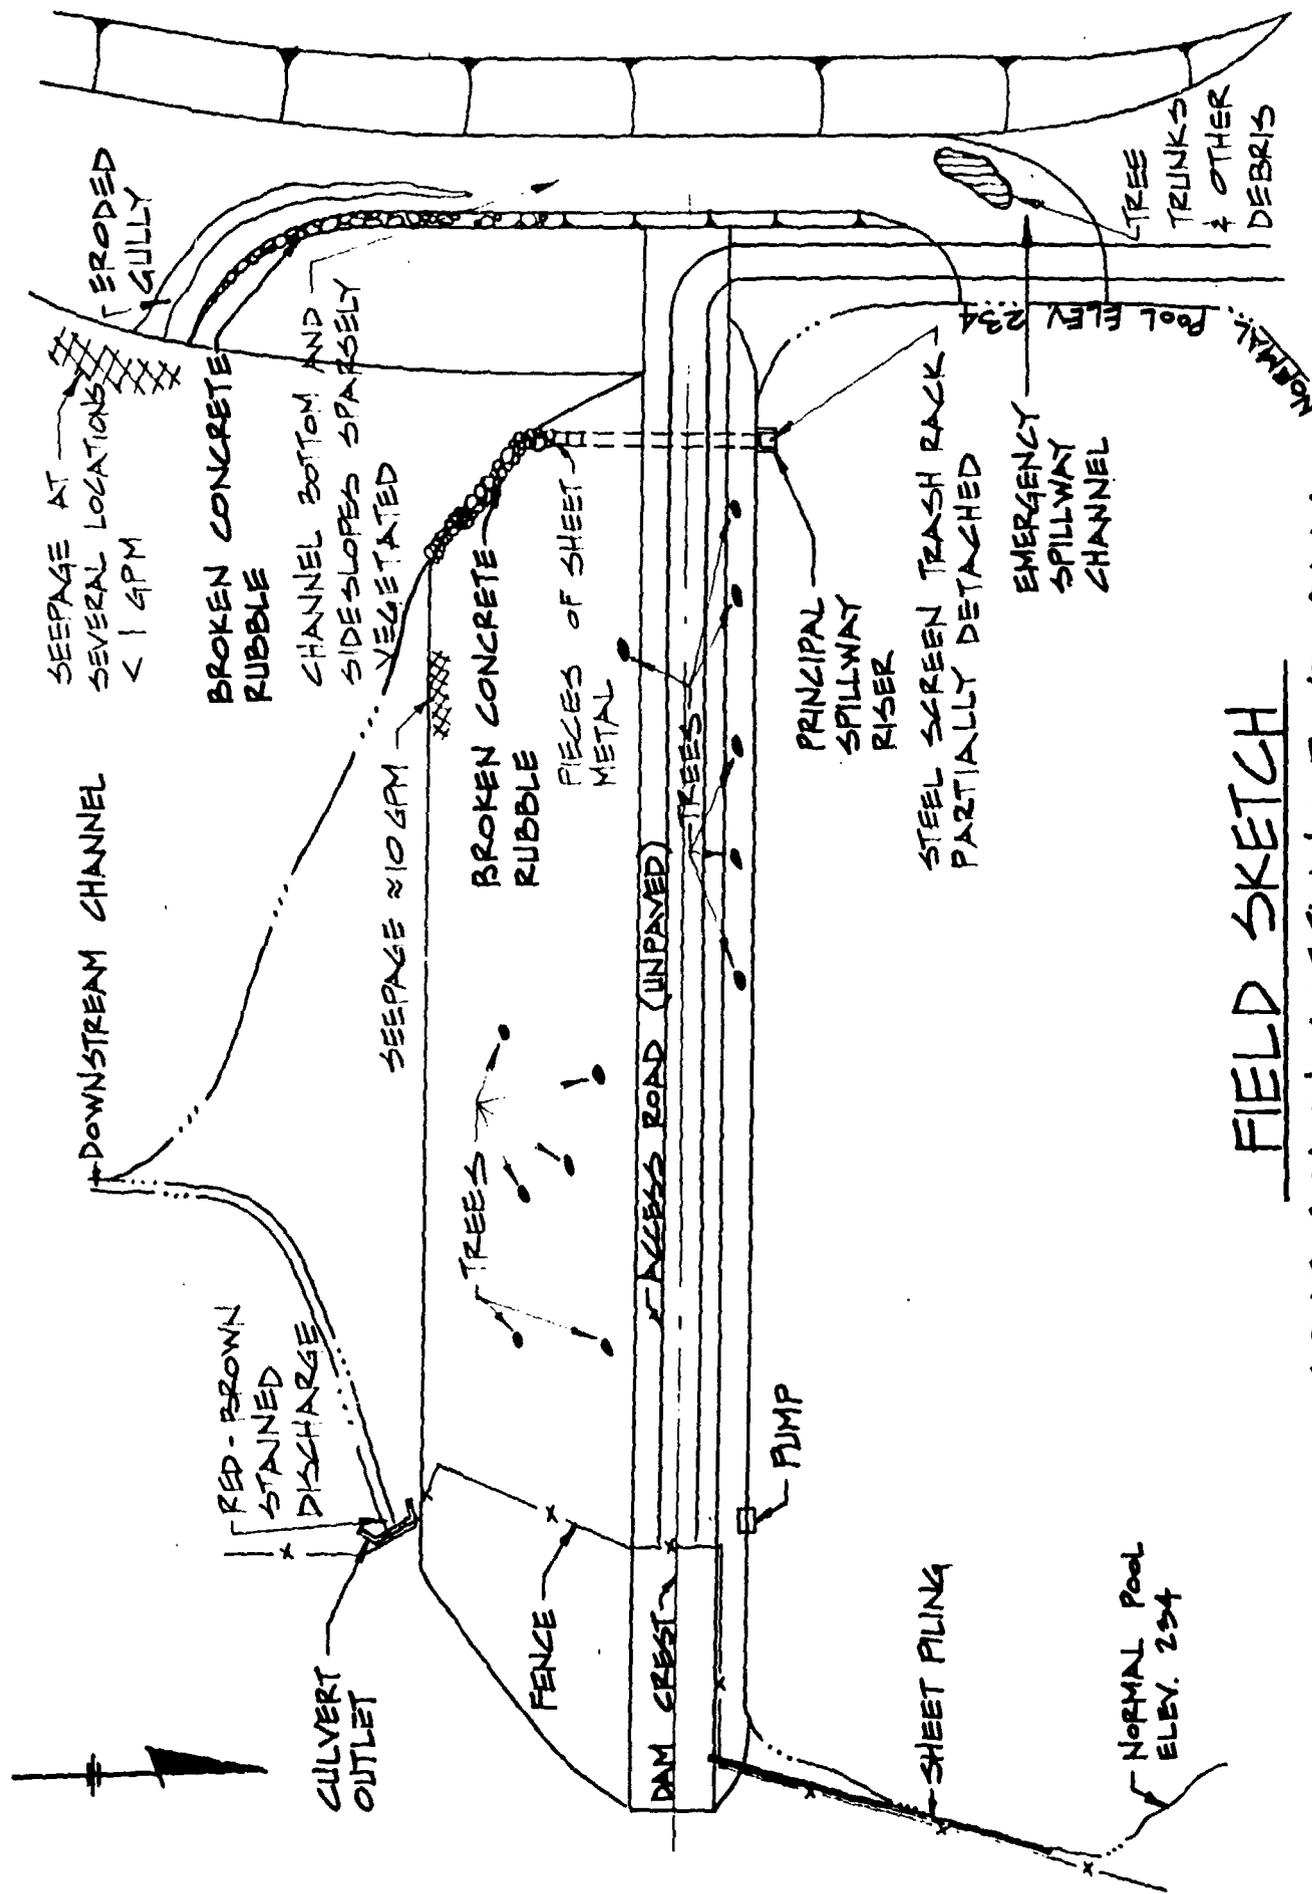
FIELD SKETCH  
CONTEE MAN SETTLING POND DAM

Several seeps were also noticed emanating from the right abutment at the outfall of the emergency spillway channel (See field sketch). The seepage flow from these seeps was also iron stained. The flow rate of each seep was estimated to be less than 1 gpm. No movement of soil fines or erosion channels were observed at the location of the seeps.

2. Monitor the seep located at the downstream embankment toe. If increased flow quantity or evidence of piping is observed, the Maryland Water Resources Administration, Dam Safety Division should be notified immediately, and necessary corrective repairs made.
