| REPORT DOCUMENTATION PAGE | | READ INSTRUCTIONS<br>BEFORE COMPLETING FORM |
|---|---|--|
| 4. TITLE (and Subtitle)<br>Phase I Inspection Report<br>Ed Pylkas Dam<br>Seneca River Basin, Tioga County, NY<br>Inventory No. 355 | | 5. TYPE OF REPORT & PERIOD COVERED<br>Phase I Inspection Report<br>National Dam Safety Program |

PHASE I INSPECTION REPORT  
NATIONAL DAM SAFETY PROGRAM  
ED PYLKAS DAM  
N.Y. 355  
DEC I.D. NO. 67-2067  
SUSQUEHANNA RIVER BASIN  
TIOGA COUNTY, NEW YORK

Name of Dam: Ed Pylkas Dam  
N.Y. 355

Date of Inspection: March 25, 1981 and April 30, 1981

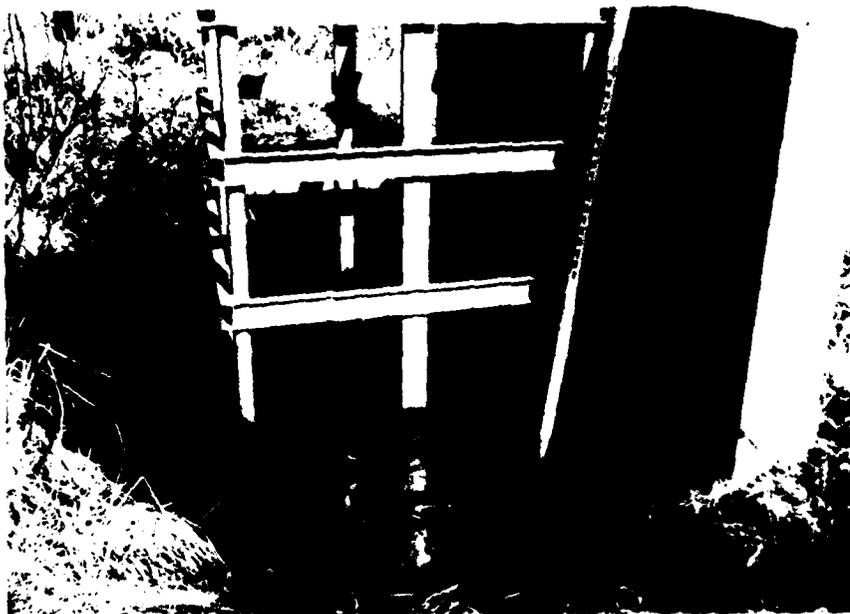
PHOTOGRAPH NO. 4  
Primary Spillway Inlet Structure

a. Concrete Surfaces The only concrete structure is the  
principal spillway drop inlet structure. Concrete is in  
good condition.
