**IMPROVED COATING SYSTEM
FOR HIGH STRENGTH TORSION BARS**

**Final Report
23 April 1981**

**U.S. ARMY TANK-AUTOMOTIVE COMMAND
RESEARCH AND DEVELOPMENT CENTER
Warren, Michigan 48090**

4. TITLE (and Subtitle) IMPROVED COATING SYSTEM FOR HIGH STRENGTH TORSION BAR Plastisol Coating System Provides a Cost Effective Means of Reducing Torsion Bar Body Corrosion	5. TYPE OF REPORT & PERIOD COVERED Final Report

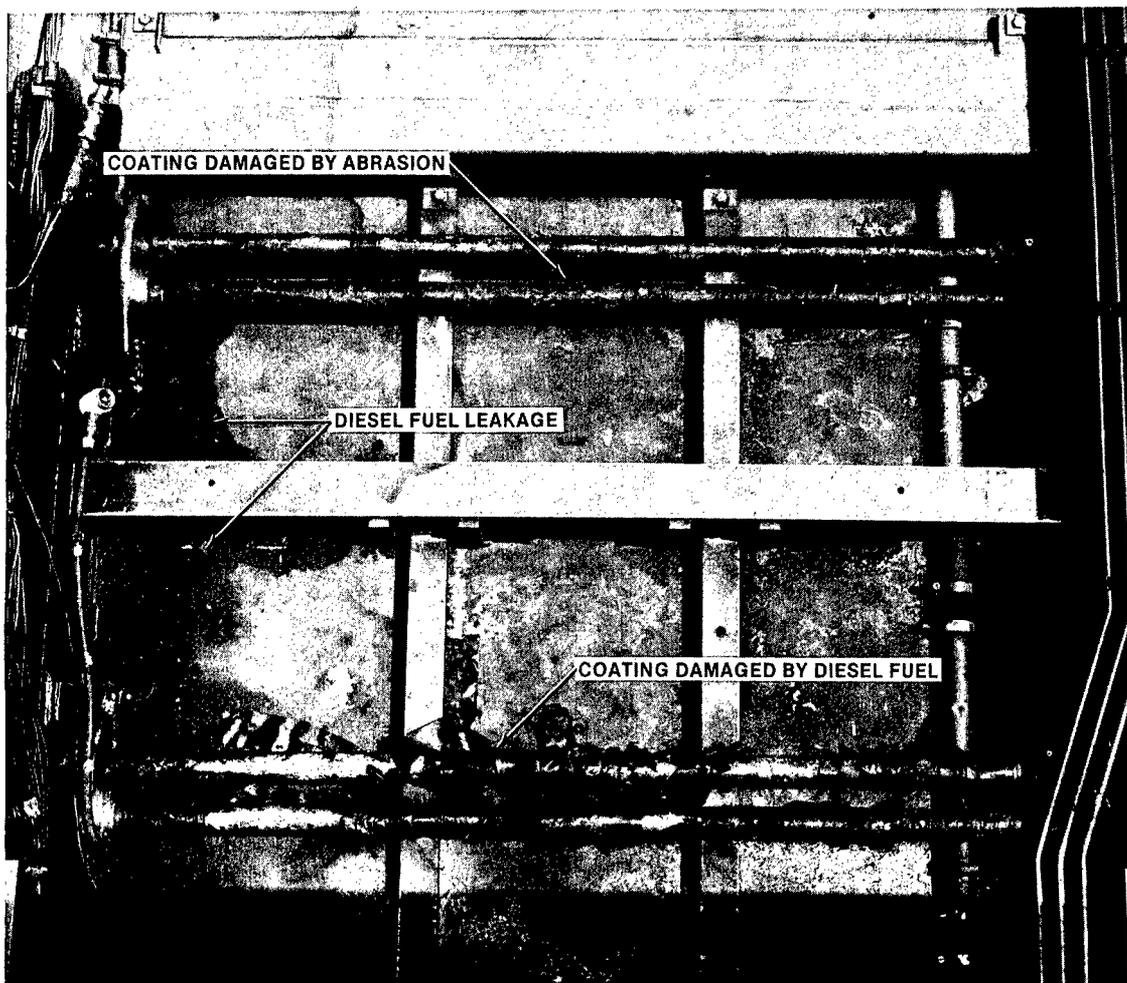
engine or crew compartment from vehicle swimming or cleaning operations run into the bilge where they come in contact with torsion bars. Diesel fuel (a hydrocarbon) has been found to attack tape adhesive, causing loss of tape integrity and exposing the primer paint to moisture and abrasive damage. Maintenance personnel sometimes walk on torsion bars or accidentally drop tools or vehicle parts onto them. Figure 1 shows an example of deterioration of the protective tape wrapping caused by diesel fuel that had leaked into the bilge and by abrasion from personnel walking on torsion bars.

Figure 1. Degradation of Torsion Bar Protective Tape Coating in M730 Vehicle (M113 Family) Bilge Resulting from Abrasion and Contact with Diesel Fuel.

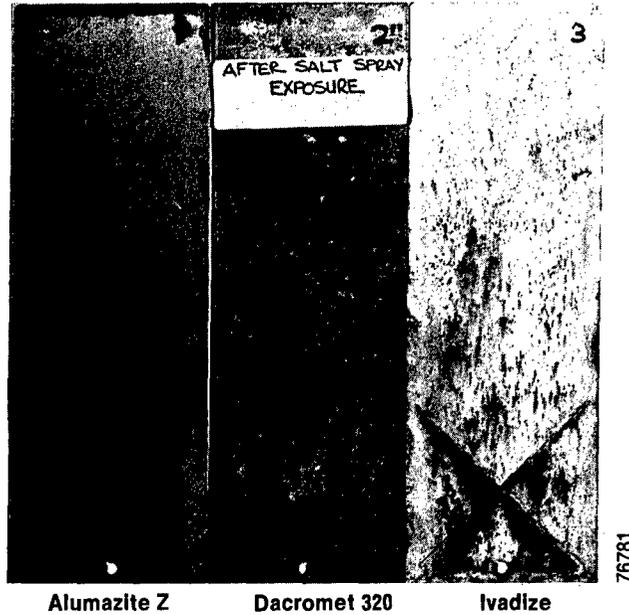
SALT SPRAY RESISTANCE Alumazite Z coating exhibited least protection (336 hours) of all coatings tested.

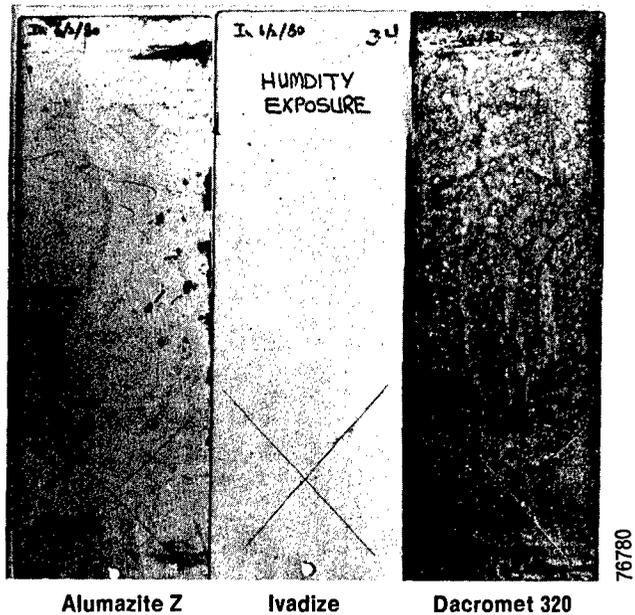
HUMIDITY RESISTANCE Alumazite Z coating exhibited least protection (336 hours) of all coatings tested.

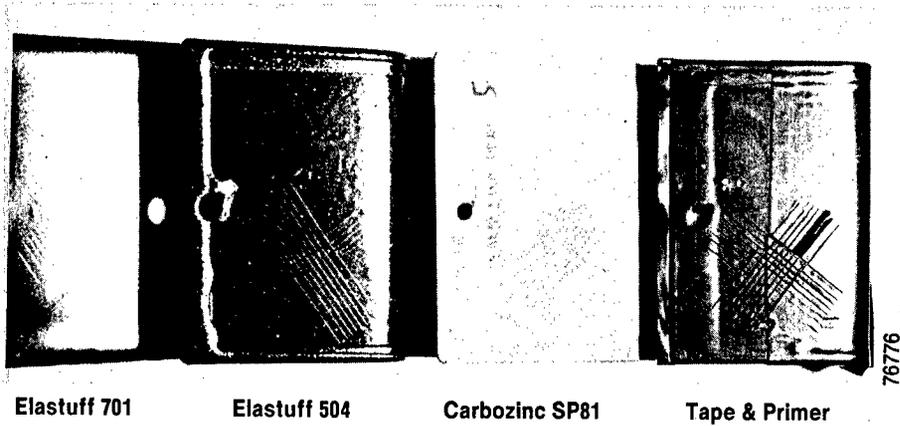
FLEXIBILITY & ADHESION Carbozinc SP81 coating failed both tests and was the only failure of all coatings tested.

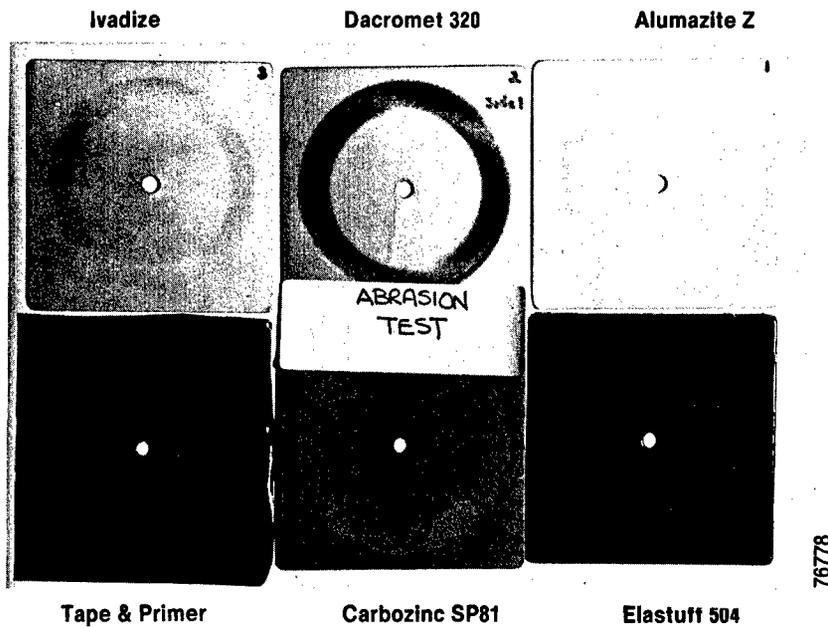
ABRASION RESISTANCE Dacromet 320 coating was penetrated, exposing steel panel.
