SHIPBOARD EXPOSURE TESTING -  
USS AMERICA

E. J. Jarkowsky  
Aircraft and Crew Systems Technology Directorate  
NAVAL AIR DEVELOPMENT CENTER  
Warminster, Pennsylvania 18974  
20 August 1982

PROGRESS REPORT  
AIRTASK NO. WF61-542-001  
Work Unit No. ZM501

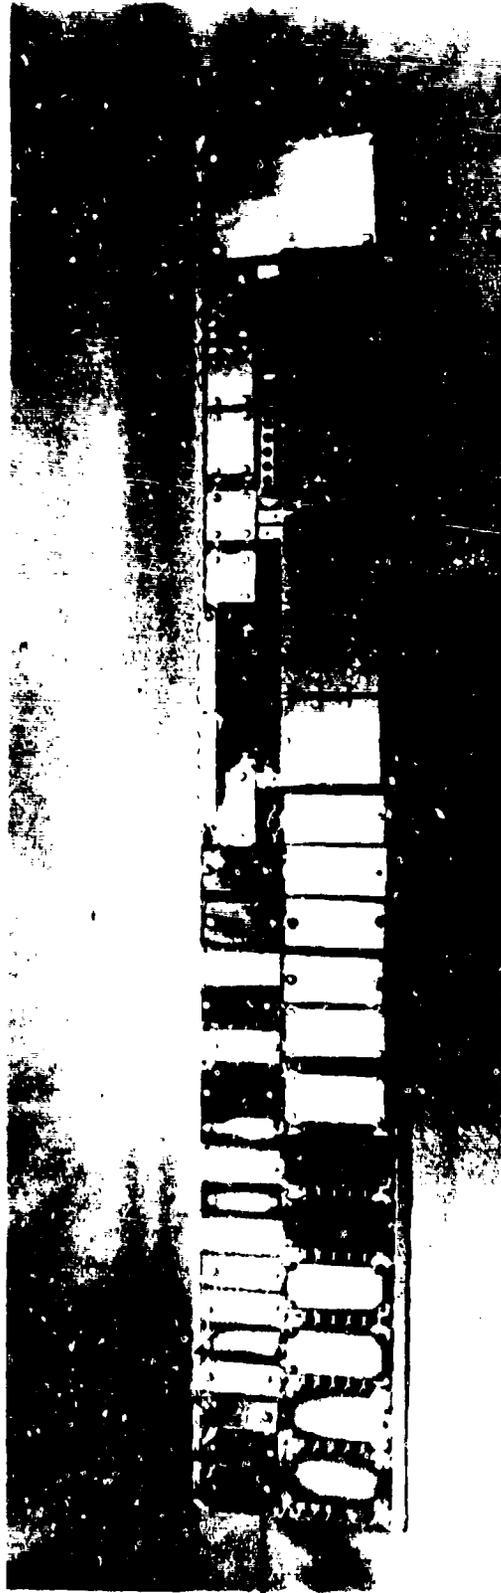
FIGURE 1. CORROSION RACK PRIOR TO EXPOSURE

The rack was made of steel, cadmium plated, chromated, and painted with MIL-P-23377 epoxy primer and MIL-C-81773 polyurethane topcoat. The rack was designed to expose the specimens at a 45° angle. Specimens were attached to the rack with nylon bolts. MIL-A-46146 silicone sealant was applied in the bolt holes and under the heads to prevent crevice corrosion. The rack was welded to the radar tower aft of the island about 1.5 meters (5') above the deck. The rack was 2.4 meters long by 0.3 meter wide (8' x 1'). The rack is shown in figure (1).

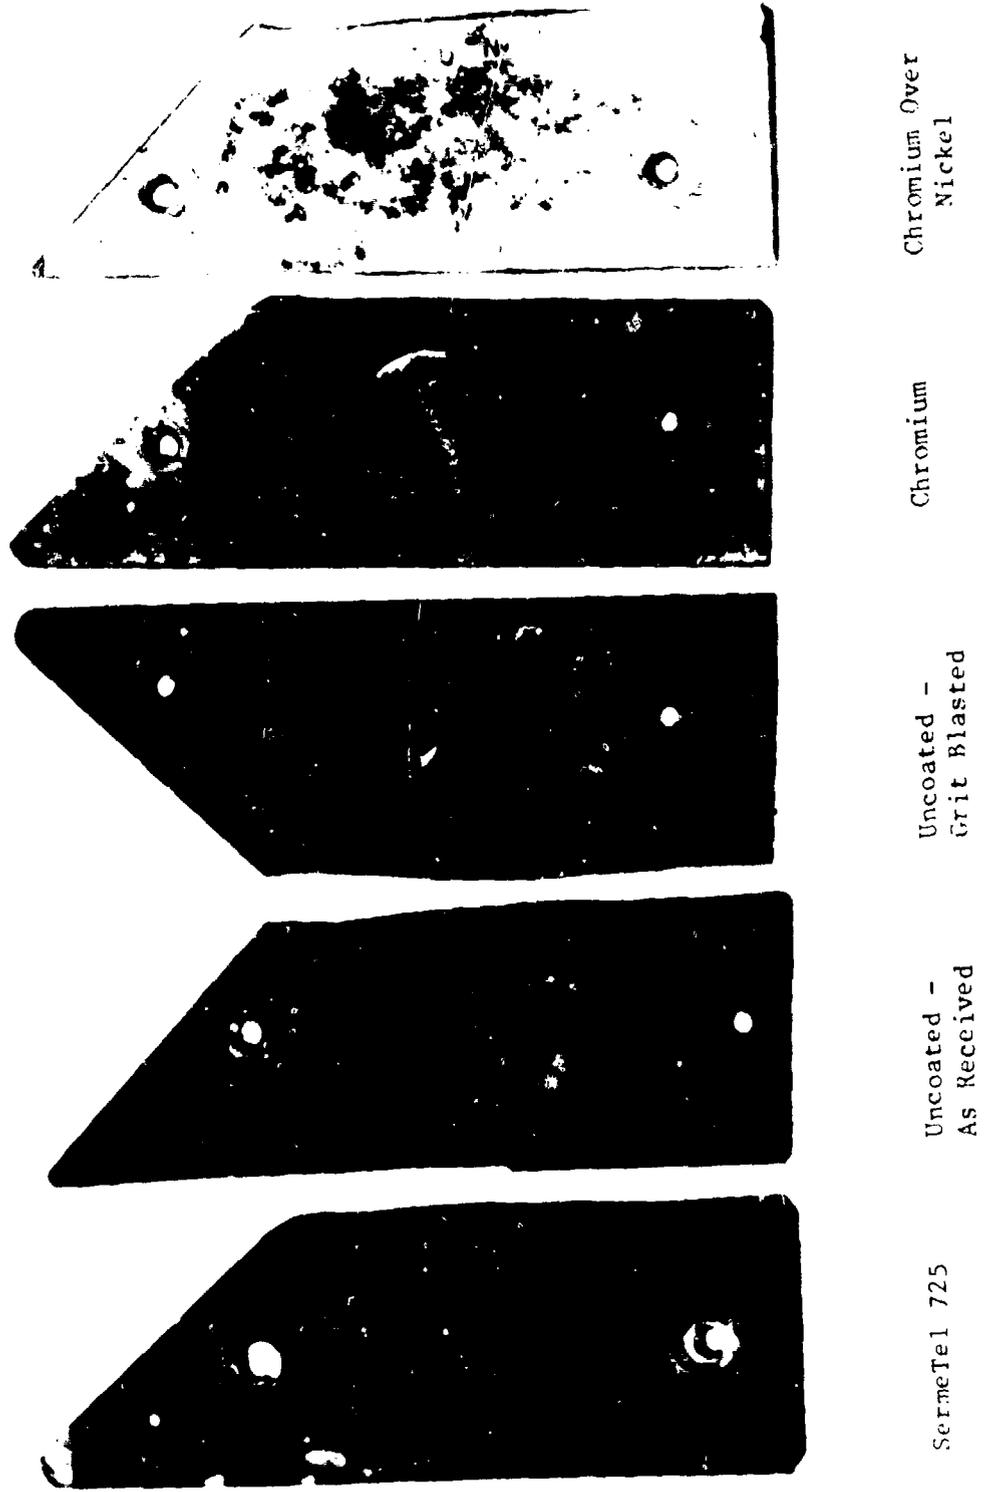
FIGURE 2. CAST 17-4 PH STAINLESS STEEL SPECIMENS AFTER EXPOSURE

The appearance of the 17-4 PH specimens following exposure is shown by figures 2 and 3. Table I gives ratings of the panels and evaluation of the appearance from the photographs furnished by ship personnel.

SermeTel 725 protected the basis metal better than any of the other coatings, showing only slight white surface corrosion. However, the coatings were quite thick (63  $\mu\text{m}$ ) compared to the chromium (5-10  $\mu\text{m}$ ), or even the chromium over nickel (total thickness 15-25  $\mu\text{m}$ ). Both chromium and chromium over nickel were considered poor. It should be noted that SermeTel 725 is a dark brown coating with much the same appearance as rust in the photographs.

The difference between the uncoated as-received, and grit blasted panels was striking, especially for the wrought material. Apparently, any passivity the surface had as-received was destroyed by grit blasting. It also roughened the surface and may have embedded impurities in it. In any case, the grit blasted panels rusted considerably more than the as-received panels.

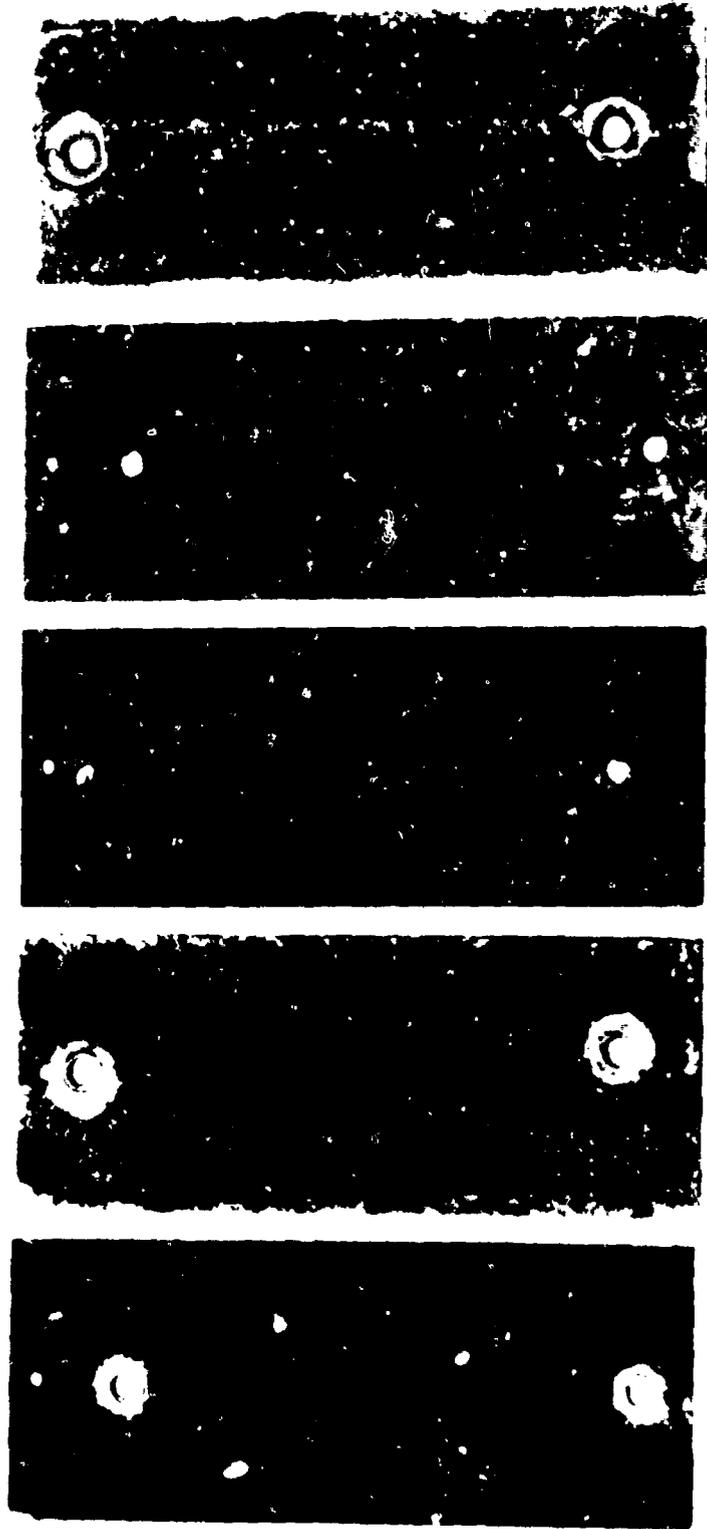
FIGURE 4. 4130 STEEL SPECIMENS AFTER EXPOSURE

As shown in figures 4 to 6 and Table II, the most protective coating for 4130 steel was SermeTel 725, which again showed only light white corrosion. Cadmium, both bright and dull (13  $\mu\text{m}$ ) was next best with general white corrosion and some slight rust staining at the end of the cruise. IVD aluminum, 25  $\mu\text{m}$  thick, had general white corrosion and a few rust spots through the coating; the 13  $\mu\text{m}$  coating was completely replaced by rust. The aluminum-manganese coated panels were 90% rusted. Both chromium and chromium over nickel plated panels were badly rusted - chromium 100% and chromium over nickel only slightly less.

Some further rating of the coatings was possible from the photographs taken periodically. By the end of February, two months after exposure began, chromium showed superficial rust over the whole surface, and chromium over nickel had many isolated rust spots. The thin (13  $\mu\text{m}$ ) IVD aluminum coating had only white corrosion at the end of April, but by July the panels were 75% rusted. Aluminum-manganese began to show rust spots by the end of two months, but corroded more slowly than IVD aluminum.

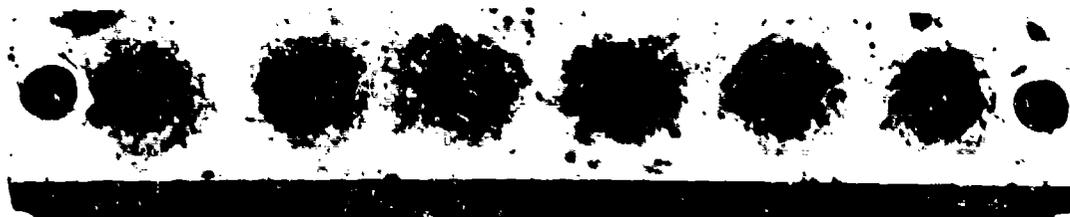
FIGURE 7. COATED STEEL FASTENERS IN ANODIZED 7075-T6 ALUMINUM ALLOY PLATE AFTER EXPOSURE

The coated steel screws installed in 7075-T6 plate are shown in figure 7. There were two sets of cadmium plated screws, one for controls for the IVD aluminum coatings and one for controls for the aluminum-manganese. The cadmium screws were generally in fairly good condition on the heads. A few had small rust spots, but otherwise had only white corrosion. The IVD coatings had largely given way to rust. Aluminum-manganese showed rust spots, but most of the coating was intact.

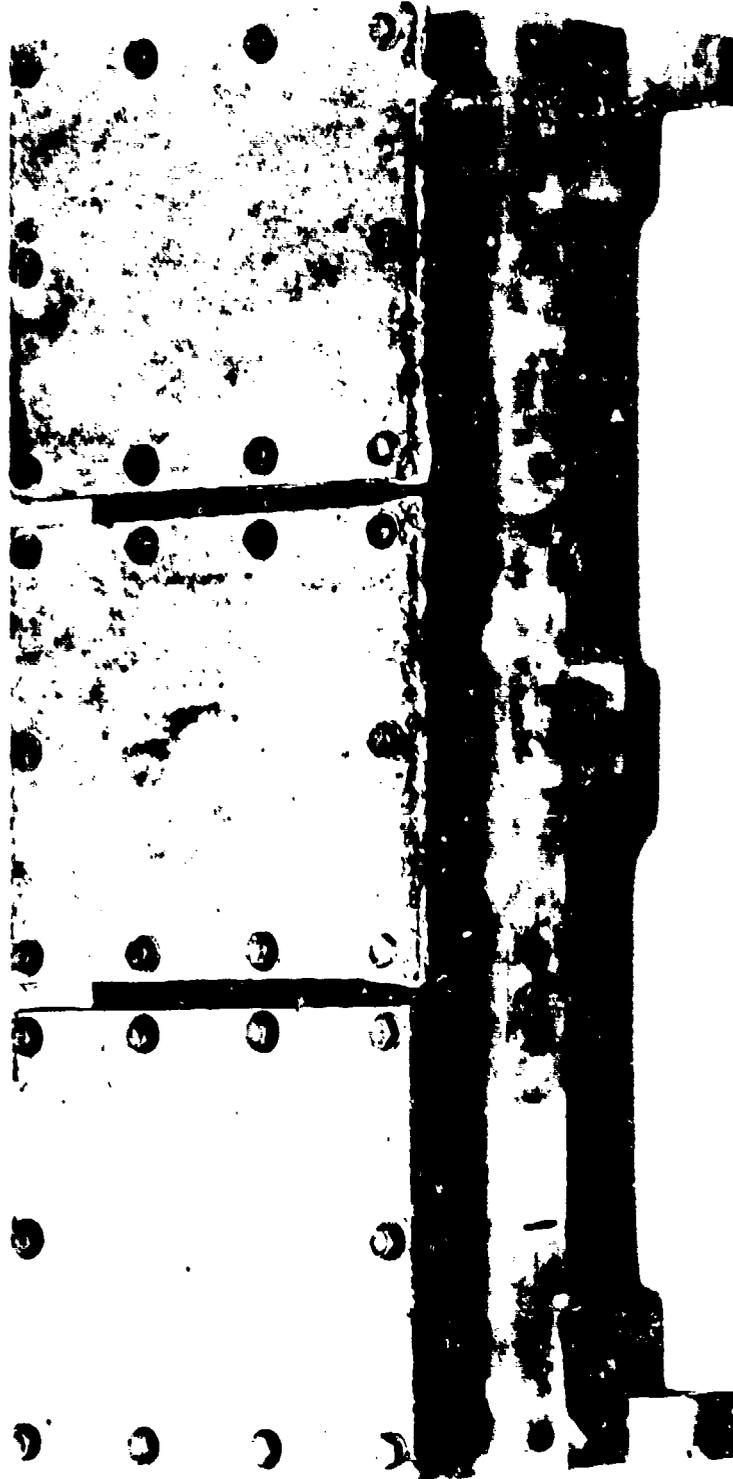
FIGURE 10. EMI SEAL ASSEMBLIES AFTER EXPOSURE

The EMI seal assemblies were opened up at the interim inspection, 109 days after they had been placed on the rack. At that time, they were in perfect condition, showing no signs of corrosion in the seal area or elsewhere on the boxes, and no deterioration of the gaskets. They were then resealed. The pictures taken in April showed what appeared to be the beginning of very slight corrosion at the bottom edge of the seal area on the boxes with silver plated copper filled seals. By July, the corrosion had advanced very slightly and there was some very slight corrosion beginning at the seal area of the boxes with silver filled gaskets. Figure 10 shows three of the assemblies at the end of the exposure period. Covers and seals from these assemblies are shown in figure 11. The assemblies not shown were similar in appearance. The silver plated copper filled gaskets resulted in the most galvanic corrosion with silver filled gaskets next and no corrosion on the aluminum in contact with the unfilled silicone gaskets. Some of the apparent deterioration was in the form of slight swelling of the exposed edges of the filled gaskets.

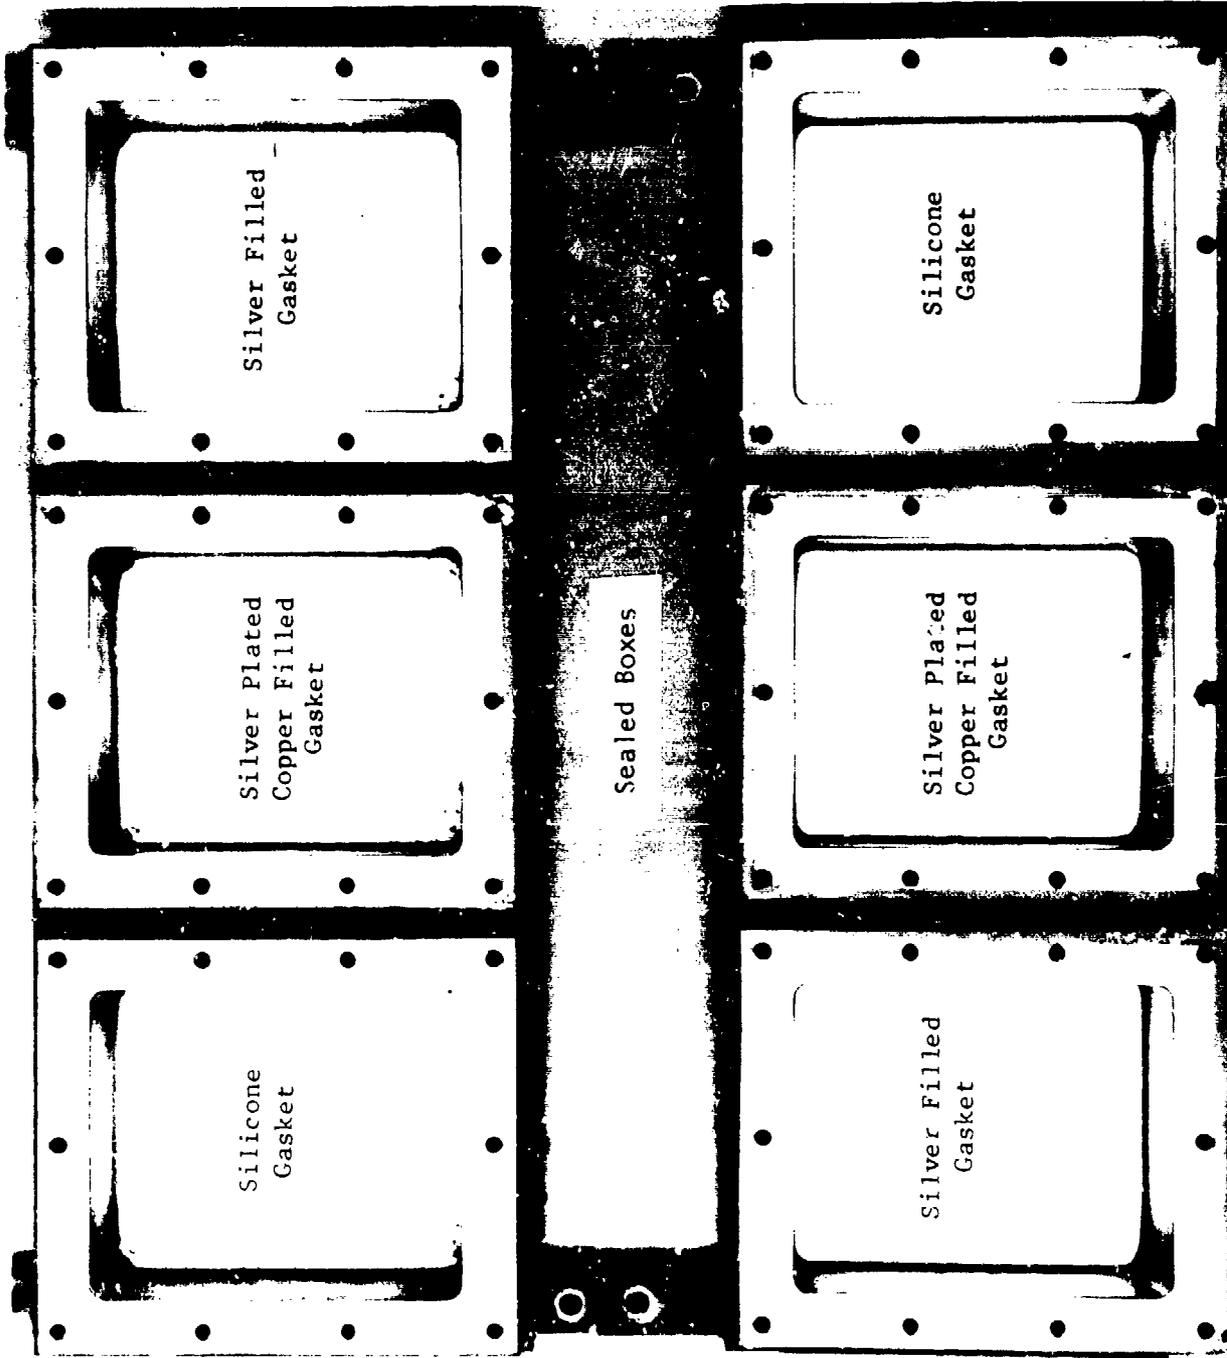
FIGURE 12. EMI SEAL ASSEMBLIES AFTER EXPOSURE (BOTTOM HALF)

Figure 12 shows all six boxes with the covers and seals removed. The only difference between the boxes with holes drilled in the bottoms and those completely closed was slight corrosion in the bottoms of the "open" boxes. Otherwise, corrosion was confined to the outer edges of the seal areas and was not nearly as severe as it appeared to be from the outside. The unpainted contact areas, where the EMI seals have to maintain good electrical contact, were in excellent condition. A temporary preservative such as AMLGUARD (MIL-C-85054) might have prevented corrosion from appearing at all, if it had been applied periodically to the outer edges.
