TN NO: N-1647

TITLE: MICROBIOLOGICAL DEFACEMENT OF NAVY BUILDINGS

AUTHOR: R. W. Drisko, T. B. O'Neill, and J. R. Moses

DATE: October 1982

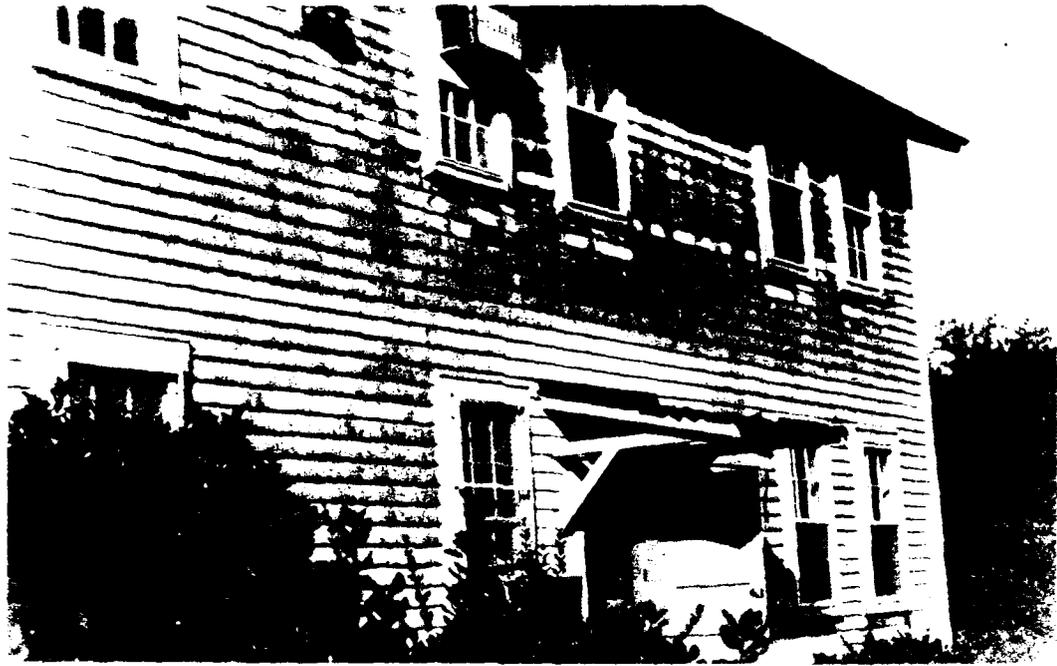
Microbial defacement and deterioration of organic coatings occur at Naval installations around the world. Although destructive microbes deface buildings at most locations (e.g., Naval Weapons Station Yorktown, VA, Figure 1), they are especially prevalent at tropical and subtropical locations. Economic effects to the Navy have never been determined, but losses caused by microbiological attack on paints and paint films in the United States have been conservatively estimated to exceed \$1 million annually (Ref 1). These cost figures do not include damage to substrates such as communications equipment, utilities, etc., which would greatly increase this estimate. Thus, the total annual damage probably exceeds several million dollars. Also of importance is the increasing awareness of the relationship of mildew to serious, chronic health problems (Ref 2). Many individuals are hypersensitive to airborne fungal parts (e.g., hyphae and spores) which, upon inhalation, act as allergens producing hypersensitivity pneumonitis. Of the fungal genera cited in this report, Aspergillus, Aureobasidium, Cladosporium, and Alternaria have been identified as allergens. Aspergillus is also associated with aspergilloma (fungus balls consisting of fungal parts in bloody sputum). Fusarium, also identified in this study, can, upon contamination of the eye, cause blindness.

Figure 1. Mildew defacement of building at Naval Weapons Station Yorktown, VA.

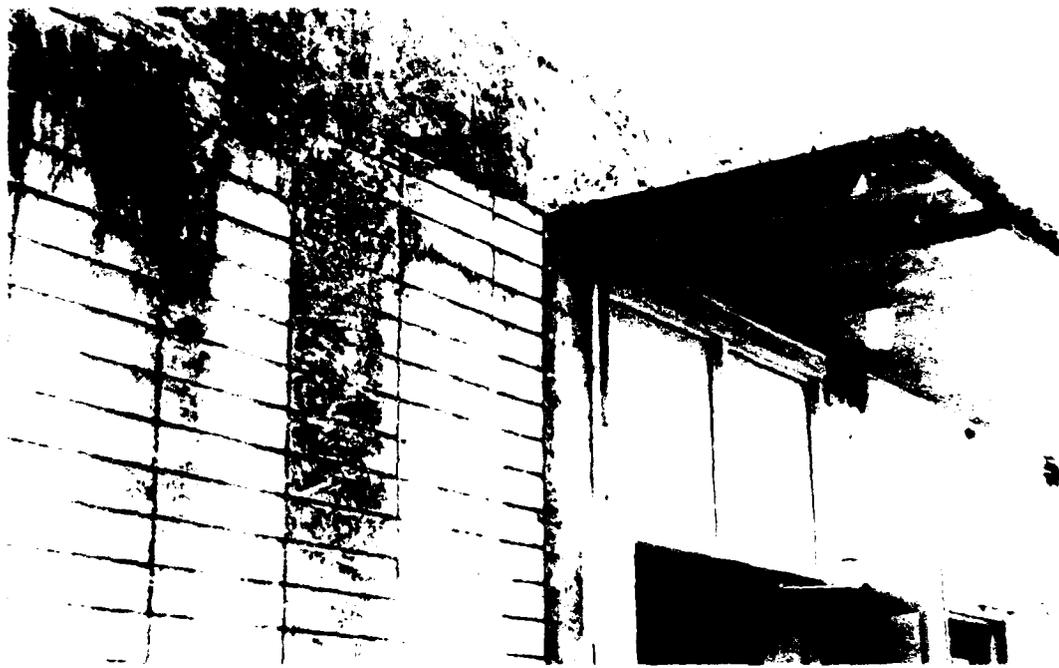
Figure 2. Black algal defacement accelerated by water running down side of building at Guam.

1. Design or modify drainage systems for roofs of buildings to prevent water (a) from running off the roof and down the building's sides and (b) from ponding on the roof or other building components.

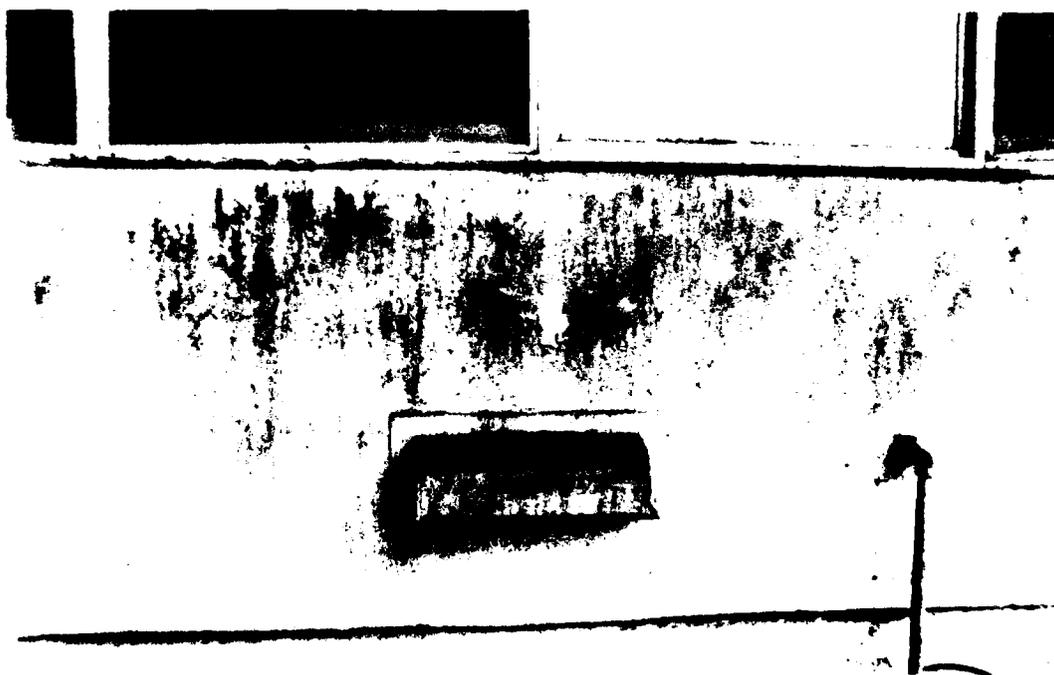
Figure 4. Green and red algal defacement of building exterior at Cubi Point.

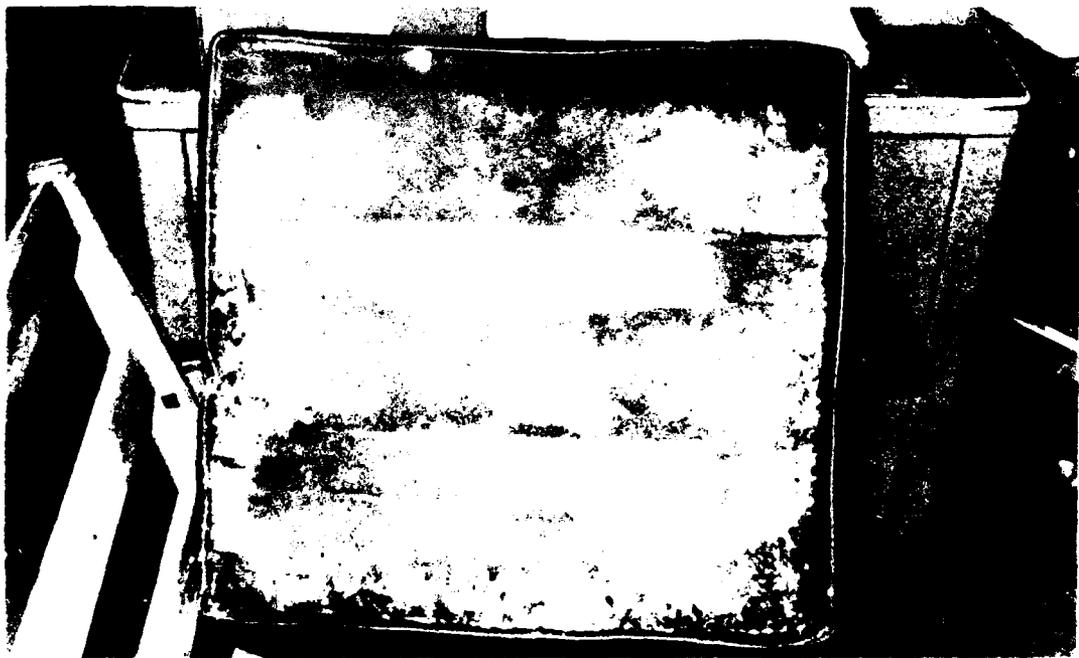
Mildew defacement was greatest at Guam where most occurred on exterior surfaces, but some was also found on interior walls, plastic cushions (Figure 6), and other surfaces at the Navy hospital and two

chapels. These interior growths are believed to be related to inadequate air conditioning with FCU's. Mildew was prevalent in air-conditioned rooms behind large items of furniture where air circulation was restricted. Their growth is presently controlled by periodic washing with vinegar and water.

Figure 6. Mildew on plastic seat cushion at Guam.
