# CONSTRUCTION FOUNDATION REPORT

**SOUTH PLATTE RIVER BASIN  
BEAR CREEK LAKE, COLORADO**

**VOLUME I  
TEXT AND PHOTOS**

**FEBRUARY 1983**

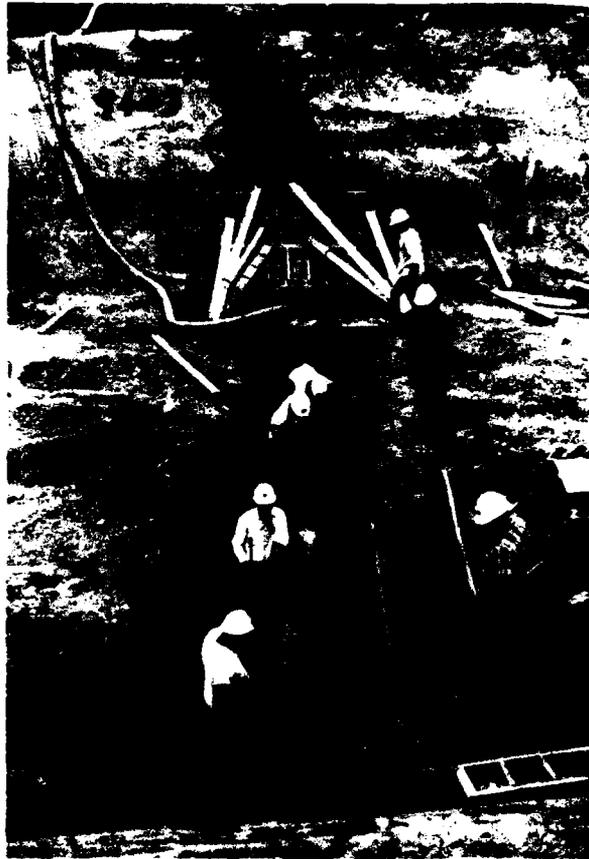
3.7.3.1. South Embankment Inspection Trench: Two shear zones were observed in the trench; one near Station 9+00 (Photo No. 41) and the other near Station 1+00. The shear zone near Station 9+00 had a strike of N. 46°W. and a dip of 74°NE, the same attitude as bedding in bedrock. Material in this shear zone was made up of alternating thin fractured stringers of ironstone, shale, and clay, with a total width of about 2 feet. On the downstream face five ironstone stringers were noted 1/2 to 6 inches thick. The ironstone stringers were highly fractured and water ran freely through these fractures on this side of the trench. A probable source of the water was a nearby irrigation canal. This shear zone was dental treated with lean concrete for an area of 5 feet wide and 5 feet deep to eliminate the possibility of piping through the impervious section of the embankment. A fault was observed near Station 1+00. It had 1 to 2-1/2 inches of clay gouge on the fault plane. A number of thin ironstone stringers appeared above the fault plane but not below, indicating displacement of at least 10 feet. On the downstream face the fault plane is curved, with a strike of N. 25°W. and a dip of 15°SW a few feet above the floor. On the upstream face, the fault dips 3° NE with the same strike as on the downstream face. Since this fault was near the end of the trench in the right abutment, it was felt that it would not affect the integrity of the foundation of the south embankment. If the water in the lake should ever rise to elevation 5673, the upstream side

PHOTO NO. 41. Dental cleaning of  
shear zone across south embank-  
ment trench, Sta. 9+03.  
Looking northwest. 9/16/75.
