TECHNICAL REPORT ARLCB-TR-83022

**METALLOGRAPHIC STUDIES OF EROSION
AND THERMO-CHEMICAL CRACKING
OF CANNON TUBES**

**R. M. FISHER
A. SZIRMAE
M. H. KAMDAR**

MAY 1983

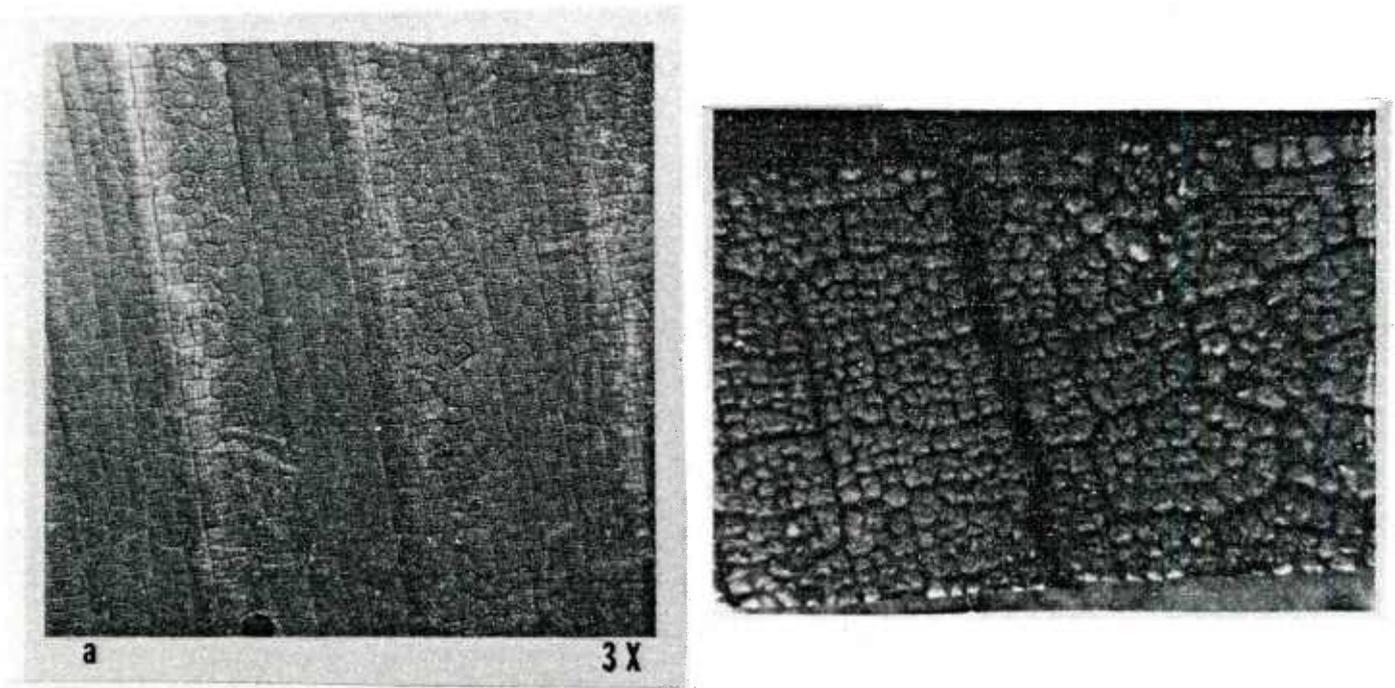
Figure 1. Cannon Tube T-45, Bore Surface.

The characteristic heat-checking pattern and deep cracks parallel to the rifling are illustrated in Figure 1. The bright areas are abrasion marks caused by the rotating Cu band. The appearance of this surface in the SEM is shown in Figure 2, along with an EDX spectrum illustrating the occurrence of a considerable amount of Ti and lesser concentrations of Al, S, K, and Cu. Point-to-point probing revealed that the Fe signal from the steel base largely came from the spaces between the hillocks and that the Cu was associated with the abrasion marks.

(a) (3X).

(b) (10X).

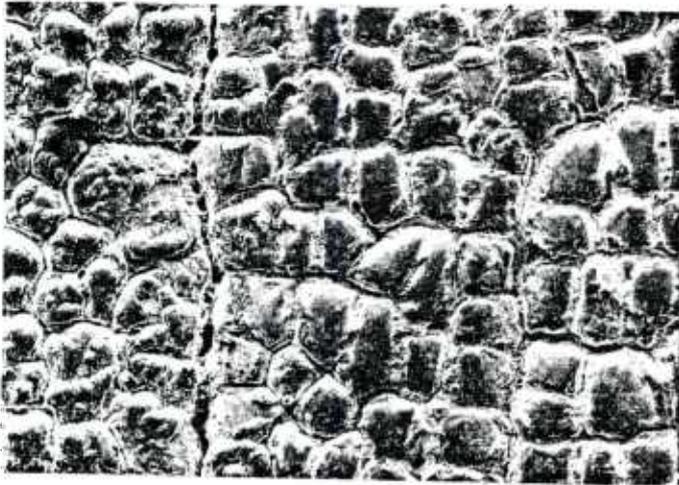
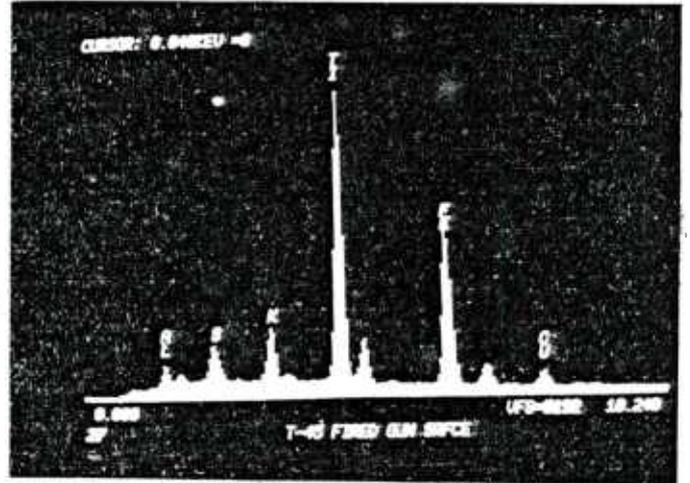
Figure 2. Cannon Tube T-45, Bore Surface.

(a) SEM (60X).

(b) EDX.

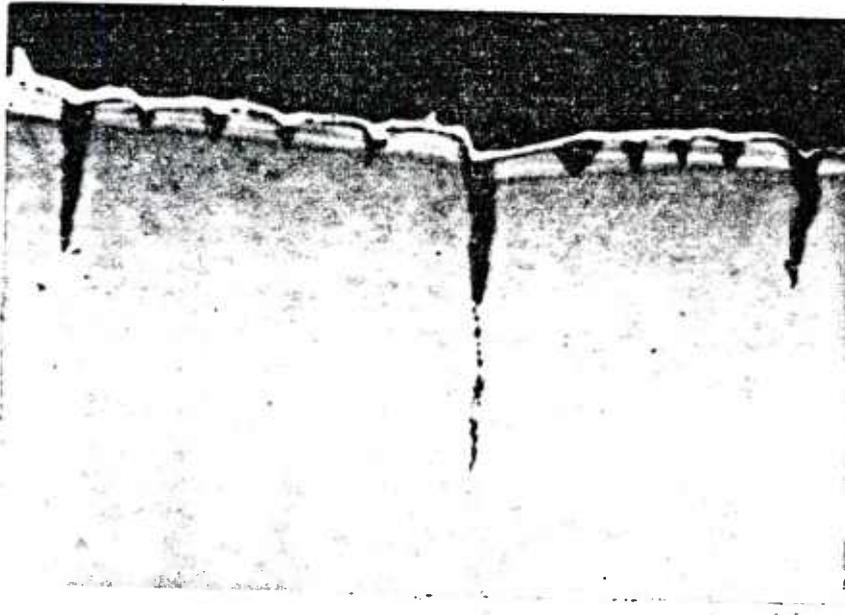
Figure 3. Cannon Tube T-45, Cross-Section. (50X)

A Ni plated, polished, and lightly etched cross-section of sample T-45, illustrating the alternating pattern of shallow, deep, and very deep cracks that is typical of fired cannons, is shown in Figure 3.

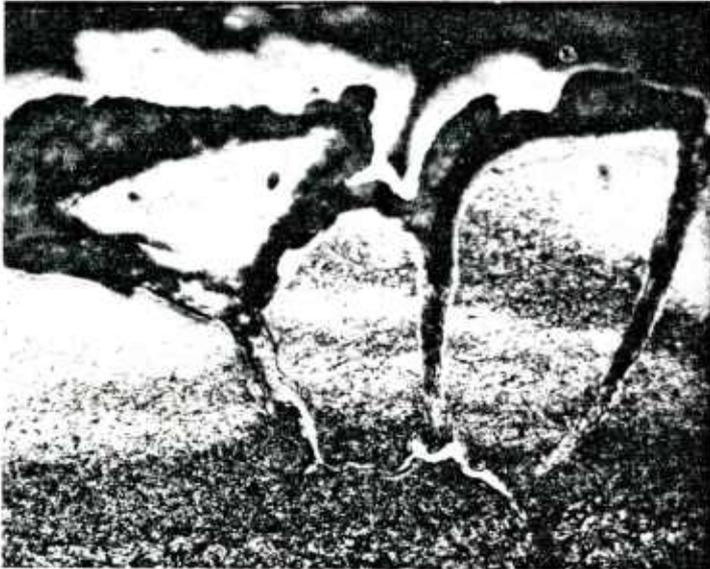
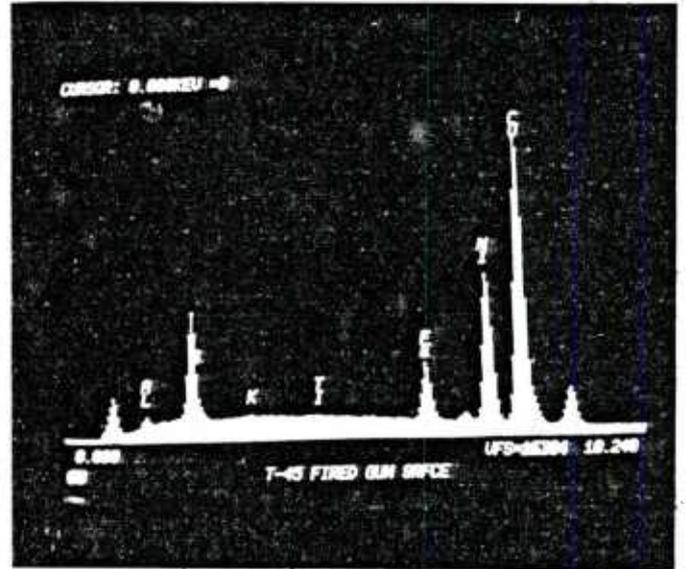
Figure 4. Cannon Tube T-45, Taper Sections.

The near-surface structure of this sample can be seen in more detail in the optical micrograph of a 15° taper section shown in Figure 4a. EDXS analysis of this same area in the SEM revealed that a considerable amount of Cu, and some S and Al were present in the altered ferrite region below the white layers. Penetration of Ni during plating demonstrated that these cracks were open to the bore surface.

(a) Optical (200X).

(b) EDXS.

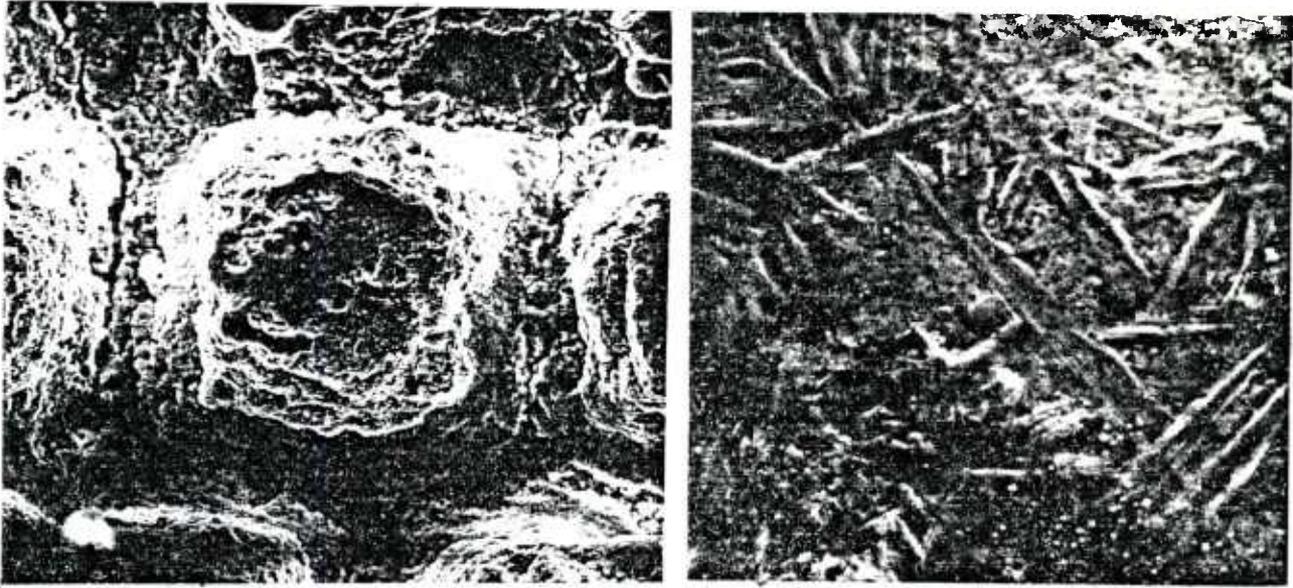
Figure 5. Cannon Tube 6326, Bore Surface.

Examination of the bore surface of cannon tube 6826 (no additive in the propellant) in the SEM revealed a rather different appearance, as illustrated in Figure 5. The small crystals visible on the surface at higher magnification were suspected to be cementite (Fe_3C). This opinion was confirmed by subsequent Auger, Mossbauer, and SIMS analyses of the surface, and by stripping the surface film and obtaining direct electron diffraction evidence for Fe_3C .

(a) (500X).

(b) 2000X.

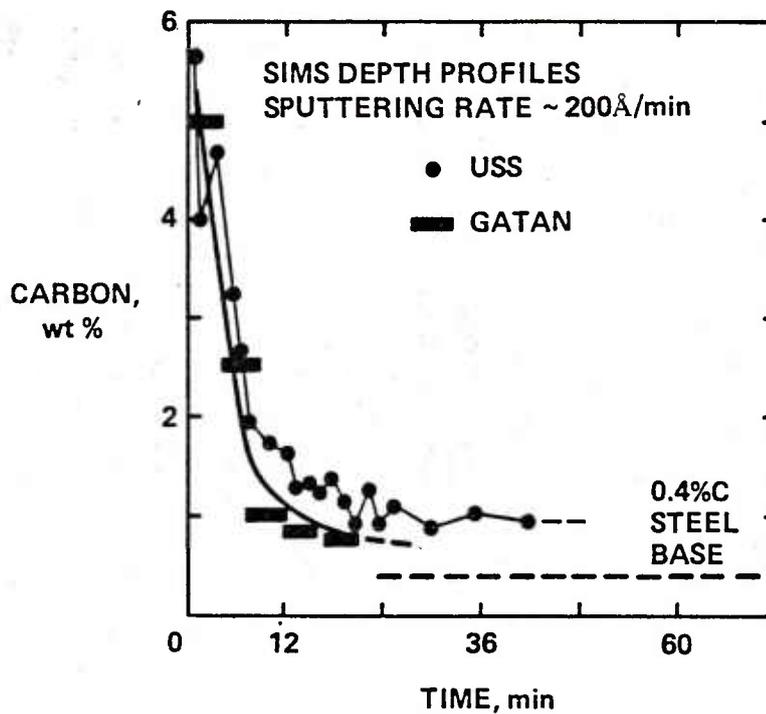
Figure 6. Cannon Tube 6826, Bore Surface.

The carbon concentration in the white layer region was determined by several techniques including a Mossbauer surface analysis method, depth profiling by Auger and SIMS, and profiles on cross-sections by electron probe analysis using a special light element detector. All of these methods indicated the presence of 0.25 to 0.5 μm of Fe_3C on the surface and a subsurface layer of about 2 to 10 μm of austenite containing two percent carbon near the surface and about one percent carbon in the interior. The very rough surface of eroded corrosion tubes precludes obtaining more than an estimate of the thicknesses of the white layer constituents by profiling. An example of a SIMS depth profile is illustrated in Figure 6.

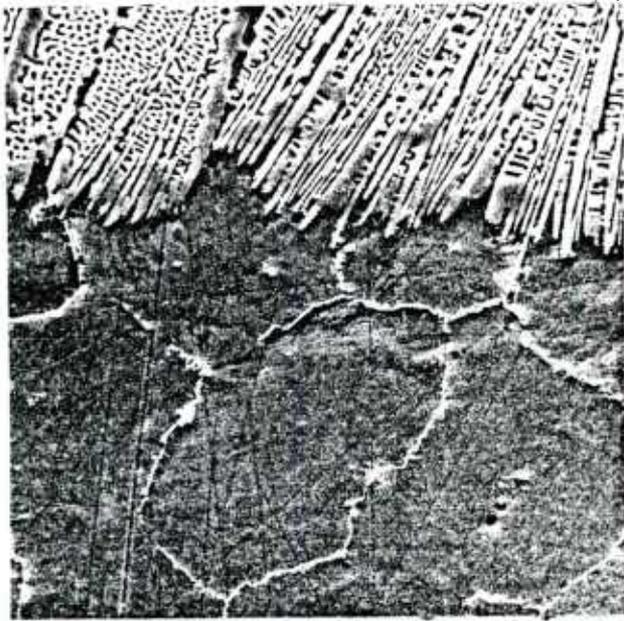
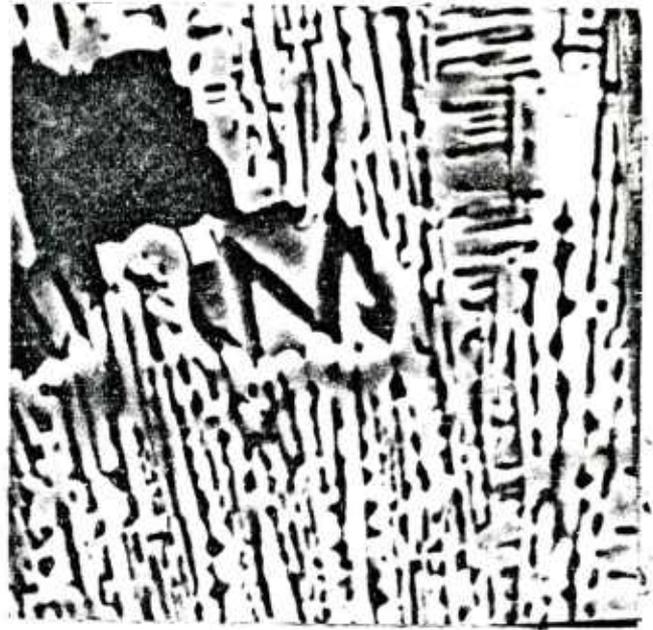
Figure 7. Simulation Specimen Pulse Heated in Methane.

The effects of chemical alteration of the surface of 4340 steel during pulse heating in high pressure methane are illustrated in Figure 7. Polished and etched 6° taper sections reveal the appearance of the surface eutectic structure (with pools of austenite) and the grain boundary carbides in the subsurface austenite. The very fine scale of the eutectic suggests an extremely rapid solidification rate. An example of transformation of a surface austenite pool to martensite is illustrated in Figure 7a.

(a) SEM (2000X).

(b) SEM (5000X).

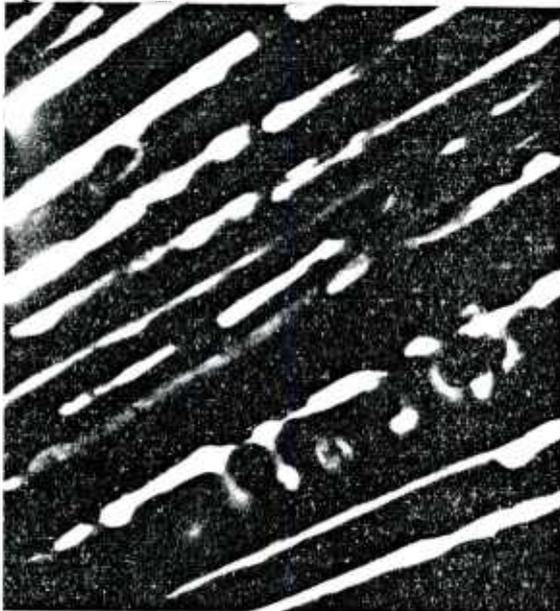
Figure 8. Simulation Specimen Pulse Heated in Methane.

Transmission electron micrographs illustrating the lamellar structure of the surface carbide film and an example of the high carbon plate martensite which formed in the subsurface austenite region are shown in Figure 8. The electron diffraction pattern from this film confirmed that it was Fe₃C, i.e., identical to that observed for fired cannon specimens.

(a) HVEM (16,000X).

(b) HVEM (21,500X).

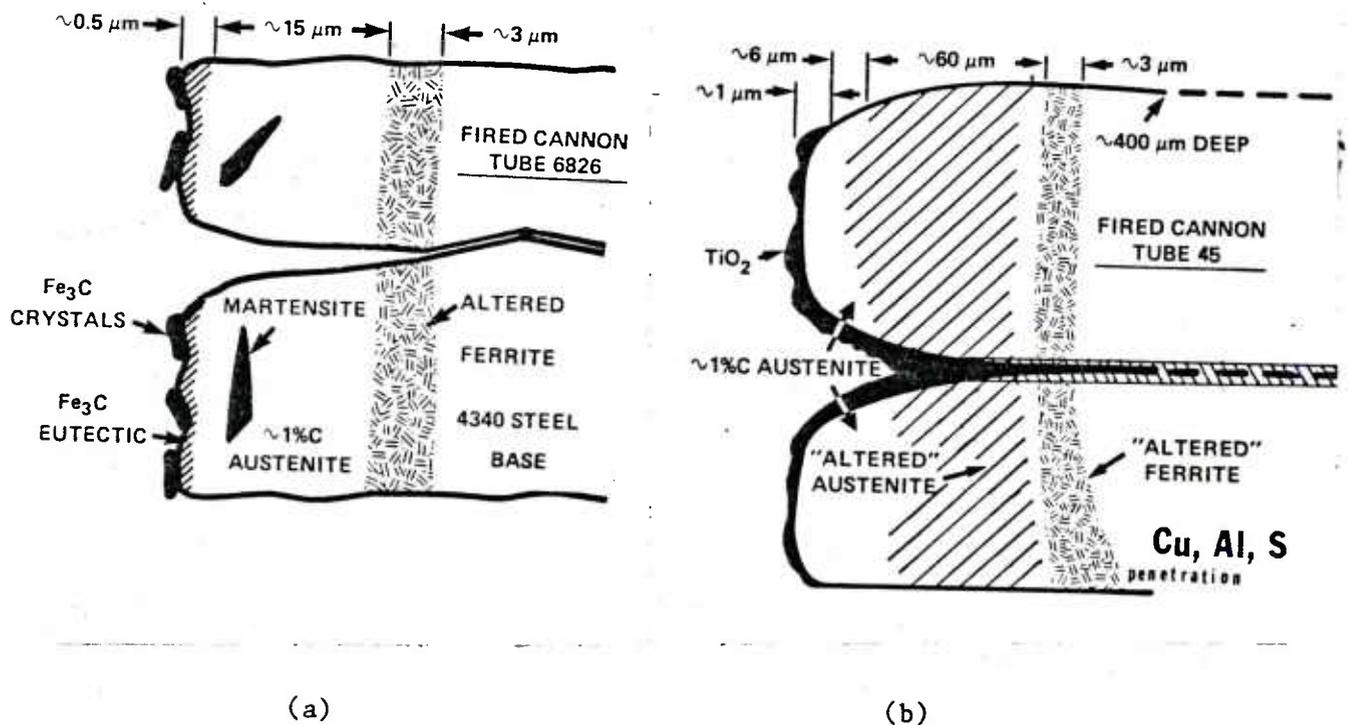
Figure 9. Schematic Illustration of Cannon Bore Surface.

The deep penetrating cracks in fired cannon tubes were found to contain Cu, and lesser amounts of Al and S right to the tip of the crack, i.e., more than 400 μm in some cases. The results of all of the various observations and analyses of eroded bore surfaces from two cannons are summarized schematically in Figure 9.

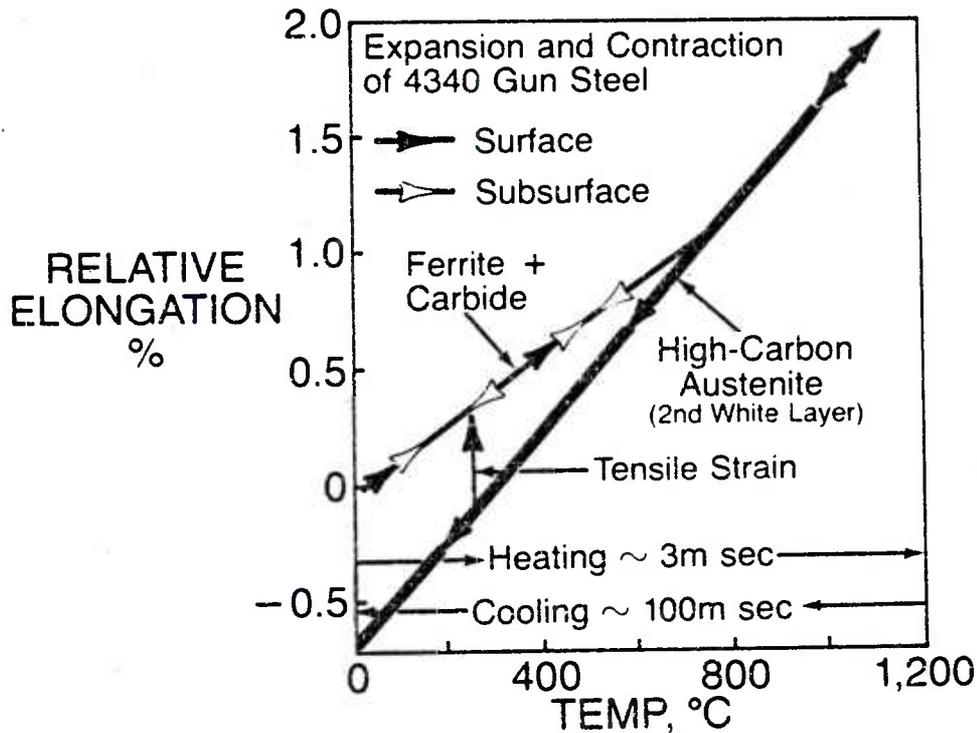
Figure 11. Illustration of Origin of Heat Checking.

Rupture of the surface results from rapid thermal expansion and contraction of the surface during each firing cycle. The expansion coefficients of ferrite and austenites are very different so that the presence of a surface layer of high carbon austenite (with a very low M_s) can result in very large tensile strains, as illustrated qualitatively in Figure 11. Because of the large mass of the cannon tube, cooling of the heat-affected zone is relatively rapid and the effective strain rate fairly high, resulting in the formation of "quenching cracks". The occurrence of coarse and fine networks suggests that the stresses relieved by an initial stage of crack formation build up during further cooling and cause secondary cracking. This is analogous to the familiar paint cracking or mud flat crack patterns.
