TR-0084(4930-01)-2 SD-TR-83-92

Pulsed D₂-F₂ Chain-Laser Damage to Coated Window and Mirror Components

S. T. AMIMOTO, J. S. WHITTIER, A. WHITTAKER,
A. CHASE, and R. HOFLAND, Jr.
Aerophysics Laboratory
Laboratory Operations
The Aerospace Corporation
El Segundo, Calif. 90245

15 December 1983

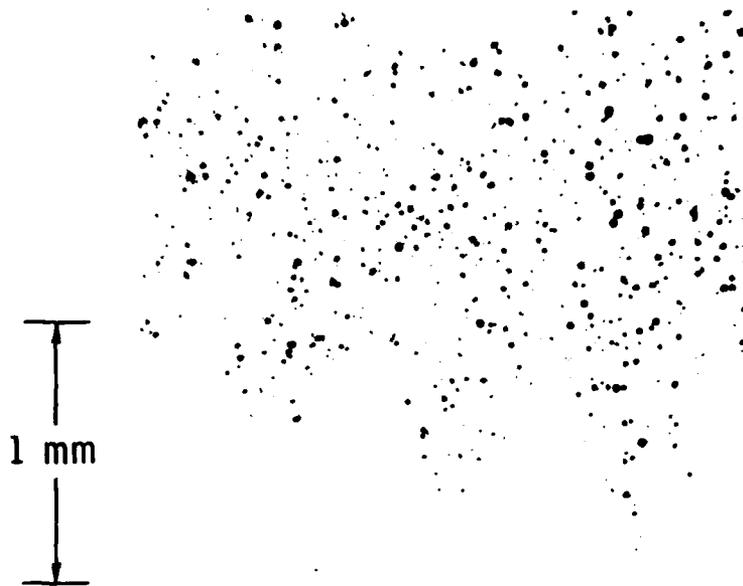
Fig. 6b. Unmasked Mirror Segment. Lower half not exposed to laser radiation. Upper half exposed to 9.5 J/cm^2 . (Original magnification 37.5X)
