ASPETUCK RES. DAM
CT 00021

PHASE I INSPECTION REPORT
NATIONAL DAM INSPECTION PROGRAM

SEPTEMBER 1980

SAUGATUCK RIVER BASIN
EASTON, CONNECTICUT

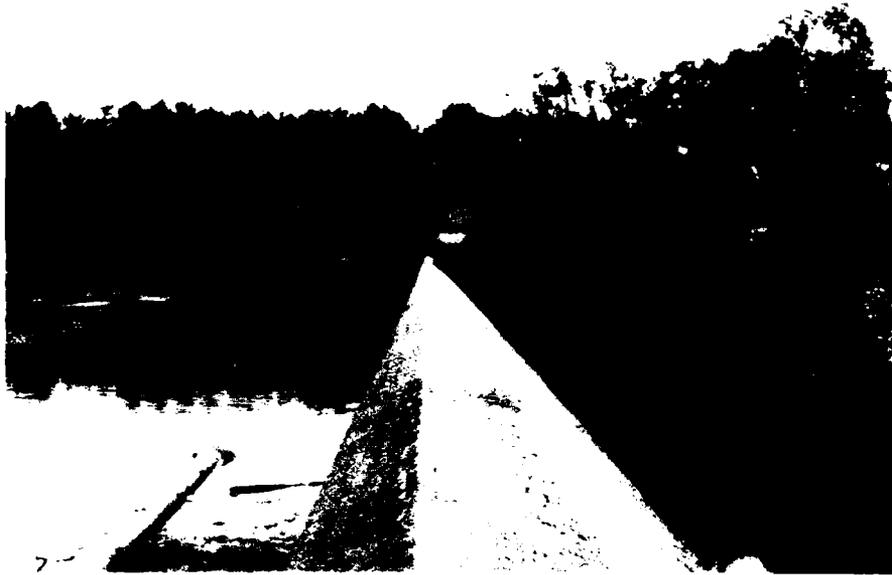
PHOTO 1
SPILLWAY CREST LOOKING EAST

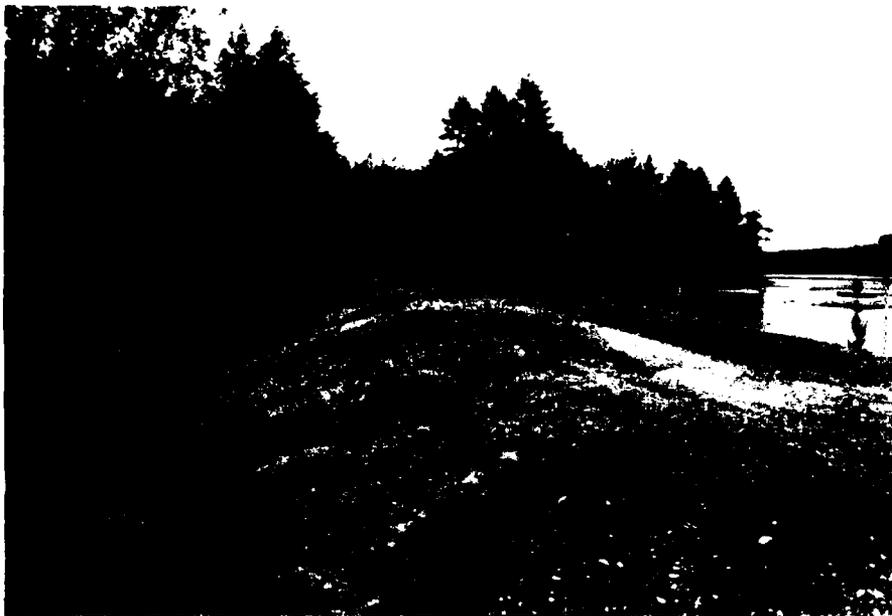
PHOTO 2
WEST EMBANKMENT

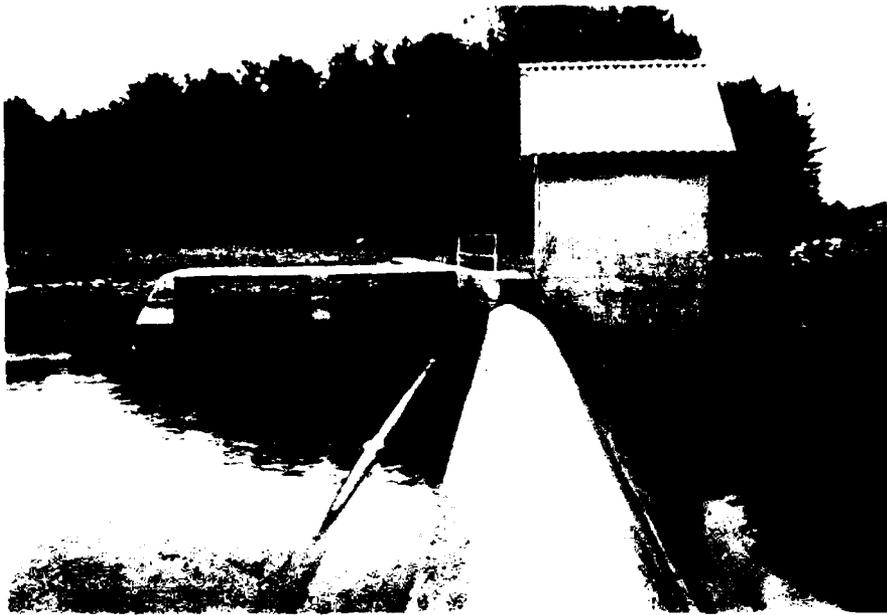
PHOTO 3
DIVERSION INLET - GATE HOUSE - BLOWOFF

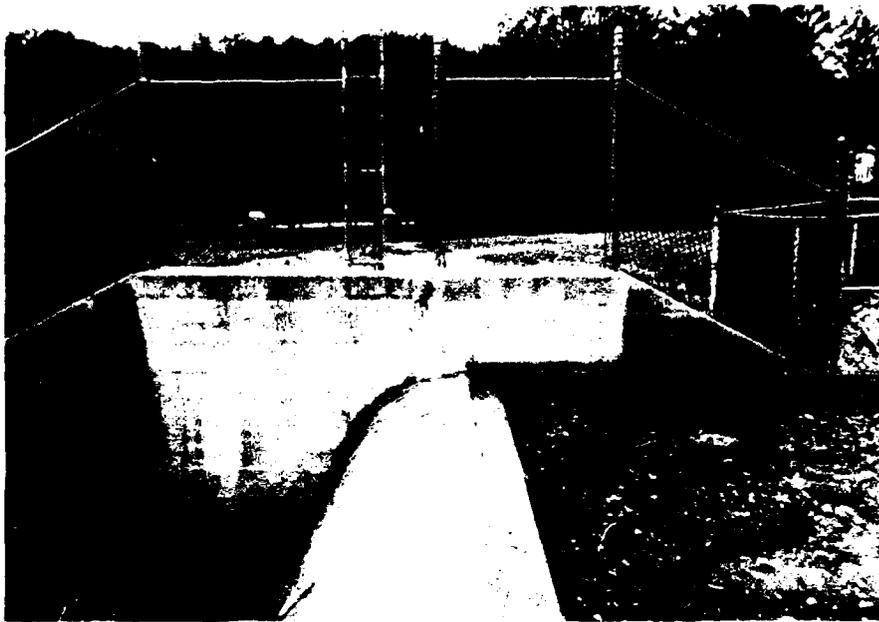
There is a masonry apron at the toe of the spillway which was intact with no signs of distress (Photo 8). The western abutment and wingwall has a crack extending from the top of the spillway to the top of the dam. This crack was repaired in the past, but has since reopened with the mortar coming loose (Photo 7). Seepage was noted coming from around both the east and west wingwalls of the spillway. The amount of flow was negligible. There is a pipe coming from under the west wingwall. This pipe does not show on the original drawings and it is not known when it was installed. Flow out of this pipe was estimated to be 25 gallons per minute.

PHOTO 7
WEST ABUTMENT
