SUCCESS LAKE DAM

CT 00079

PHASE I INSPECTION REPORT

NATIONAL DAM INSPECTION PROGRAM

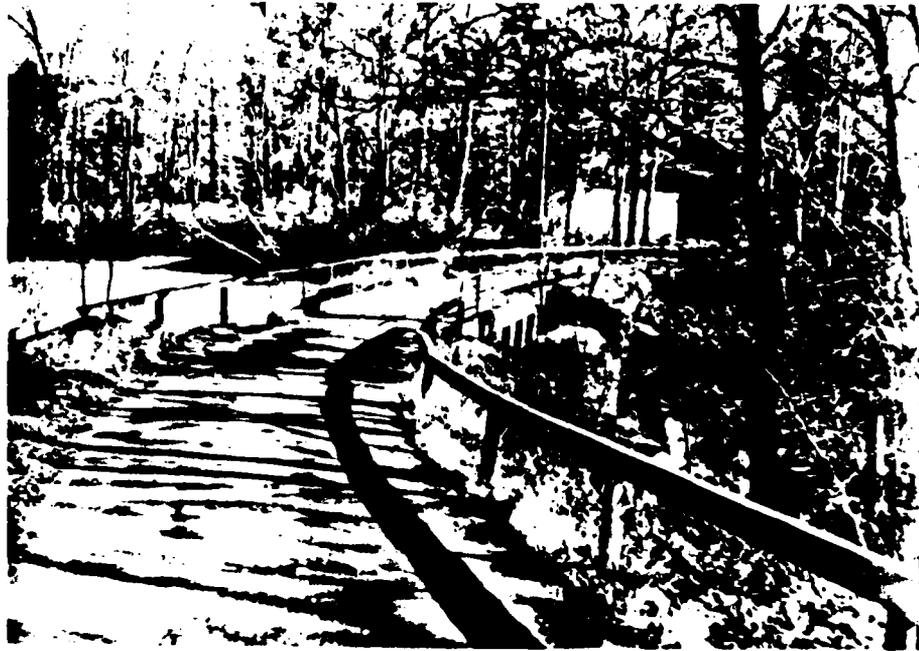
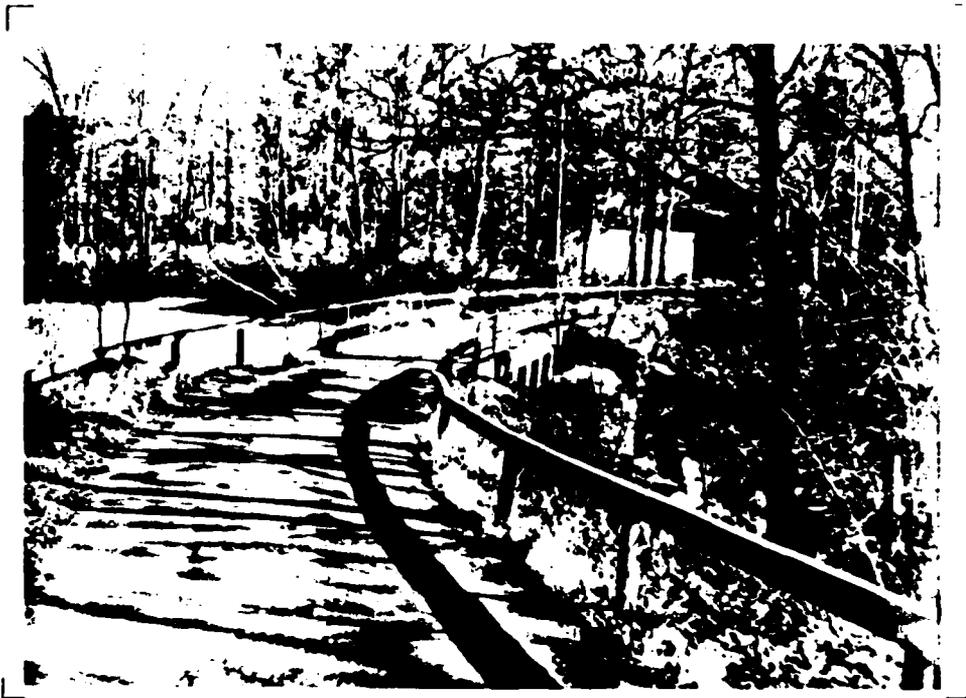
Photo 1 Top of dam and single lane road.

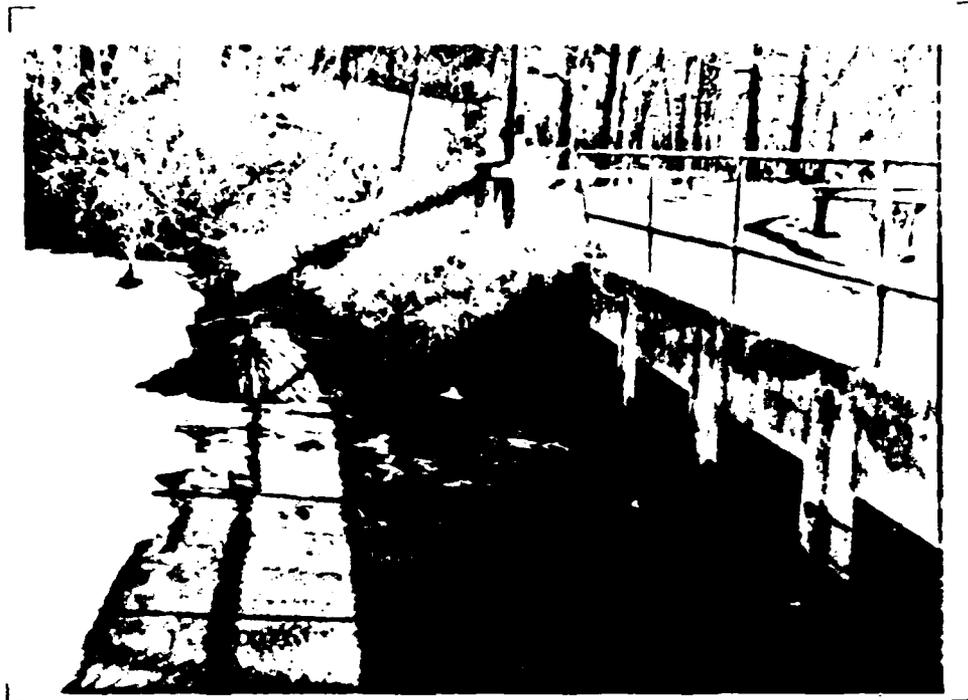
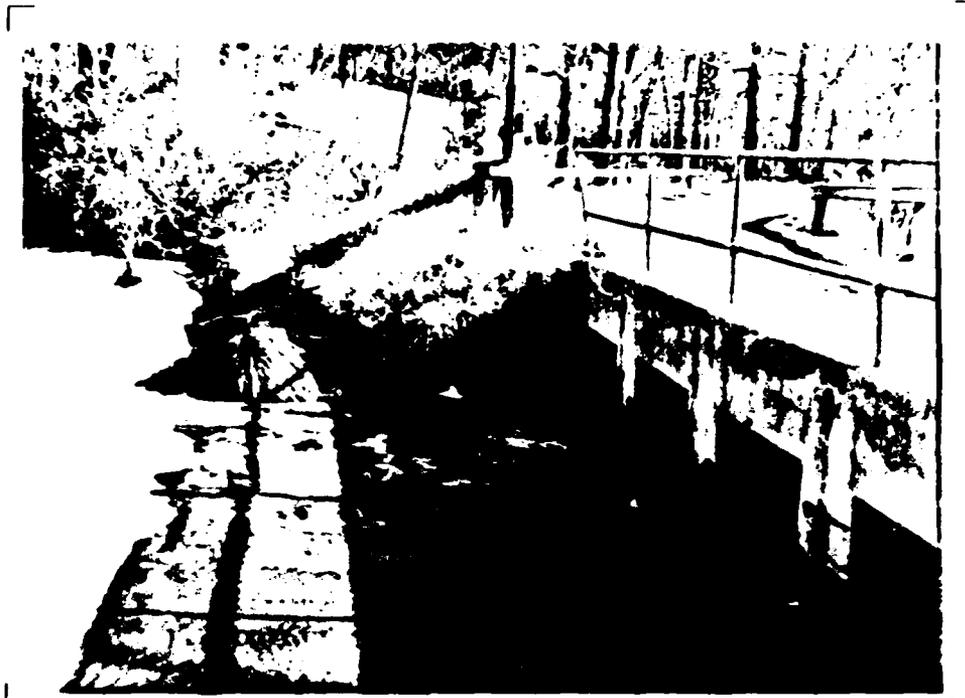
Photo 3 Upstream face of dam, spillway crest and left dam embankment.
