CONNECTICUT COASTAL  
BRANFORD, CONNECTICUT

**BRANFORD SUPPLY PONDS DAM  
CT 00116**

**PHASE 1 INSPECTION REPORT  
NATIONAL DAM INSPECTION PROGRAM**

APRIL 1981

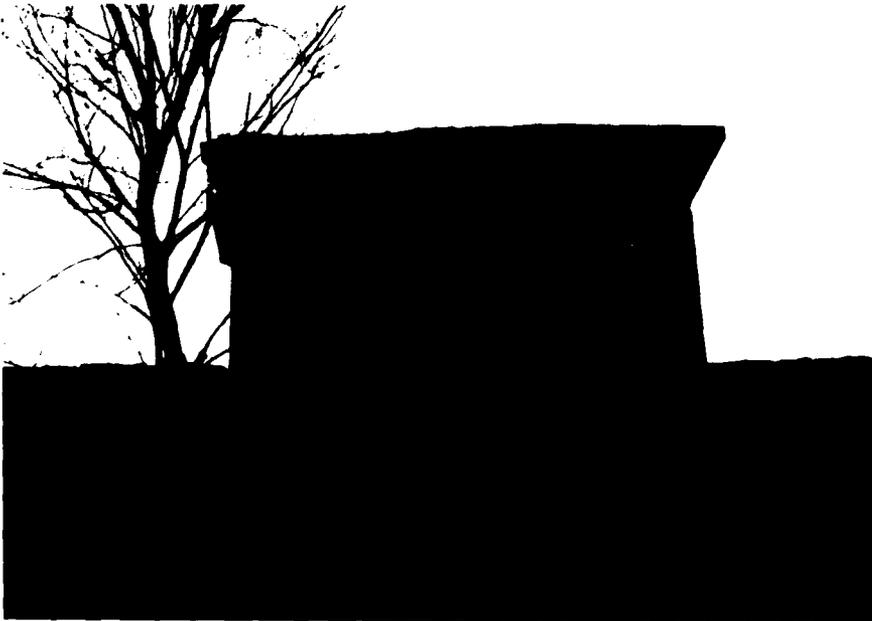
There is a gatehouse and outlet works located on the dam. The outlet works are in poor condition. There is no lock on the gatehouse door and there is evidence of trespass. There are a number of significant cracks (maximum size 1/32 of an inch) in the walls of the gatehouse. A horizontal crack runs along the perimeter 5 feet above the floor. There are three vertical cracks - two at corners of north wall and one midway in south wall - starting at the floor to a distance of 5 feet. The gate valves are unpainted, ungreased and rusty, but are still operable. The gate chamber is flooded and therefore, inaccessible by the rusting ladder leading down to it. The outside of the gatehouse is cracking in a number of places and the roof slab has visible reinforcing. The vent pipe consists of a 6 inch pipe through the downstream gatehouse wall.

8. Looking upstream at gatehouse. Note cracks and spalling of concrete on roof and at base.

5. Perform a detailed hydrologic and hydraulic analysis to assess further the potential of overtopping the dam and the need for and the means to increase project discharge capacity.
6. Repair cracking and spalling observed at the gatehouse..
7. Repair spalling and cracking of dam cap and left downstream training wall of spillway.
8. The existing tree growth within an area of 10 feet from the downstream toe of the dam should be removed by uprooting and the root zones backfilled with carefully selected soil, placed as directed by the Engineer.
